Arboricultural Health & Safety Report

Land adjacent Charney Playing Field
Charney Bassett
Wantage
Oxfordshire
OX12 0EW

February 2020

Ref: 19169

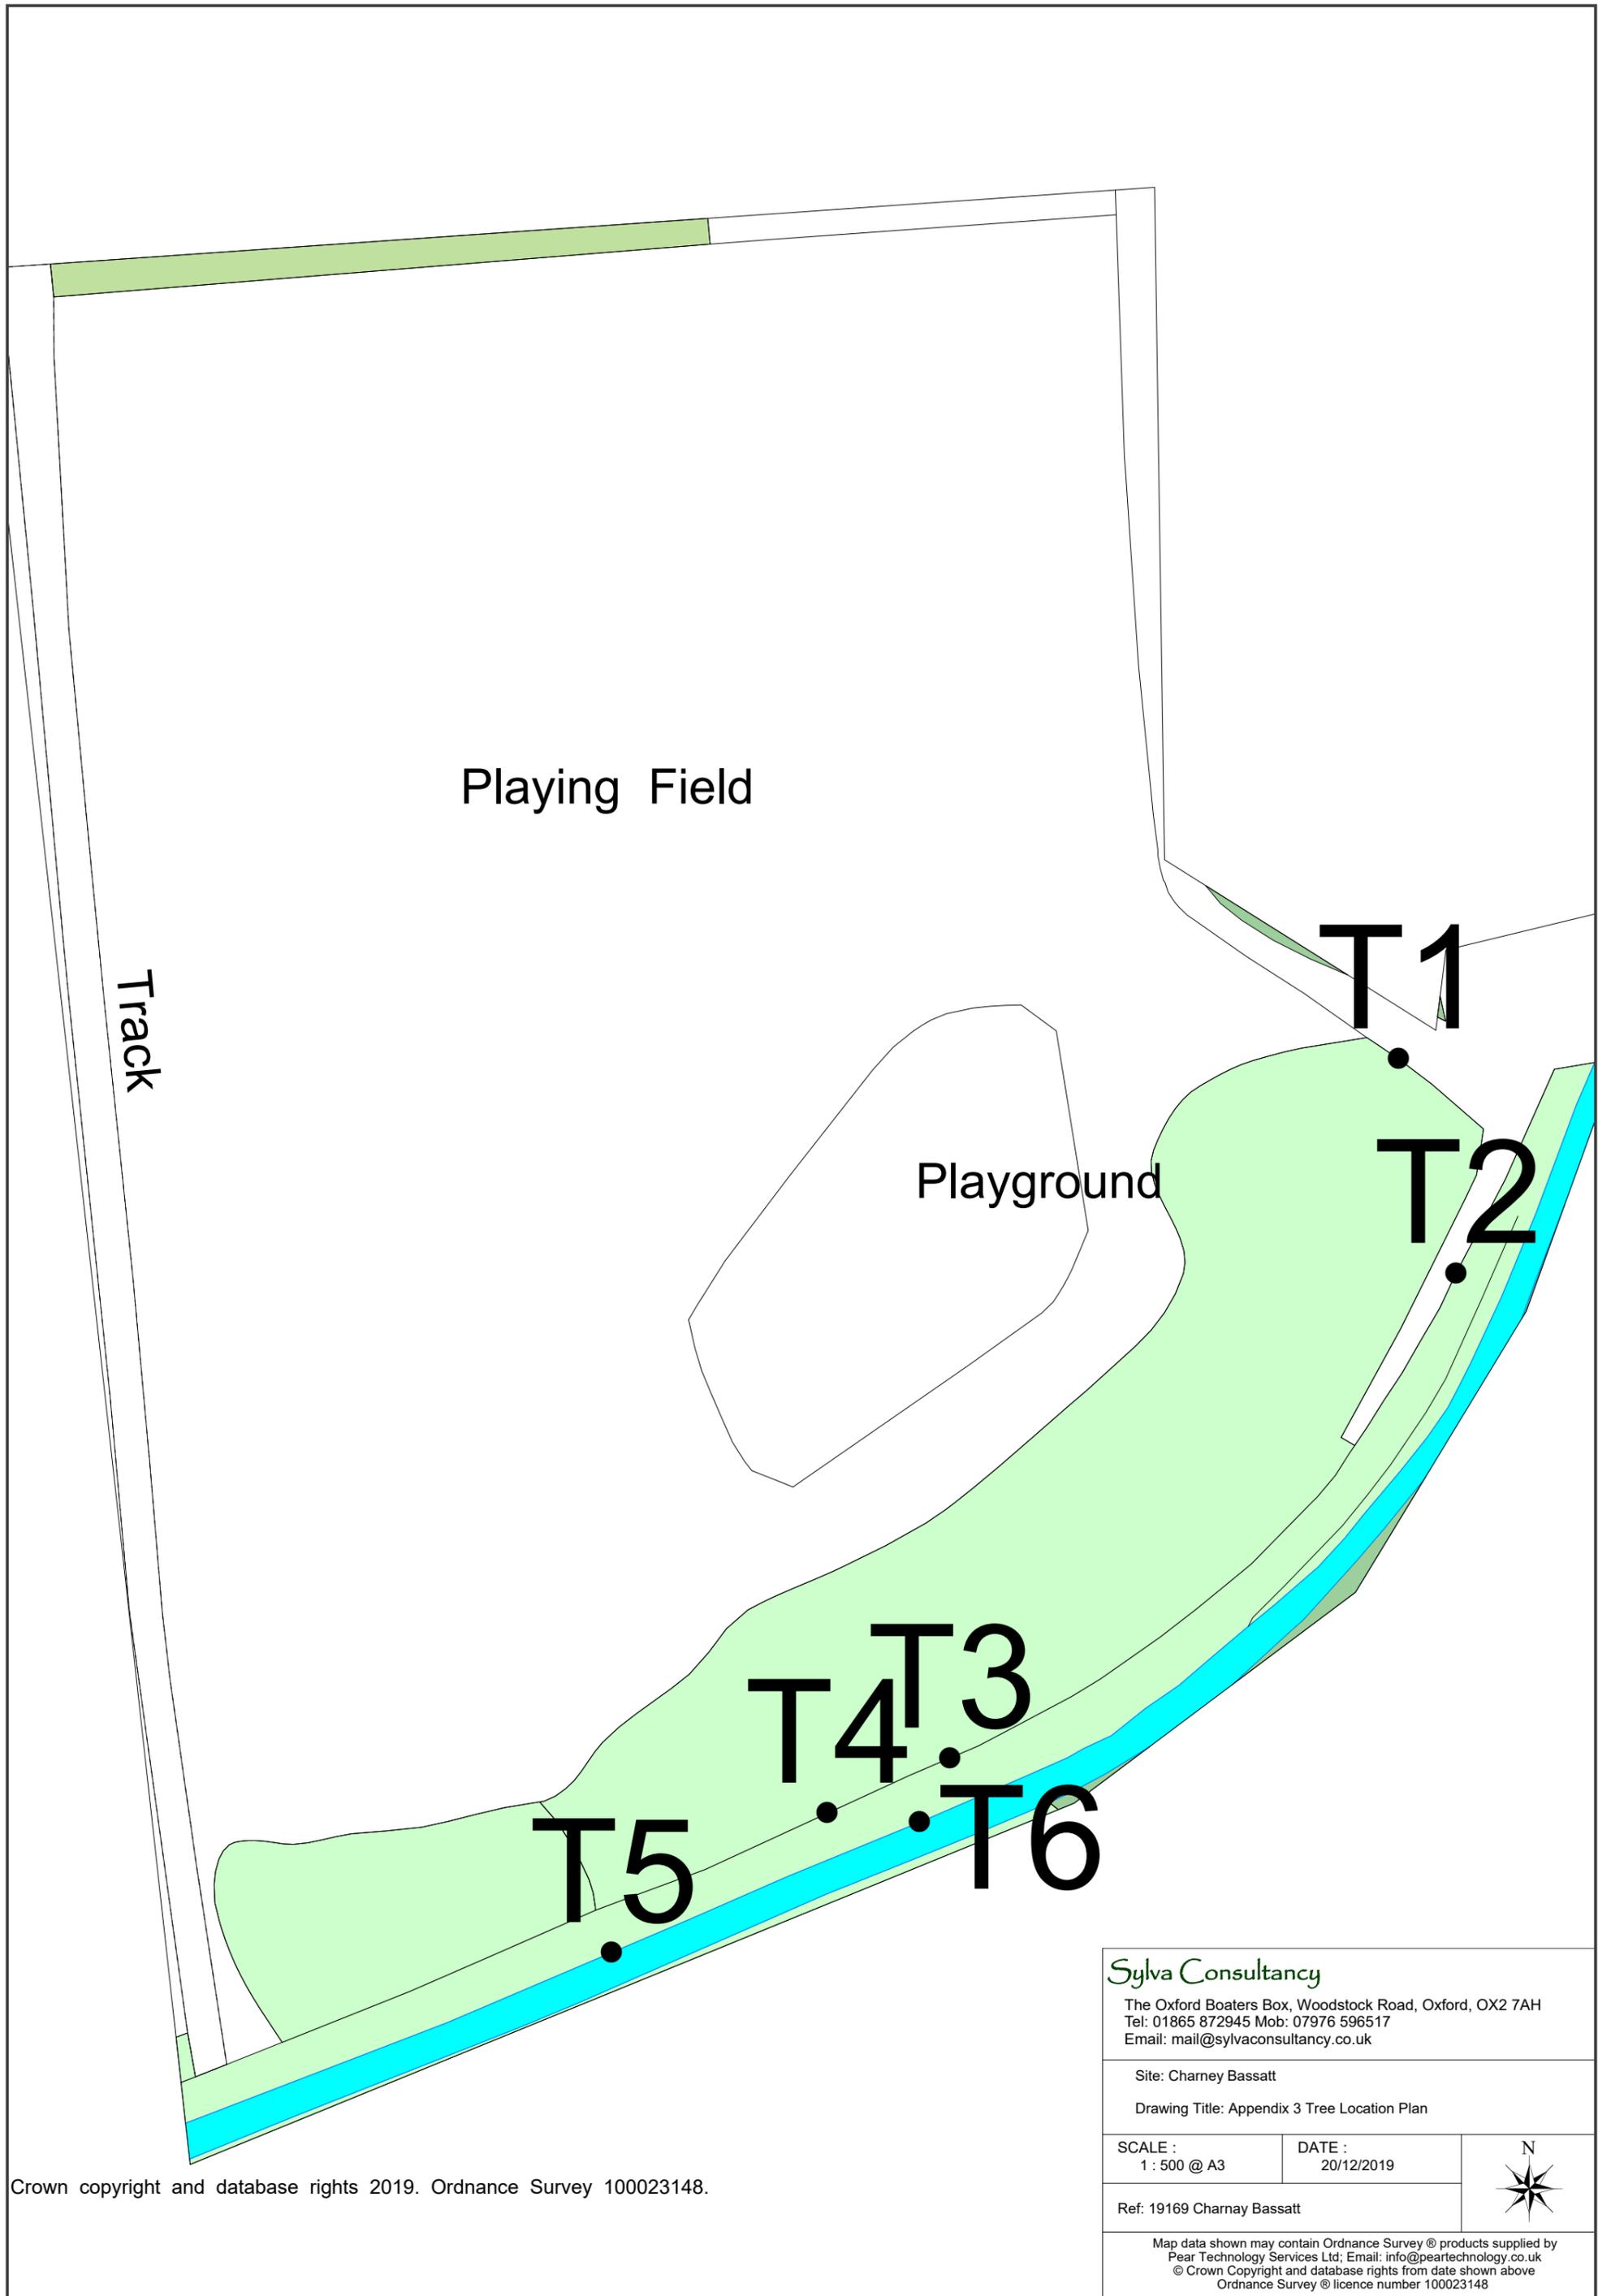
APPENDIX 3
TREE LOCATION PLAN

Tree No.	Species	HT (M)	Age Class	Phys. Cond.	Branches	Leaf/Buds	Stem	Roots	Comment	Proposed Work	Priority	Next Survey (months)
T1	Aspen	17	M	F	Major dead wood	Normal	Ivy covered	No visual defects	Failed hung up branch on east side of tree. Within falling distance of footpath.	Prune	1 Month	12
T2	English Elm	10	SM	D	Dead	Dead	Dead	Dead	Dead Elm adjacent to path. Option 1 Fell; Option 2 reduce to 3m. Second dead Elm 4 m to the south.	Fell	3 Months	
T3	Poplar	21	M	F	Damage/wounding; Minor dead wood	Normal	Ivy covered	No visual defects	X1 limb rubbing on the adjacent stem of tree. Reduce upper canopy by 3m to remove direct contact and to reduce risk of failure.	Prune	3 Months	12
T4	Aspen	22	M	F	Damage/wounding	Normal	Ivy covered	No visual defects	Damage on main stem caused by T3. Reduce canopy below damage area - approx. 3m.	Prune	3 Months	12
T5	Norway Maple	15	SM	P	Damage/wounding	Normal	Bark wounds; Leaning	No visual defects	Growing adjacent to ditch. Significant wounding on main stem. Leans towards path. Reduce to 3m	Fell	3 Months

T6	Aspen	14	M	P	Damage/wounding	Normal	Failed leader	No visual defects	Part failed leader at 12m agl - growing towards neighbouring property and over stream. Priority to remove.	Fell	1 Month

Tree No.	Species	Work Category 1	Work Item 1	Priority 1	Work Category 2	Work Item 2	Priority 2	Work Category 3	Work Item 3	Priority 3	Comment	Date of Works
T1	Aspen	Prune	Faulted branch/limbs	1 Month							Remove ailed hung up branch on east side of tree.	
T2	Elm	Option 1	Fell to ground level	3 Months	Option 2	Fell to safe height	3 Months				Dead Elm adjacent to path. Option 1 Fell; Option 2 reduce to 3m. Second dead Elm 4 m to the south - same options.	
T3	Poplar	Prune	Reduce faulted limbs/stems	3 Months							Reduce upper canopy by 3m to remove direct contact with rubbing branch on adjacent tree and to reduce risk of failure.	
T4	Aspen	Prune	Reduce faulted limbs/stems	3 Months							Reduce canopy below damage area - approx. 3m	
T5	Norway Maple	Fell	Fell to safe height	3 Months							Tree leans towards path. Reduce to 3m.	
T6	Aspen	Fell	Fell to ground level	1 Month

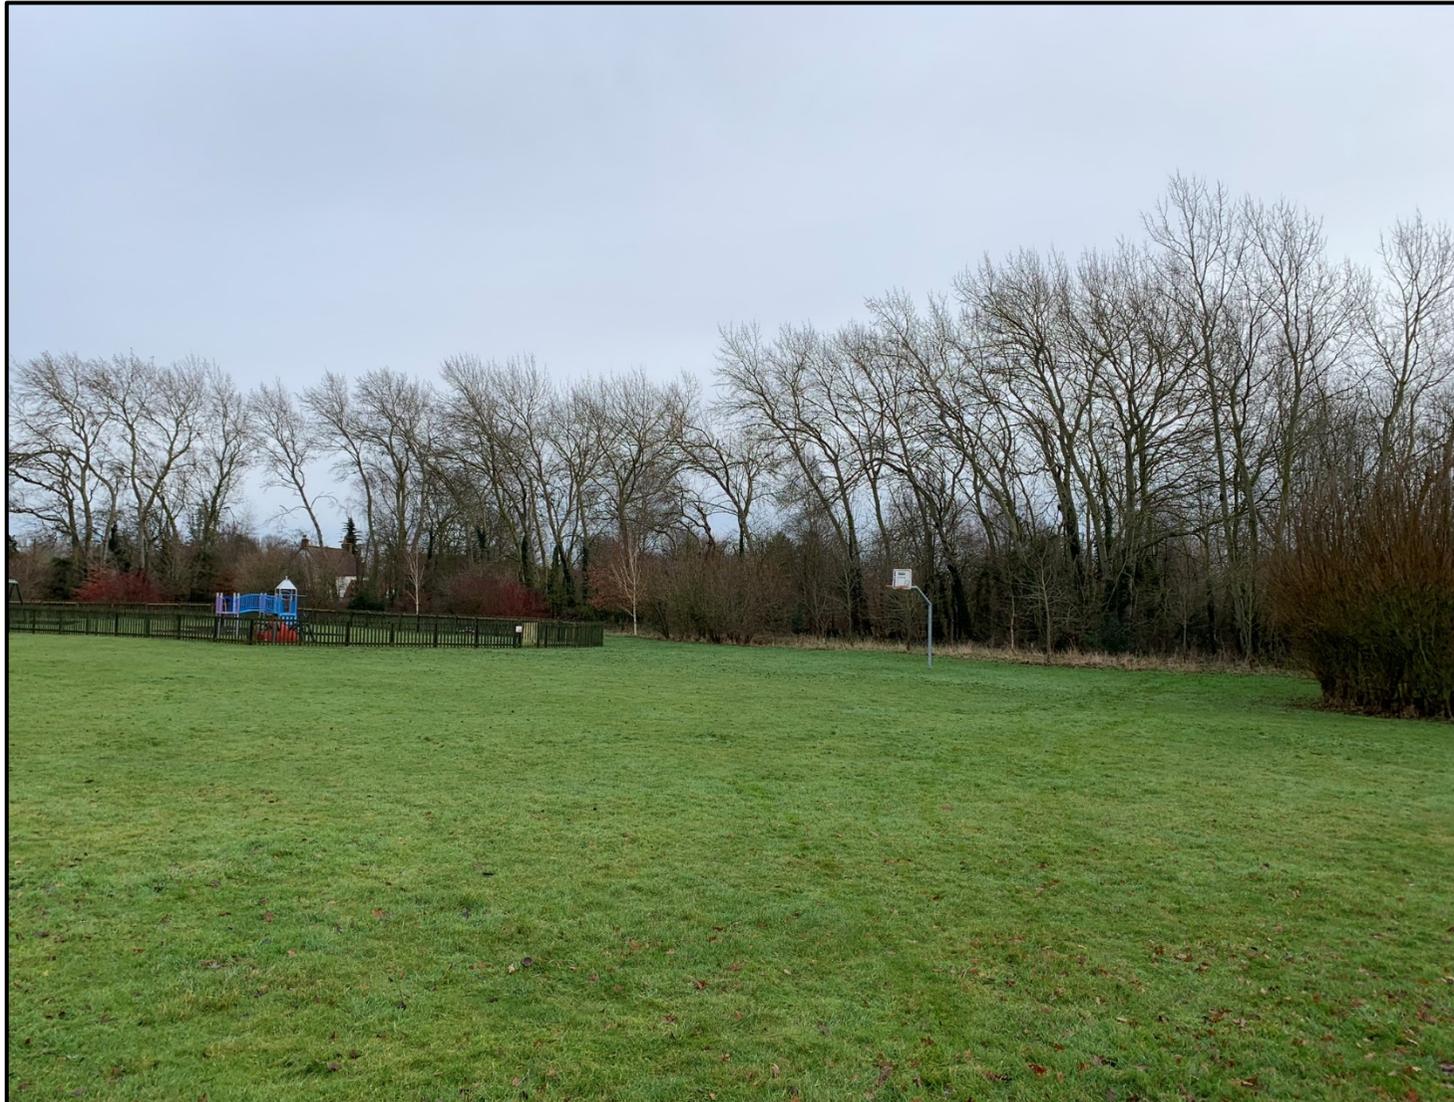
Photograph of Aspen Group

- 3.2.1 The majority of the Aspen trees have ivy present on the main stems and or within tree canopies. Whilst it is acknowledged the many benefits of retaining ivy, ivy can obscure defects. Ivy growth is not a threat to the health of otherwise healthy trees. On this occasion, although the ivy was moved aside in order to assess trees it was beyond the scope of this report to sever the ivy in order to allow a full inspection to be carried out of every ivy-clad tree.

- 5.2.1 The trees are etiolated in form with trees on the north side of the Bridle path 5 'reaching' for light to the north and trees growing to the south 'reaching for light' to the south. Competition for tree growth due to the close spacings (and lack of early thinning works) has resulted in biased canopy growths which is considered less than desirable. It is considered that there is an option to undertake a 50% crown reduction to retain the trees that would allow greater longevity of the trees in the landscape. However the proposed reduction works does not follow good arboricultural practice (the amount of reduction works) but should the percentage be less it is regarded that no net benefit would occur (the trees would still be exposed in the landscape with uneven canopy growth).

- 3.2.2 To ensure that the trees with ivy are free from significant defects and/or decay it is been recommended for the ivy to be severed and for the trees to be re-inspected once the ivy has died back.

5.4.3 This option could be viewed as quite 'extreme' and that initially you would be losing a valuable local landscape component of the area. However, whilst costs would be initially high it is expected some of these can be offset. Costs for H&S Inspections would be negated up to between 10-15 years as the trees become establish. So once replacement planting has been carried out the only initial costs would be replacing losses with thinning works occurring as the trees start maturing. With restocking there is a good opportunity to move away from the current monoculture. Follow up work can be community based and this will aid in providing a sense of 'ownership' with the trees so there is a greater likelihood of the trees reaching maturity and making a positive contribution to the local area.

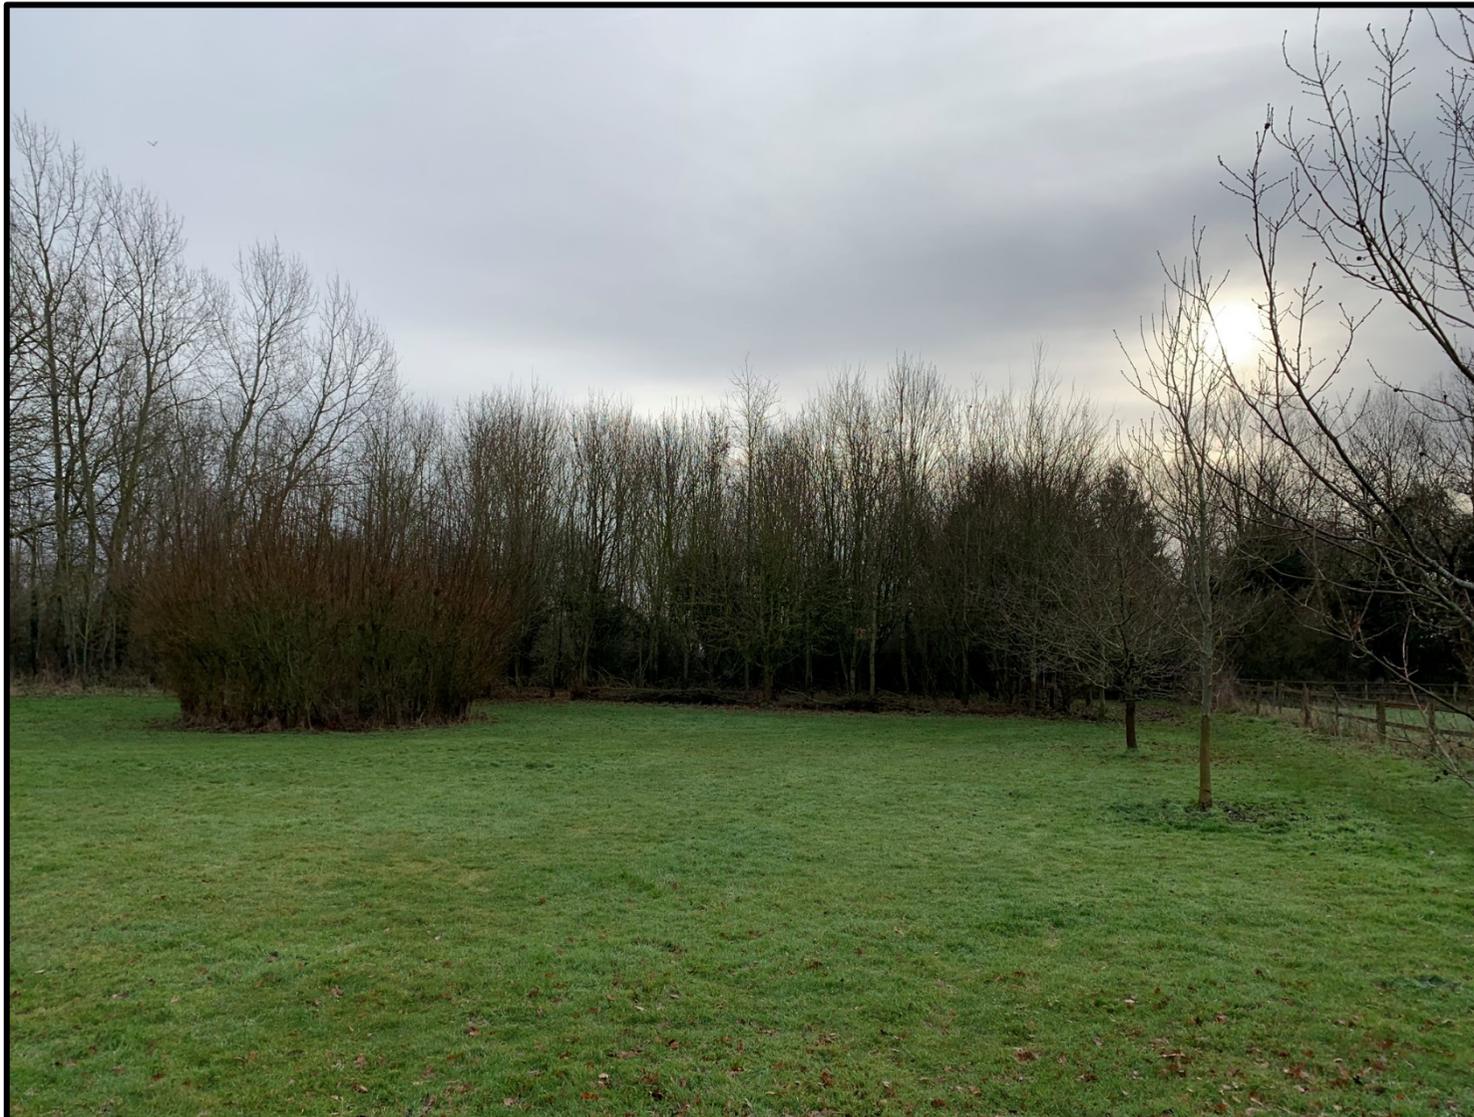
Photograph of Copse

- 3.2.4 The Copse area consists of young mixed species trees with the dominant species recorded as Ash, Hazel, Field Maple and Oak. A young Hawthorn hedge is also present that runs along Bridlepath 5 to the south of the Copse. The spacing of the trees is a typical of tree planting spaces associated with newly planted areas under forestry management. Whilst it is acknowledged that some management is occurring tree spacings are still very close which has resulted in many of the tree's forms being etiolated.
- 3.2.5 The recommended work for this area is to undertake 'thinning' works of 10%, concentrating on removing the poorer quality trees in order to allow the 'better' specimens to establish.

3. Undertake thinning works of 10% with the Copse Area.
- 4.2 All pruning works should be carried out in accordance with British Standard 3998: 2010 'Recommendations for Tree Works' and in compliance with good practice as promoted by the Arboricultural and Forestry Advisory Group. It is further recommended that prior to any tree works recommended an inspection for the present of bats is undertaken.
