## Annual Inspection

Charney Hall and Field Trust

Charney Field

Inspection Ref: 1586347

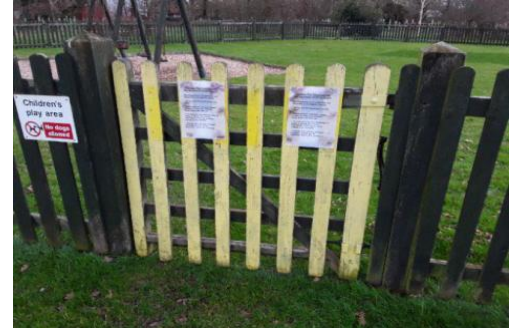
**Item:** Gate - Self Closing  
**Manufacturer:** Unknown  
**Surface Type:** Grass  
**Item Quantity:** 2  
**Equipment Compliance:** N/A  
**Surface Area Compliance:** N/A

There are openings that are less than 12mm that could trap or crush fingers - Where possible a 12mm gap should be maintained on both sides or between the gate leafs

The gate is not operating correctly - Take effective action to ensure the gate closes between 4 and 8 seconds

A number of fixing(s) have worked loose - Secure all loose fixings

There is some evidence of rot in the timber - Monitor for any further deterioration and replace as required

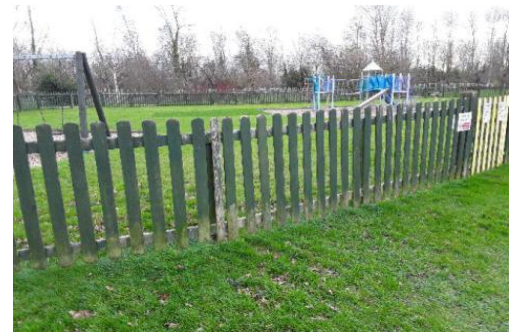
**Item:** Fencing - Timber  
**Manufacturer:** Unknown  
**Surface Type:** Grass  
**Item Quantity:** 1  
**Equipment Compliance:** N/A  
**Surface Area Compliance:** N/A

There is some strimmer / machinery damage apparent on the posts, this can penetrate the preservative applied to the timber and accelerate the rotting process - Monitor for any deterioration (rot) and replace as required

There is some damage to the fence sections - Monitor for any further deterioration and repair as required

There is some evidence of rot in the timber - Monitor for any further deterioration and replace as required

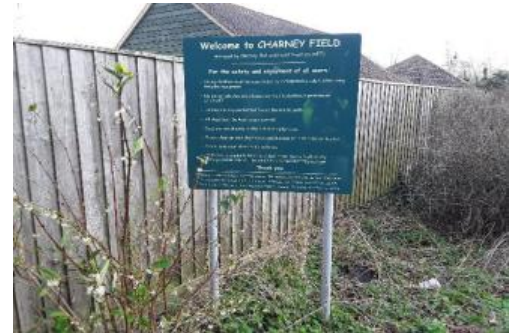
**Item:** Sign  
**Manufacturer:** Unknown  
**Surface Type:** Grass  
**Item Quantity:** 1  
**Equipment Compliance:** N/A  
**Surface Area Compliance:** N/A

This item is satisfactory - no work required -

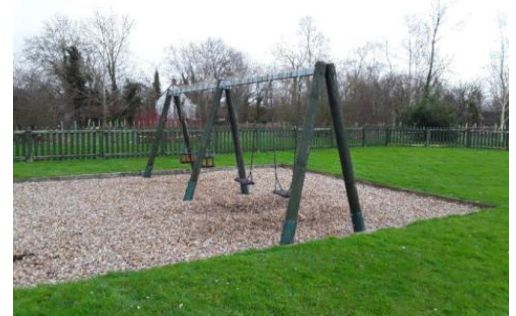
**Item:** 2 Bay 2 Flat 2 Cradle  
**Manufacturer:** Unknown  
**Surface Type:** Bark Mulch  
**Item Quantity:** 1  
**Equipment Compliance:** No  
**Surface Area Compliance:** Yes

The connecting links are in excess of 8.6mm and less than 12mm and fail the requirements of BS EN 1176 Part 1; clause 4.2.13, Chains - Monitor - No remedial work recommended

There is some notable evidence of chain wear - Monitor for any further deterioration and replace when 40% worn

The shackles are worn in excess of 40% and require renewing - Replace worn shackles

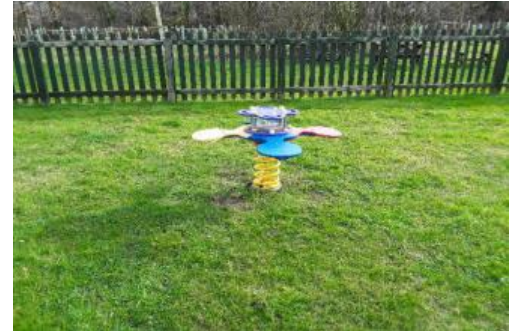
**Item:** Four Way Springer  
**Manufacturer:** Fahr Industries  
**Surface Type:** Grass Matrix Tiles  
**Item Quantity:** 1  
**Equipment Compliance:** Yes  
**Surface Area Compliance:** Yes

This item is satisfactory - no work required -

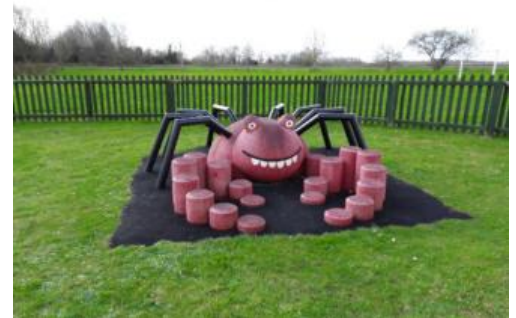
**Item:** Misc Item  
**Manufacturer:** Not Identified  
**Surface Type:** Wet Pour  
**Item Quantity:** 1  
**Equipment Compliance:** Yes  
**Surface Area Compliance:** Yes

This item is satisfactory - no work required -

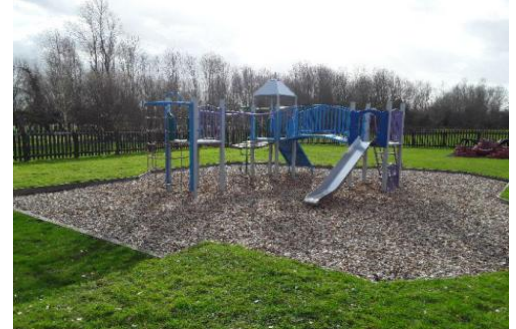
**Item:** Multi Play (Junior)  
**Manufacturer:** Not Identified  
**Surface Type:** Bark Mulch  
**Item Quantity:** 1  
**Equipment Compliance:** No  
**Surface Area Compliance:** Yes

There is some wear to the shackles. - Monitor for any further deterioration and replace when 40% worn

There is some notable evidence of chain wear - Monitor for any further deterioration and replace when 40% worn

There is/are finger entrapment/s in the frame due to missing fixings and the item fails to meet the requirements of BS EN 1176 Part 1 4.2.7.6 Entrapment of fingers - Replace the missing fixings to remove the entrapment

The item fails to meet the requirements of BS EN 1176 Part 1 4.2.7.2 head and neck entrapment in the barriers and/or steps - Monitor - No remedial work recommended

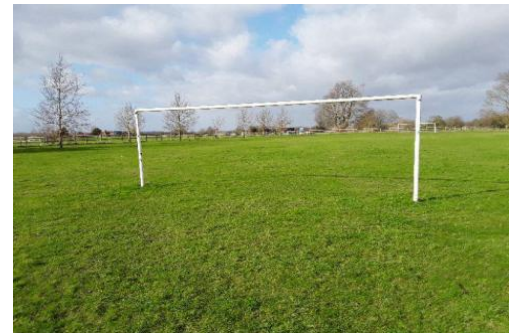
**Item:** Goal End  
**Manufacturer:** Unknown  
**Surface Type:** Grass  
**Item Quantity:** 2  
**Equipment Compliance:** N/A  
**Surface Area Compliance:** N/A

NB: We have undertaken a maintenance inspection only of the football goal(s); full load testing falls outside the scope of our inspection. - Implement load testing as required

The paintwork on this item has been damaged or worn exposing the metal underneath which is rusting - Treat any rusting components and repaint

The net is damaged - Repair as required

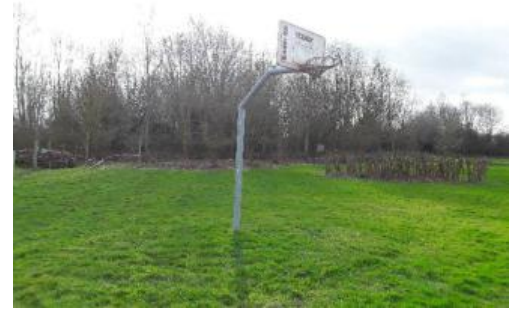
**Item:** Basketball Post  
**Manufacturer:** Baseline  
**Surface Type:** Grass  
**Item Quantity:** 1  
**Equipment Compliance:** Yes  
**Surface Area Compliance:** N/A

This item is satisfactory - no work required -

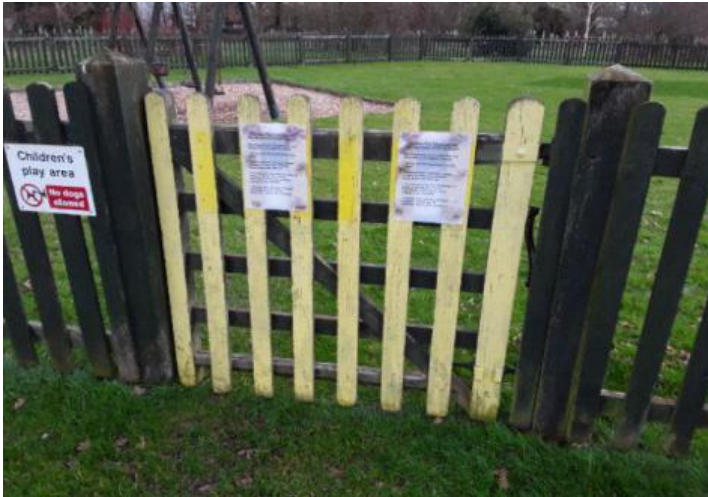
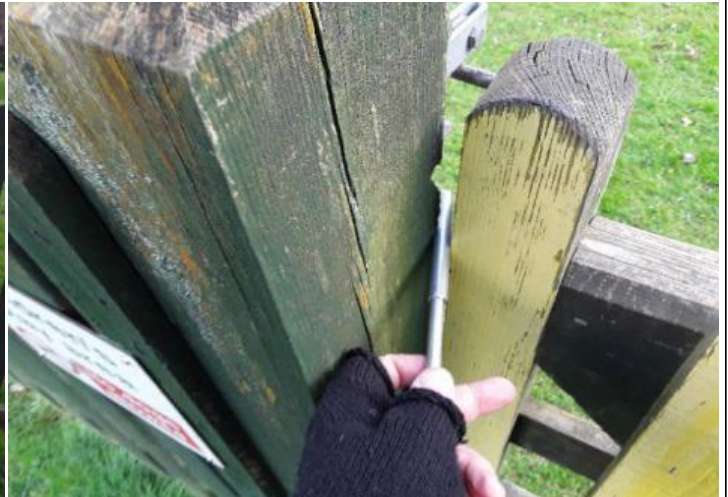
### 8 - Low Risk (Finding 1)

**Finding:** There are openings that are less than 12mm that could trap or crush fingers

**Action:** Where possible a 12mm gap should be maintained on both sides or between the gate leaves

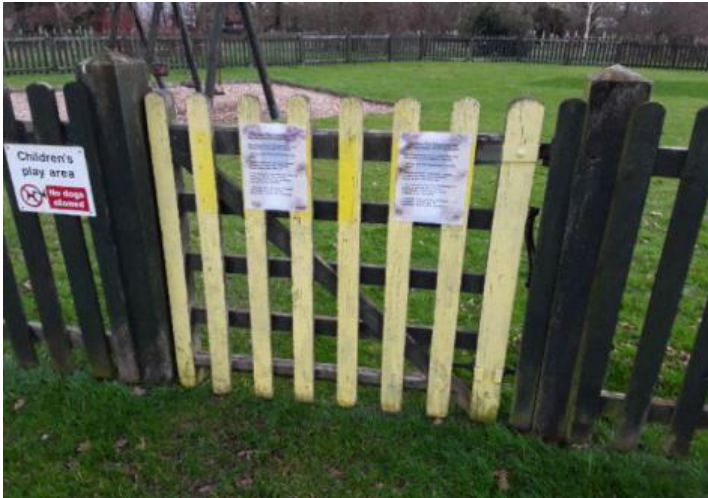
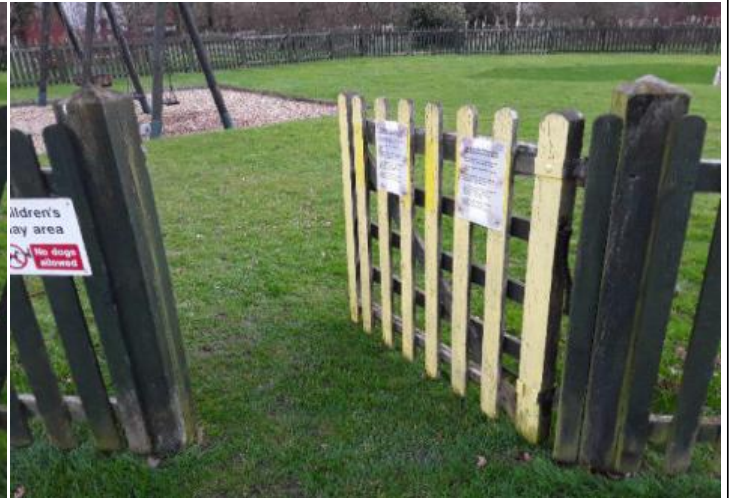
**i** 5 - Very Low Risk (Finding 2)

**Finding:** The gate is not operating correctly

**Action:** Take effective action to ensure the gate closes between 4 and 8 seconds

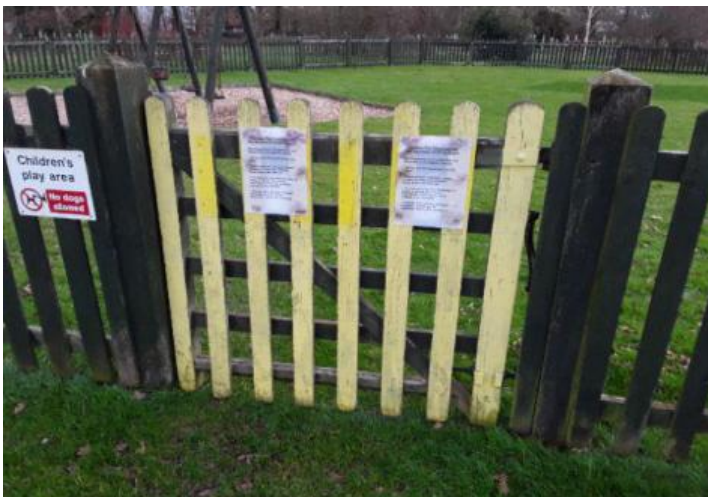
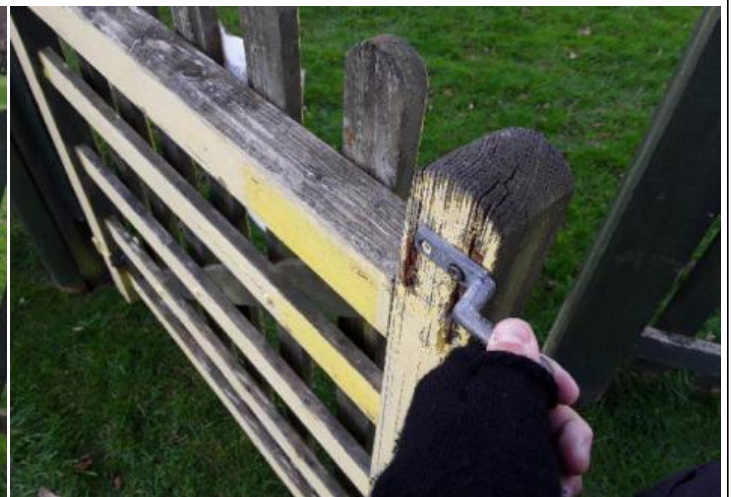
**i** 6 - Low Risk (Finding 3)

**Finding:** A number of fixing(s) have worked loose

**Action:** Secure all loose fixings

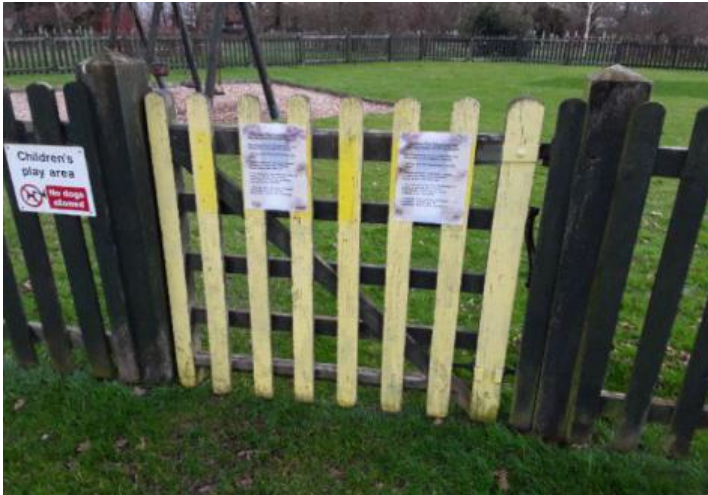
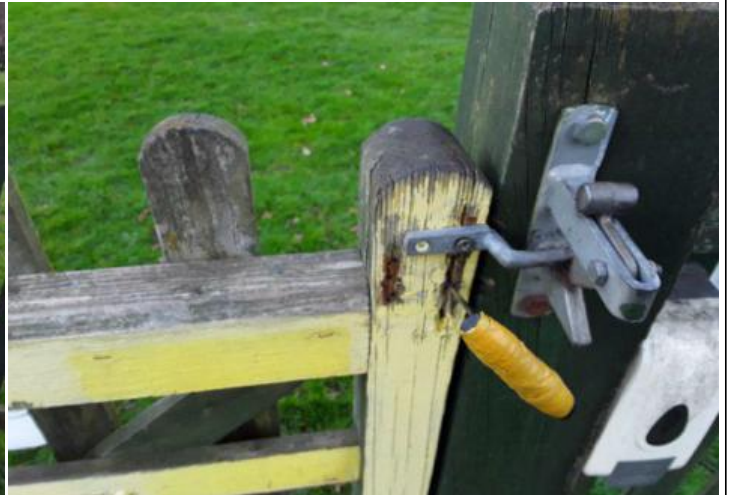
**i** 6 - Low Risk (Finding 4)

**Finding:** There is some evidence of rot in the timber

**Action:** Monitor for any further deterioration and replace as required

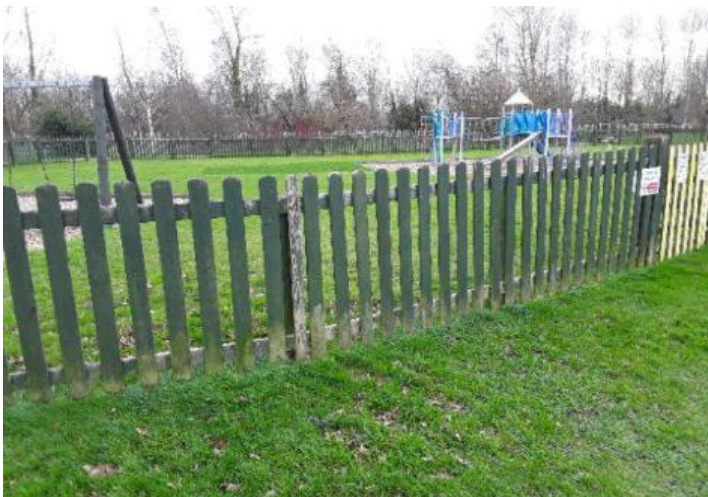
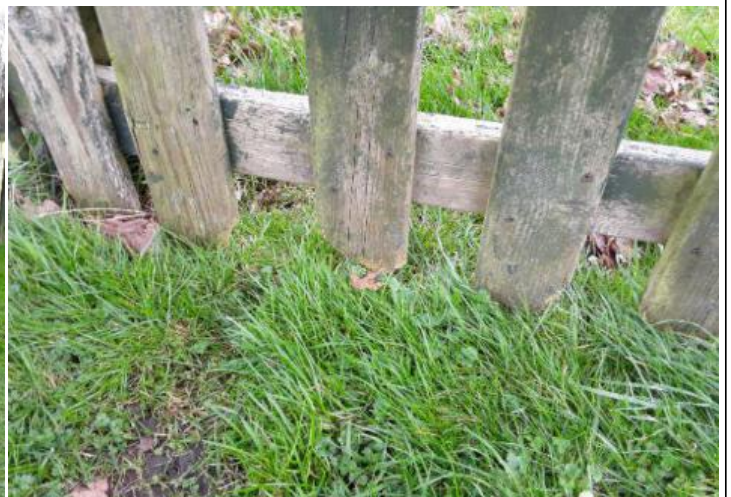
**i** 6 - Low Risk (Finding 1)

**Finding:** There is some strimmer / machinery damage apparent on the posts, this can penetrate the preservative applied to the timber and accelerate the rotting process

**Action:** Monitor for any deterioration (rot) and replace as required

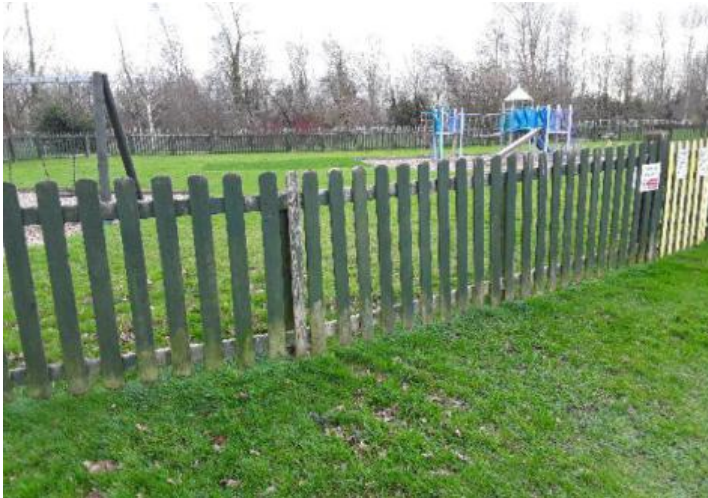
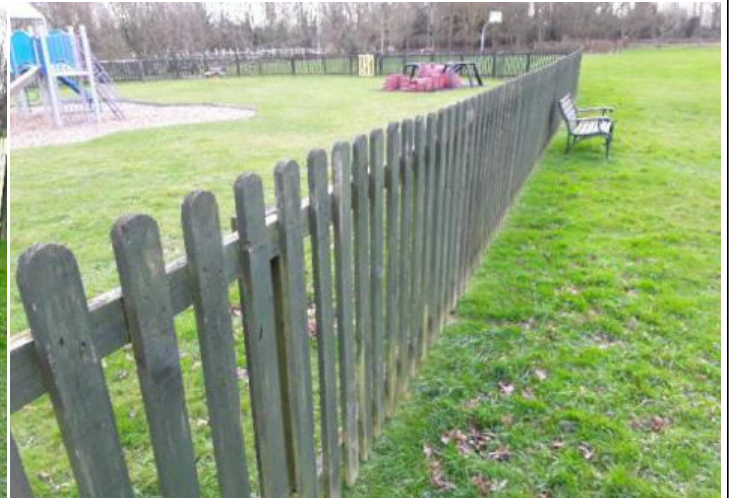
**i** 6 - Low Risk (Finding 2)

**Finding:** There is some damage to the fence sections

**Action:** Monitor for any further deterioration and repair as required

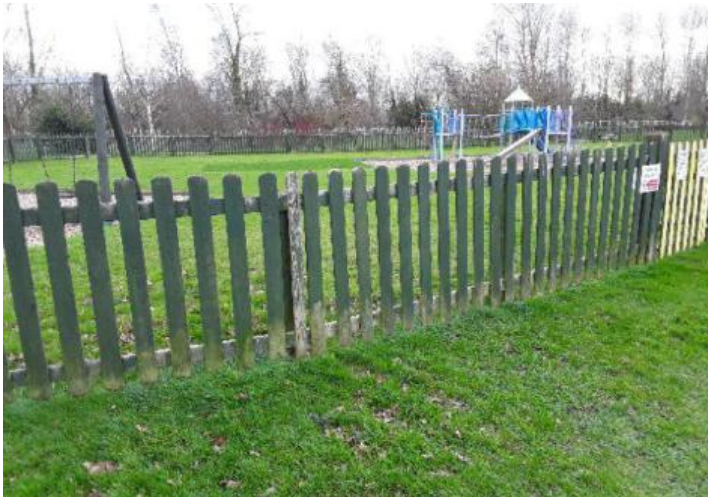
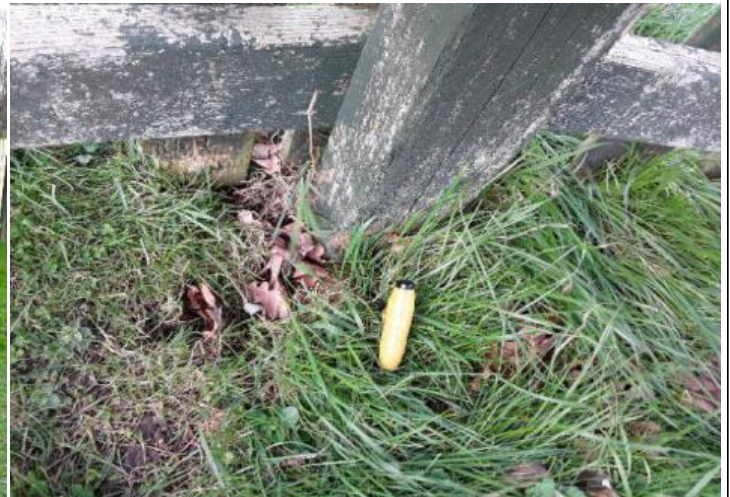
**i** 6 - Low Risk (Finding 3)

**Finding:** There is some evidence of rot in the timber

**Action:** Monitor for any further deterioration and replace as required

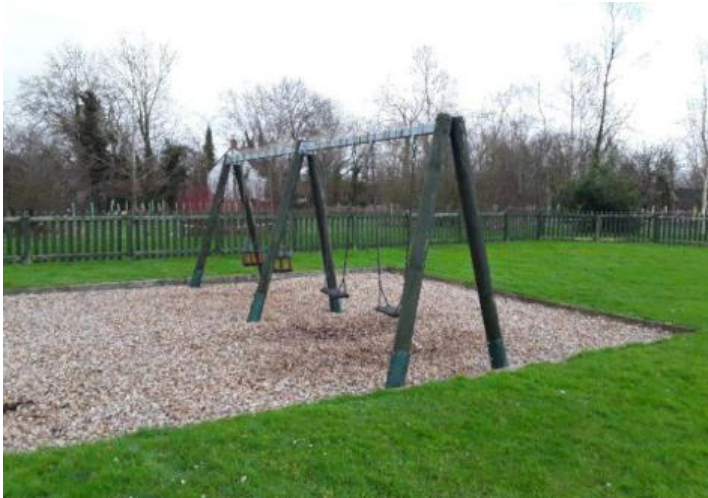
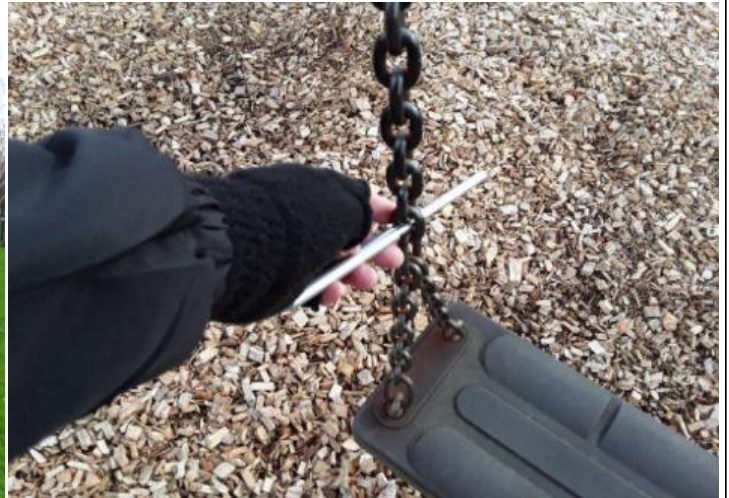
**i** 5 - Very Low Risk (Finding 1)

**Finding:** The connecting links are in excess of 8.6mm and less than 12mm and fail the requirements of BS EN 1176 Part 1; clause 4.2.13, Chains

**Action:** Monitor - No remedial work recommended

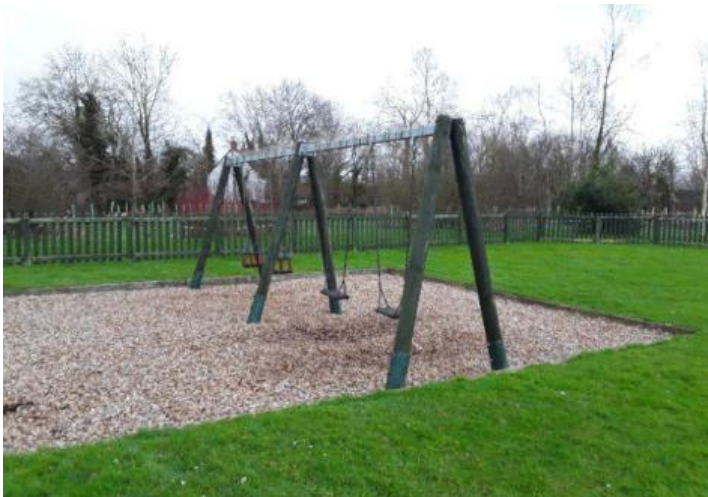
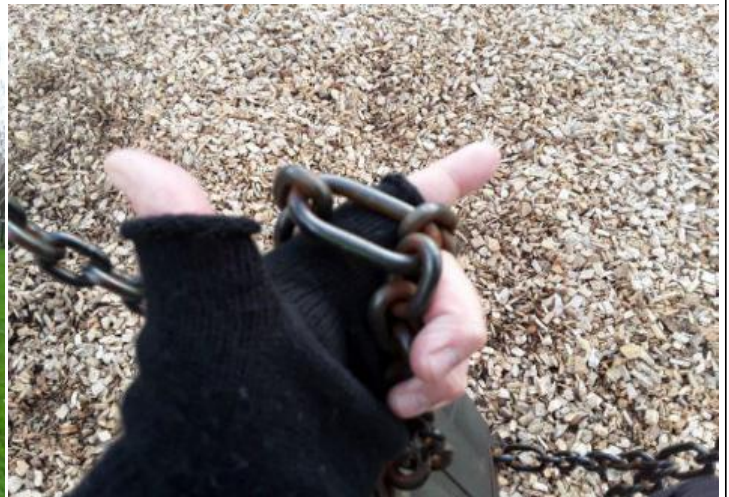
**i** 6 - Low Risk (Finding 2)

**Finding:** There is some notable evidence of chain wear

**Action:** Monitor for any further deterioration and replace when 40% worn

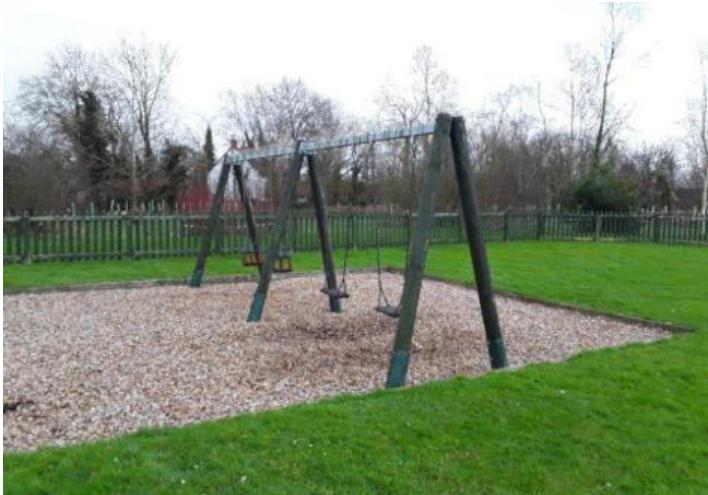
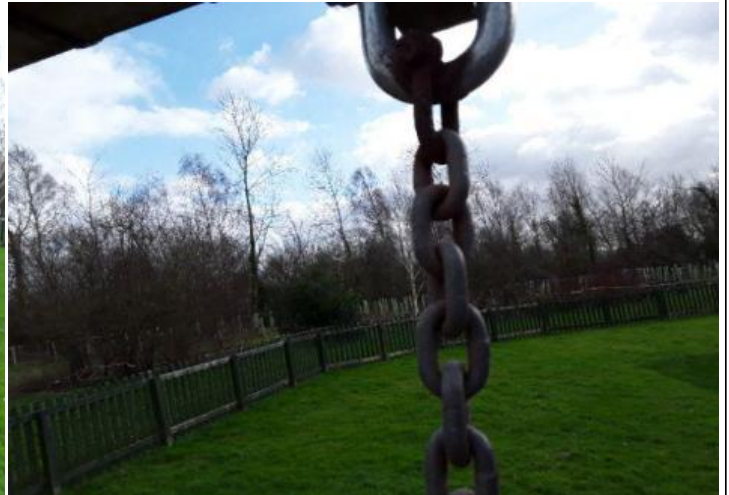
**i** 8 - Low Risk (Finding 3)

**Finding:** The shackles are worn in excess of 40% and require renewing

**Action:** Replace worn shackles

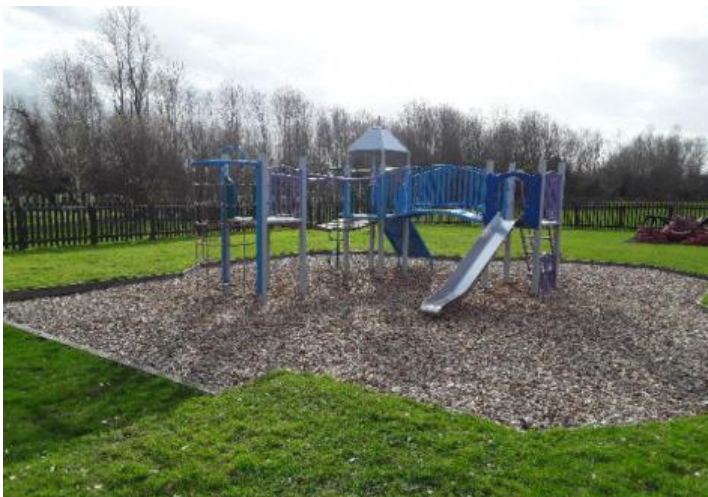
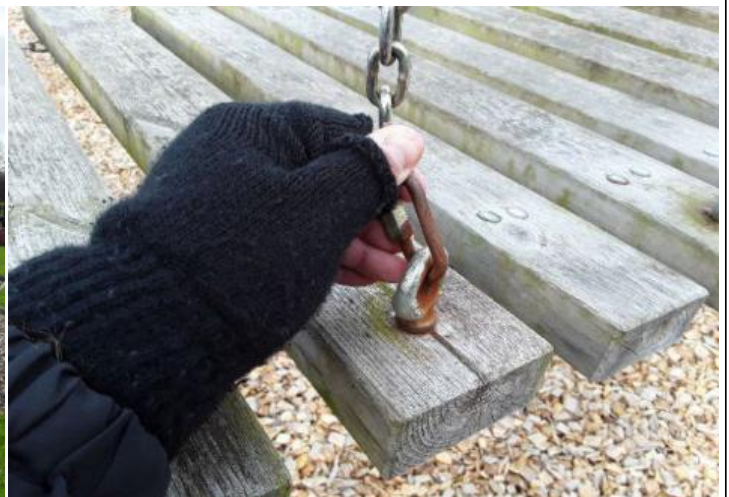
**i** 6 - Low Risk (Finding 1)

**Finding:** There is some wear to the shackles.

**Action:** Monitor for any further deterioration and replace when 40% worn

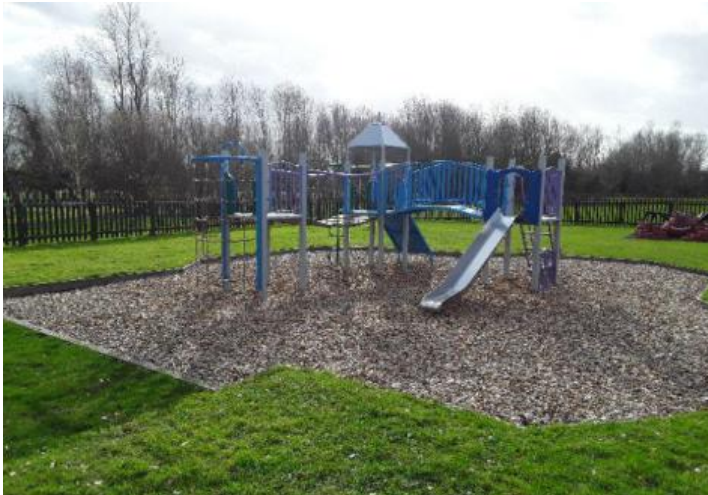
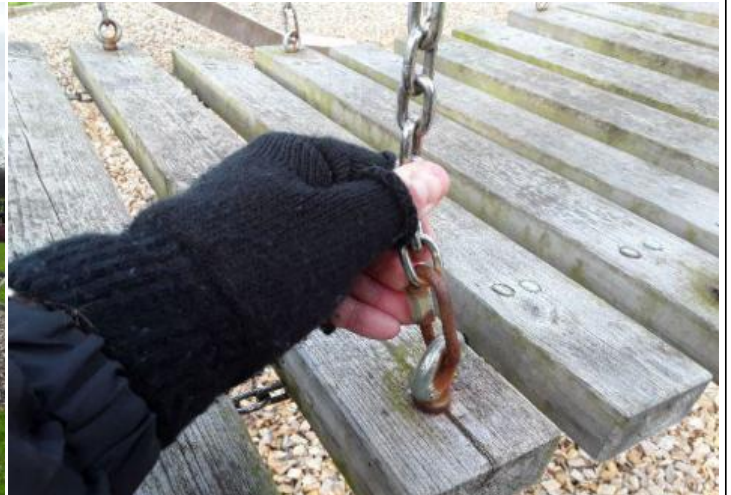
**i** 6 - Low Risk (Finding 2)

**Finding:** There is some notable evidence of chain wear

**Action:** Monitor for any further deterioration and replace when 40% worn

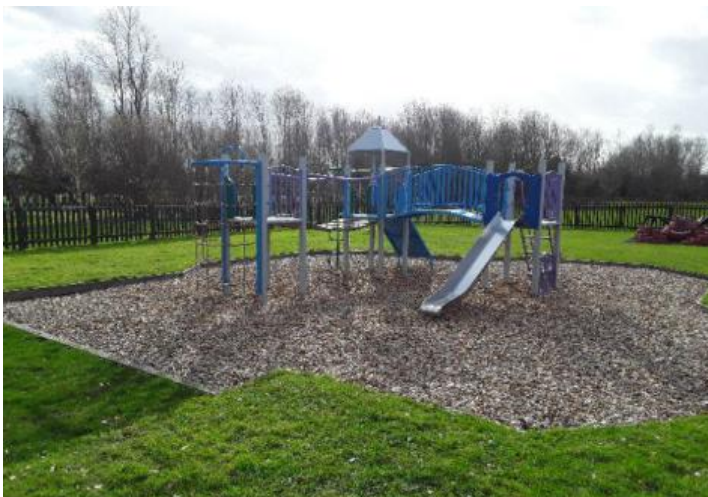
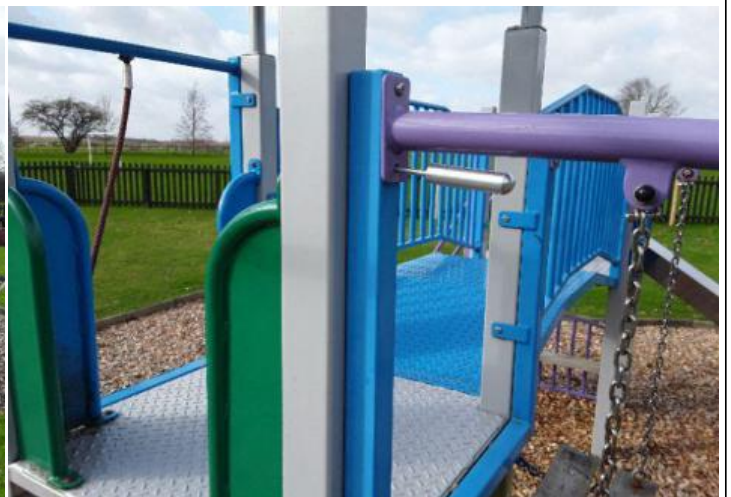
**i** 5 - Very Low Risk (Finding 3)

**Finding:** There is/are finger entrapment/s in the frame due to missing fixings and the item fails to meet the requirements of BS EN 1176 Part 1 4.2.7.6 Entrapment of fingers

**Action:** Replace the missing fixings to remove the entrapment

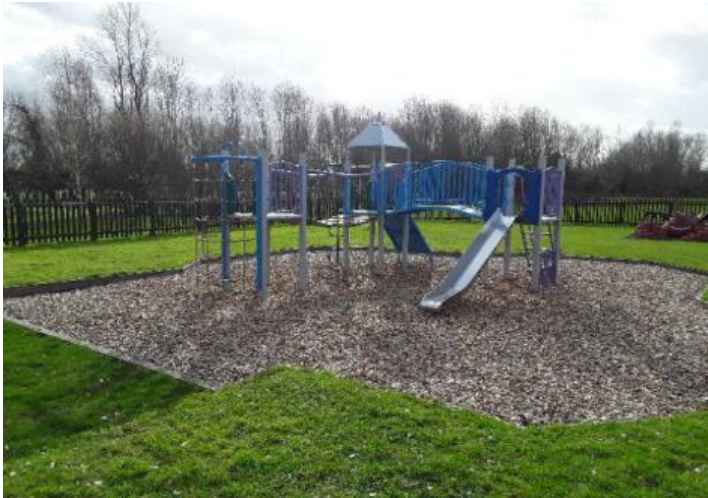
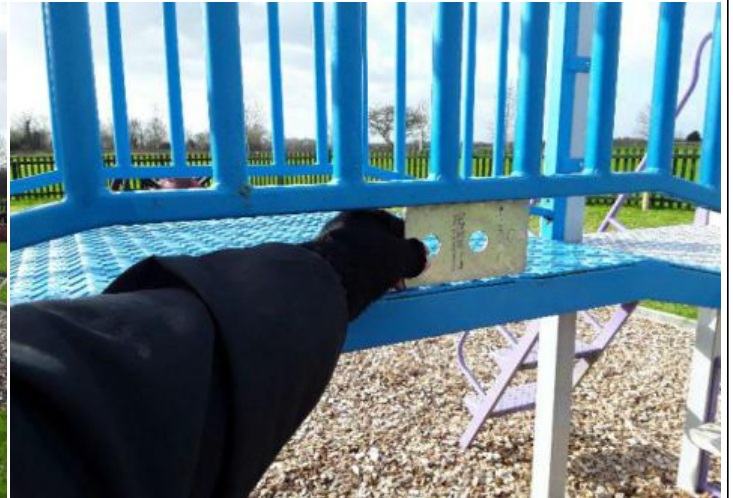
**i** 5 - Very Low Risk (Finding 4)

**Finding:** The item fails to meet the requirements of BS EN 1176 Part 1 4.2.7.2 head and neck entrapment in the barriers and/or steps

**Action:** Monitor - No remedial work recommended

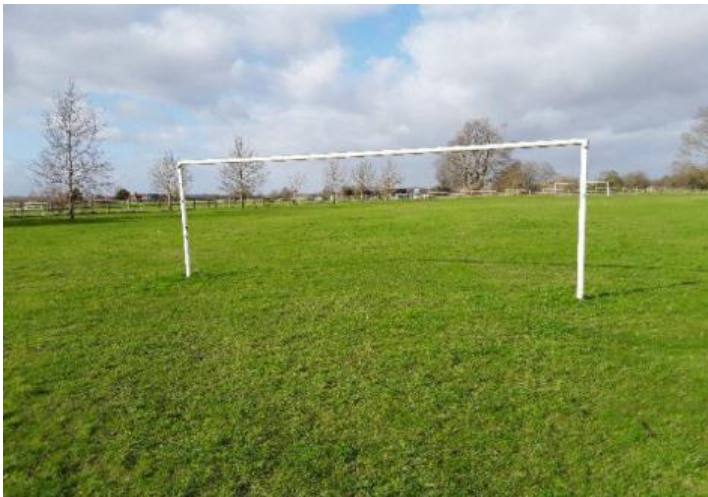
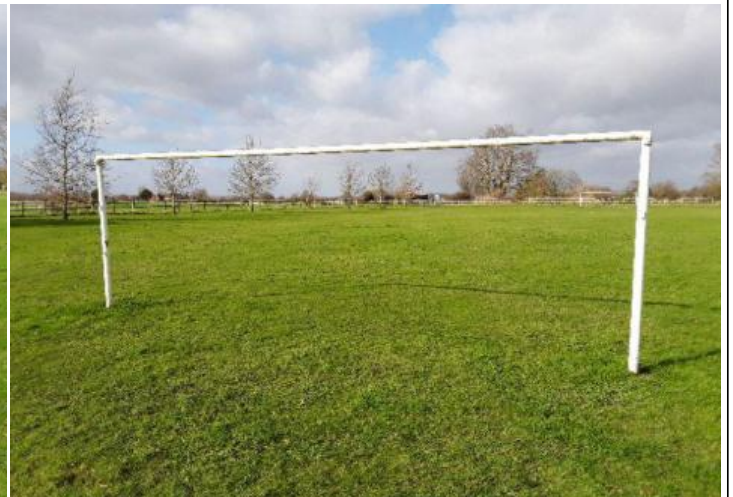
**i** 0 - Risk Assessment not Undertaken (Finding 1)

**Finding:** NB: We have undertaken a maintenance inspection only of the football goal(s); full load testing falls outside the scope of our inspection.

**Action:** Implement load testing as required

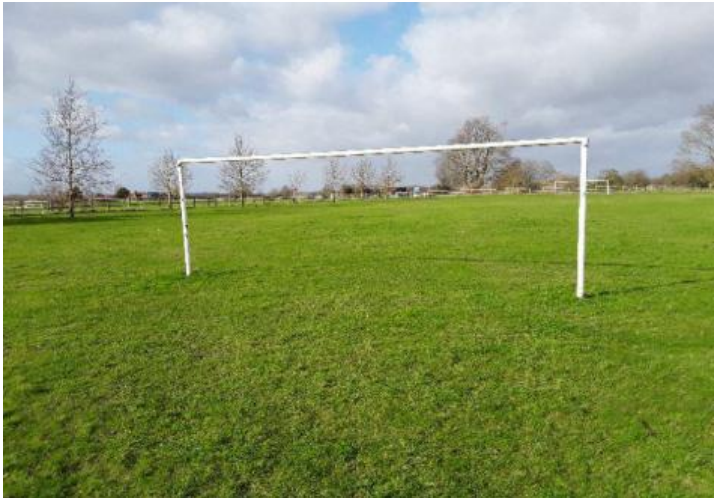
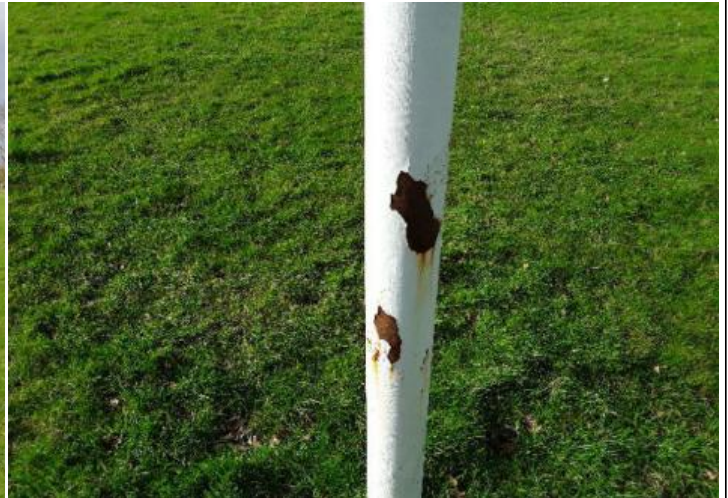
**i** 6 - Low Risk (Finding 2)

**Finding:** The paintwork on this item has been damaged or worn exposing the metal underneath which is rusting

**Action:** Treat any rusting components and repaint

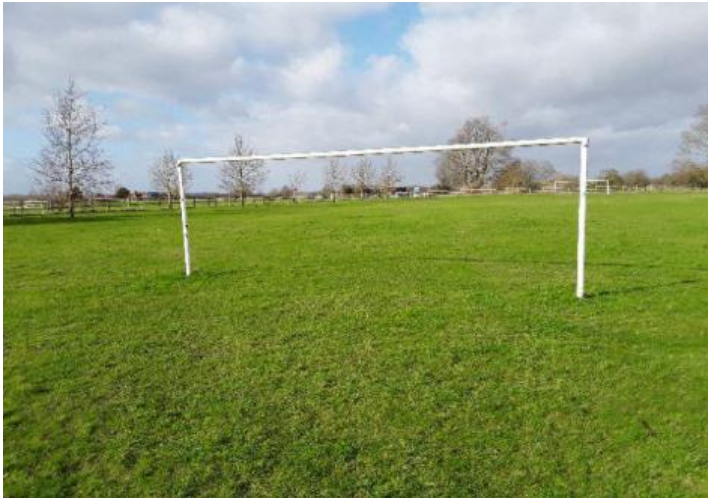
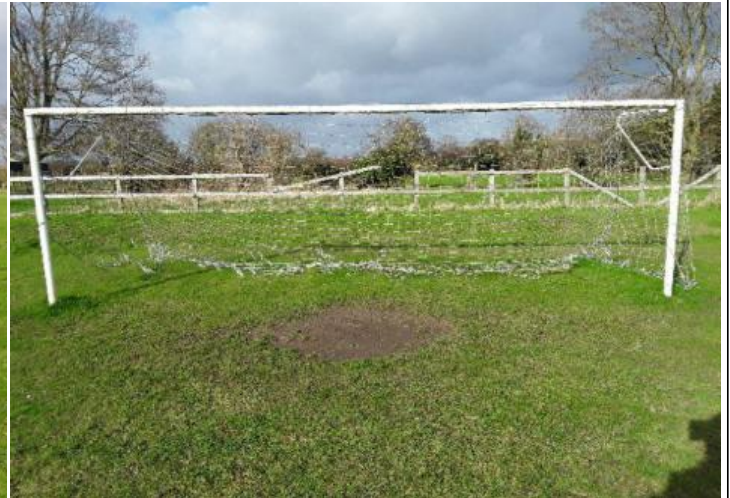
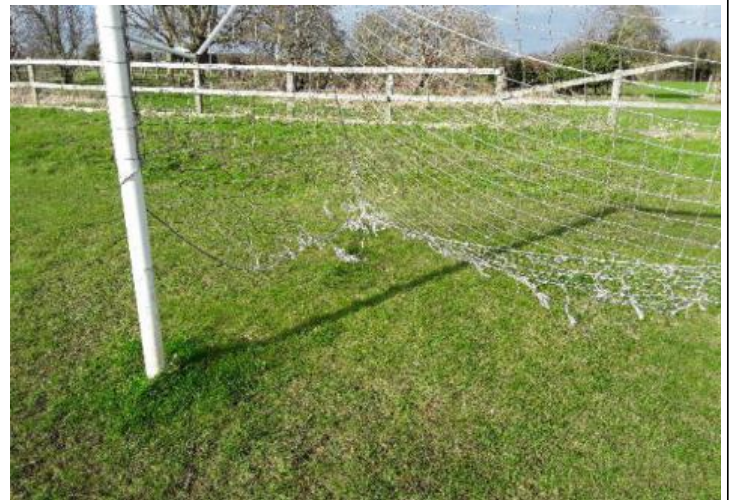
**i** 6 - Low Risk (Finding 3)

**Finding:** The net is damaged

**Action:** Repair as required
