Annual Inspection

Charney Hall and Field Trust

Charney Field

Inspection Ref: 1945513

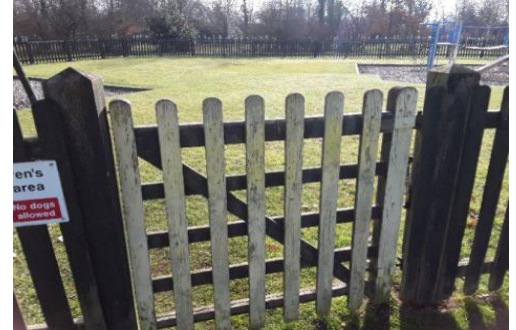
Item: Gate - Self Closing
Manufacturer: Unknown
Surface Type: Grass
Item Quantity: 2
Equipment Compliance: N/A
Surface Area Compliance: N/A

There are redundant staples present on the item - Remove

There are openings that are less than 12mm that could trap or crush fingers - Provide a 12mm gap throughout full range of motion at both sides of gate

The gate is closing too quickly (less than 4 seconds) - Take corrective action to ensure that the gate closes in 4-8 seconds

There is some evidence of rot in the timber - Monitor for any further deterioration and replace as required

A number of fixing(s) have worked loose - Secure all loose fixings

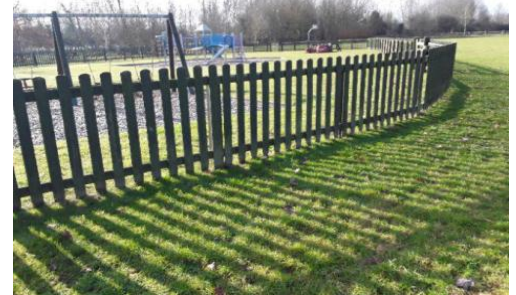
Item: Fencing - Timber
Manufacturer: Unknown
Surface Type: Grass
Item Quantity: 1
Equipment Compliance: N/A
Surface Area Compliance: N/A

There is some strimmer / machinery damage apparent on the posts, this can penetrate the preservative applied to the timber and accelerate the rotting process - Monitor for any deterioration (rot) and replace as required

There are areas or parts of the timber posts on the structure that have rotted - Replace all affected timbers

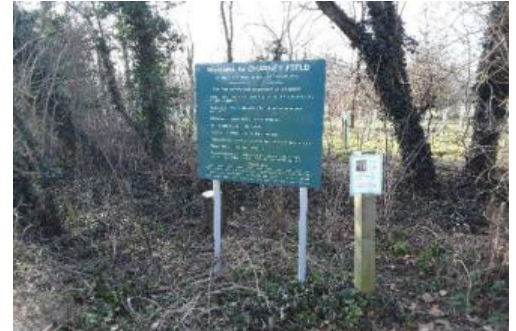
Item: Sign
Manufacturer: Unknown
Surface Type: Grass
Item Quantity: 1
Equipment Compliance: N/A
Surface Area Compliance: N/A

This item is satisfactory - no work required -

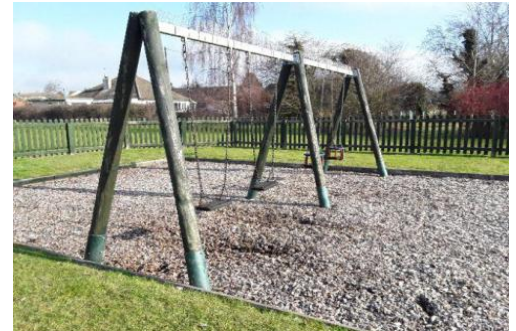
Item: 2 Bay 2 Flat 2 Cradle
Manufacturer: Unknown
Surface Type: Bark Mulch
Item Quantity: 1
Equipment Compliance: No
Surface Area Compliance: Yes

Steel bird deterrents have been used on the cross beam - Remove and replace with cable ties

The connecting links are in excess of 8.6mm and less than 12mm and fail the requirements of BS EN 1176 Part 1; clause 4.2.13, Chains - Monitor - No remedial work recommended

There is some notable evidence of chain wear - Monitor for any further deterioration and replace when 40% worn

The timber has a number of splits/shakes or air cracks and this may affect the stability or allow water ingress which will accelerate the rotting process - Monitor to ensure the splits do not cross through fixing points of the structure and/or cause any instability

There is some wear to the shackles. - Monitor for any further deterioration and replace when 40% worn

The shackles are worn in excess of 40% and require renewing - Replace worn shackles

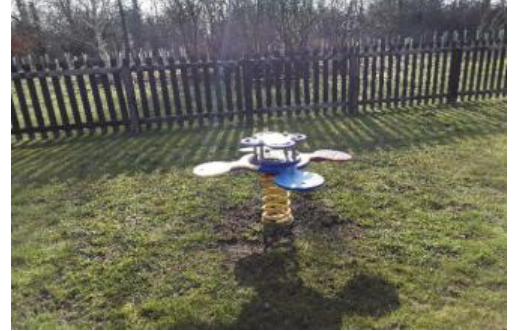
Item: Four Way Springer
Manufacturer: Fahr Industries
Surface Type: Grass Matrix Tiles
Item Quantity: 1
Equipment Compliance: Yes
Surface Area Compliance: Yes

This item is satisfactory - no work required -

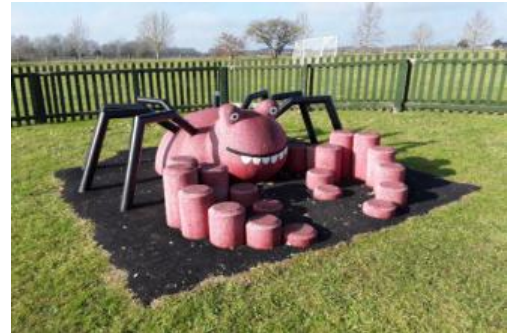
Item: Misc Item
Manufacturer: Not Identified
Surface Type: Wet Pour
Item Quantity: 1
Equipment Compliance: Yes
Surface Area Compliance: Yes

This item is satisfactory - no work required -

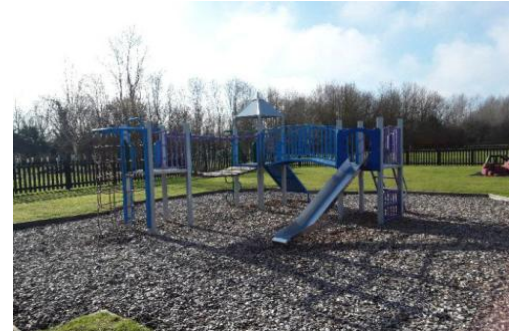
Item: Multi Play (Junior)
Manufacturer: Not Identified
Surface Type: Bark Mulch
Item Quantity: 1
Equipment Compliance: No
Surface Area Compliance: Yes

The item fails to meet the requirements of BS EN 1176 Part 1 4.2.7.2 head and neck entrapment in the barriers and/or steps - Monitor - No remedial work recommended

There is some notable evidence of chain and shackle wear - Monitor for any further deterioration and replace when 40% worn

There is/are finger entrapment/s in the frame and the item fails to meet the requirements of BS EN 1176 Part 1 4.2.7.6 Entrapment of fingers - Monitor - No remedial work recommended

There is/are finger entrapment/s in the frame due to missing fixings and the item fails to meet the requirements of BS EN 1176 Part 1 4.2.7.6 Entrapment of fingers - Replace the missing fixings to remove the entrapment

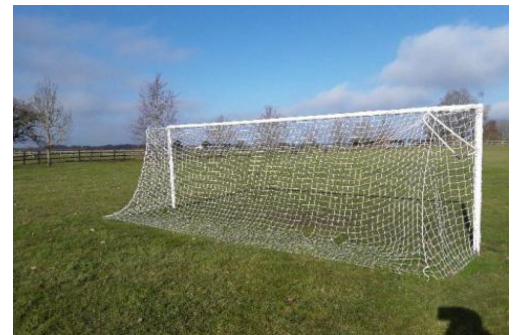
Item: Goal End
Manufacturer: Unknown
Surface Type: Grass
Item Quantity: 2
Equipment Compliance: N/A
Surface Area Compliance: N/A

NB: We have undertaken a maintenance inspection only of the football goal(s); full load testing falls outside the scope of our inspection. - Implement load testing as required

The framework has been damaged - Repair or replace the item

The goal netting has been damaged - Monitor for any further deterioration and replace as required

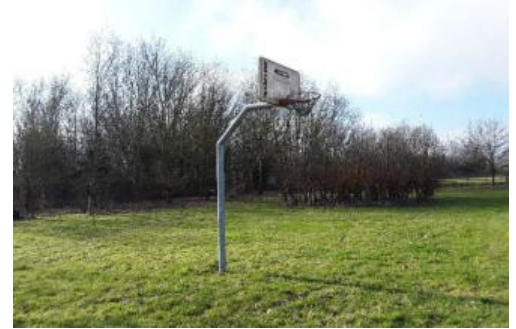
Item: Basketball Post
Manufacturer: Baseline
Surface Type: Grass
Item Quantity: 1
Equipment Compliance: Yes
Surface Area Compliance: N/A

This item is satisfactory - no work required -

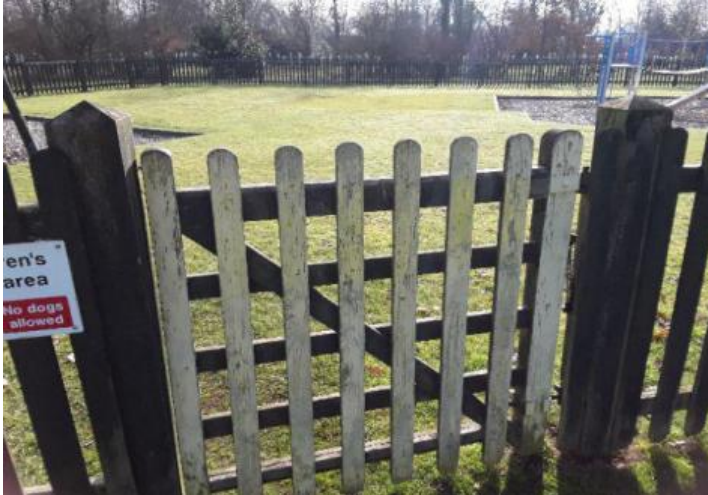
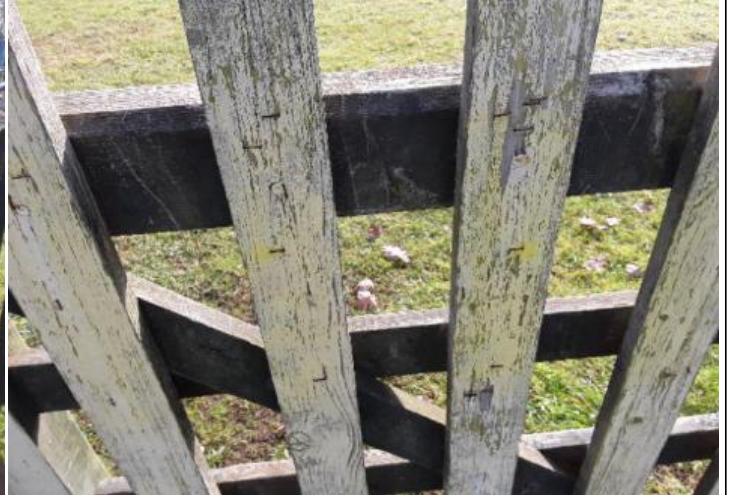
Item: Gates - Gate - Self Closing
Manufacturer: Unknown

Finding: There are redundant staples present on the item **Action:** Remove

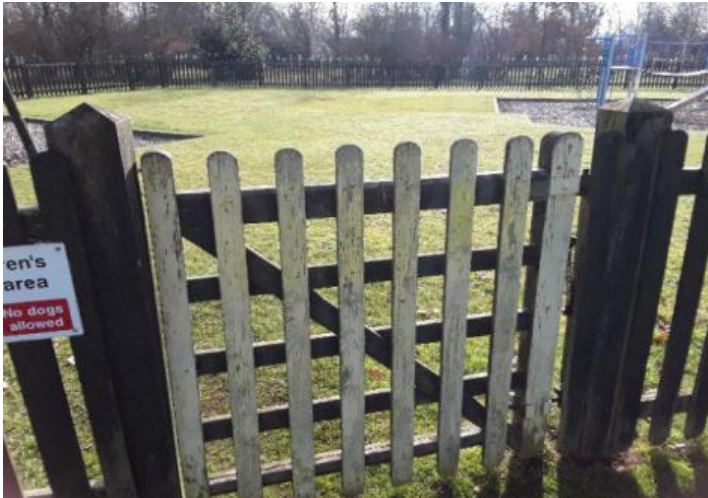
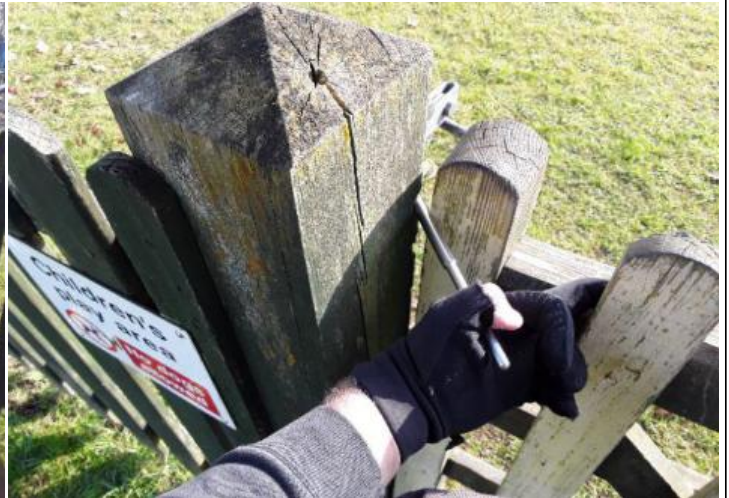
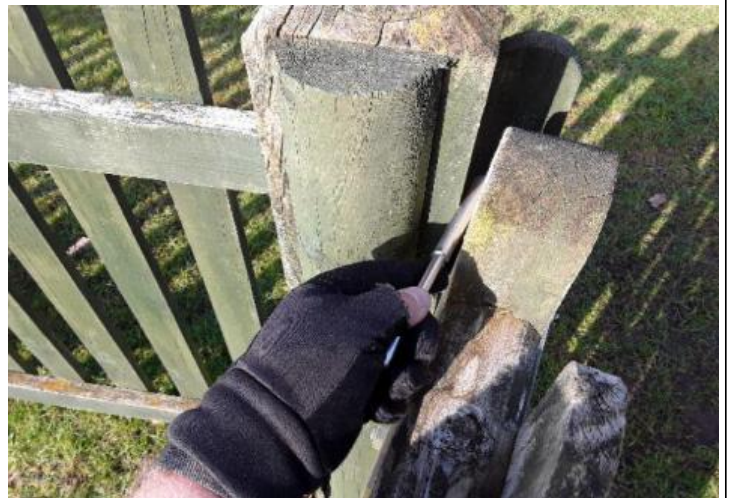
Item: Gates - Gate - Self Closing
Manufacturer: Unknown

Finding: There are openings that are less than 12mm that could trap or crush fingers

Action: Provide a 12mm gap throughout full range of motion at both sides of gate

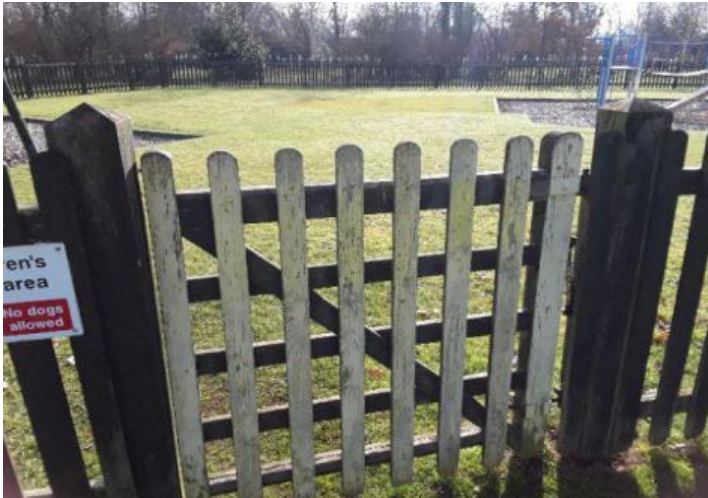
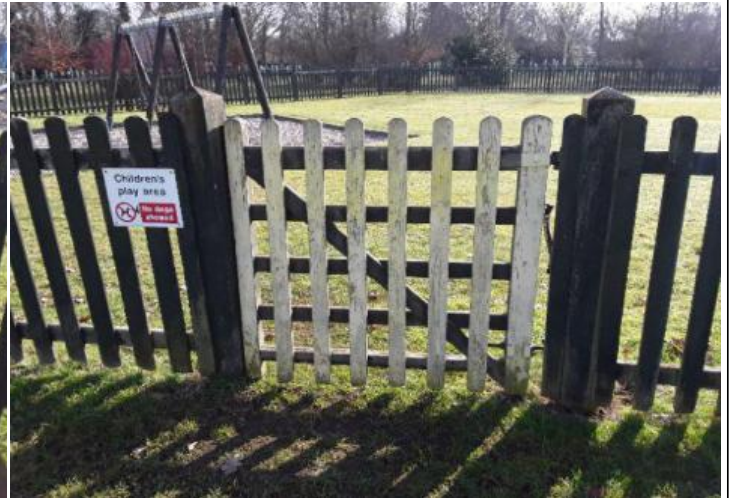
Item: Gates - Gate - Self Closing
Manufacturer: Unknown

Finding: The gate is closing too quickly (less than 4 seconds)

Action: Take corrective action to ensure that the gate closes in 4-8 seconds

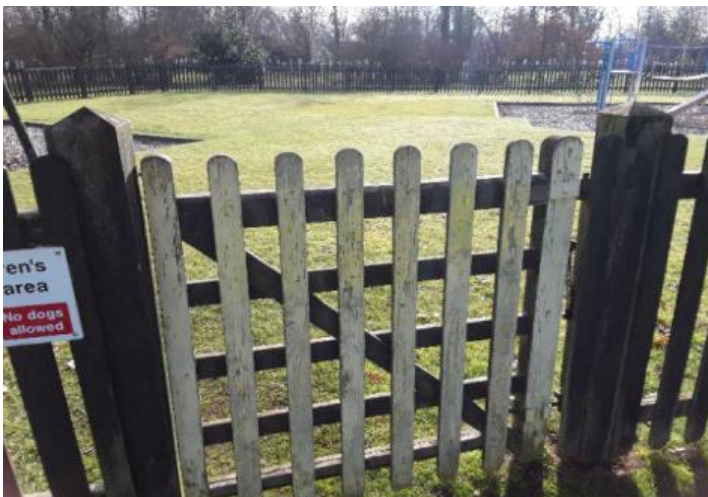
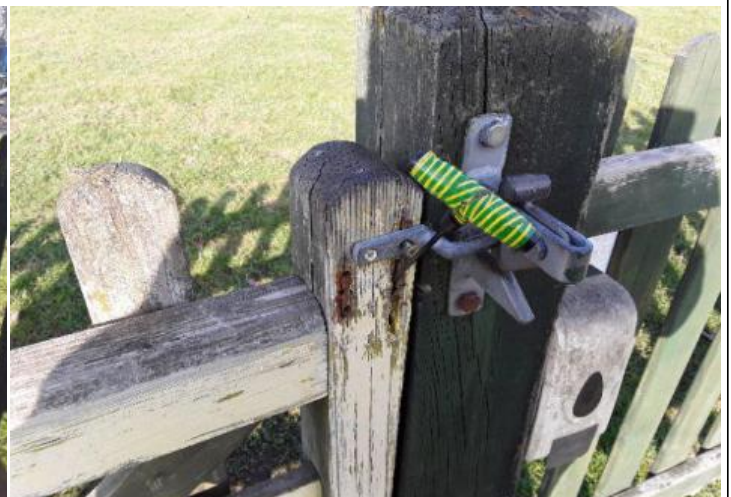
Item: Gates - Gate - Self Closing
Manufacturer: Unknown

Finding: There is some evidence of rot in the timber

Action: Monitor for any further deterioration and replace as required

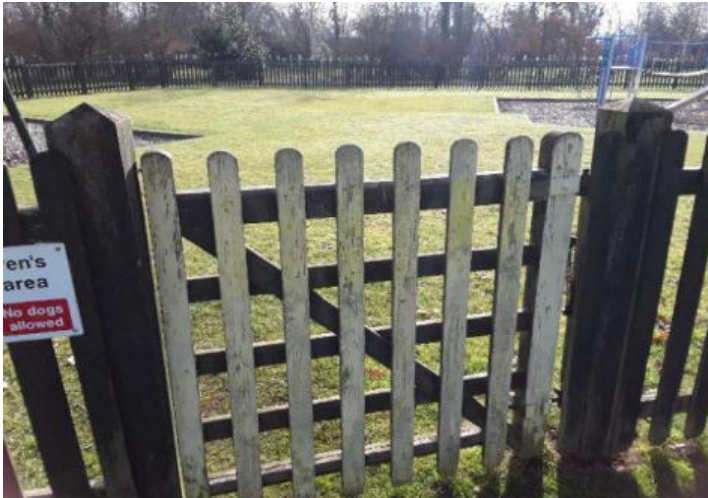
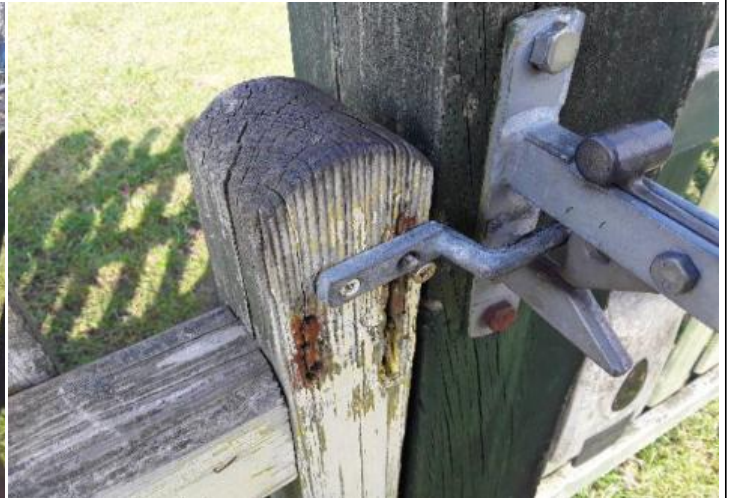
Item: Gates - Gate - Self Closing
Manufacturer: Unknown

Finding: A number of fixing(s) have worked loose

Action: Secure all loose fixings

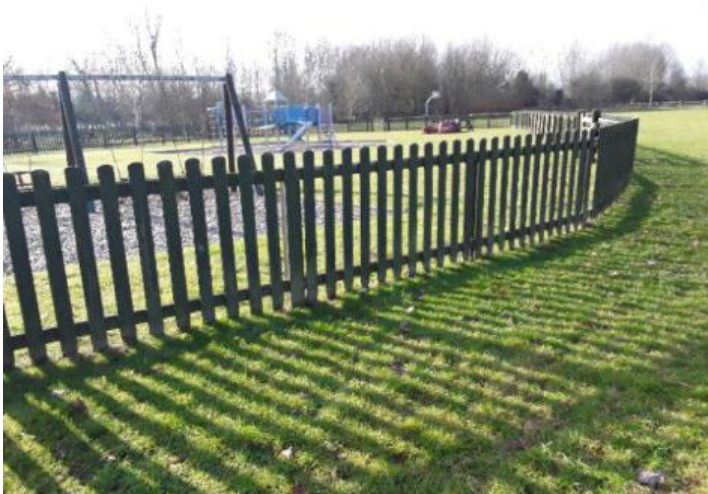
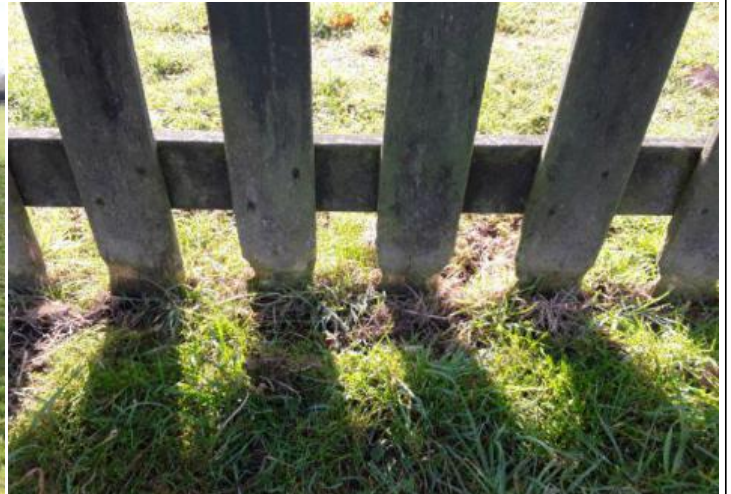
Item: Fences - Fencing - Timber
Manufacturer: Unknown

Finding: There is some strimmer / machinery damage apparent on the posts, this can penetrate the preservative applied to the timber and accelerate the rotting process

Action: Monitor for any deterioration (rot) and replace as required

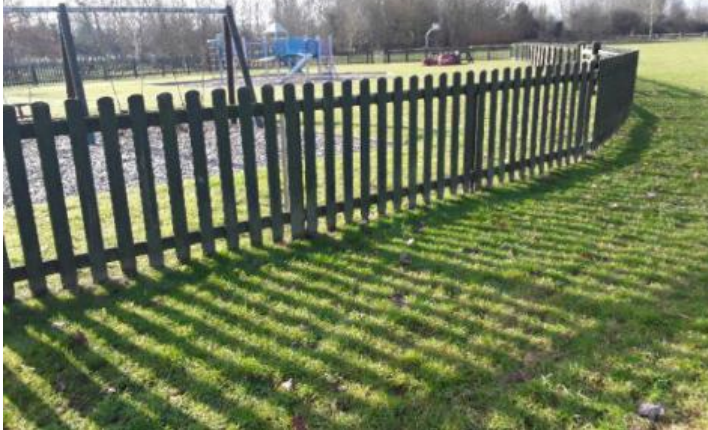
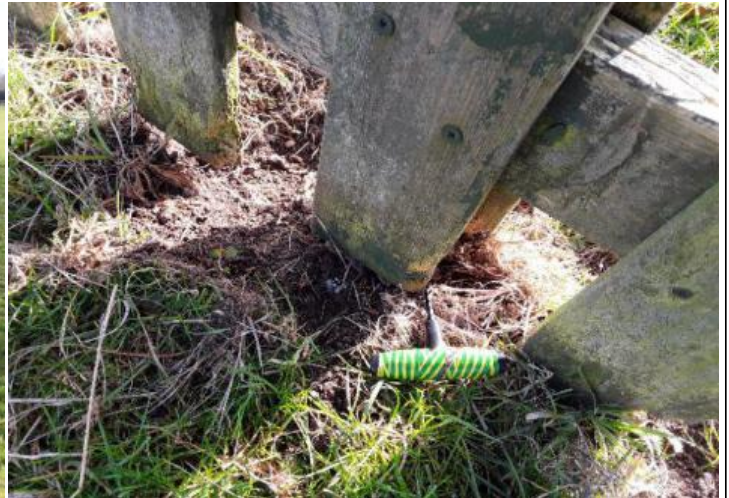
Item: Fences - Fencing - Timber
Manufacturer: Unknown

Finding: There are areas or parts of the timber posts on the structure that have rotted
Action: Replace all affected timbers

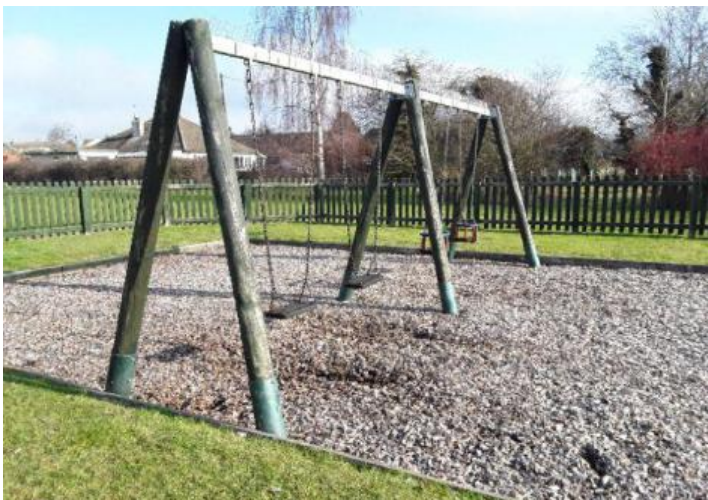
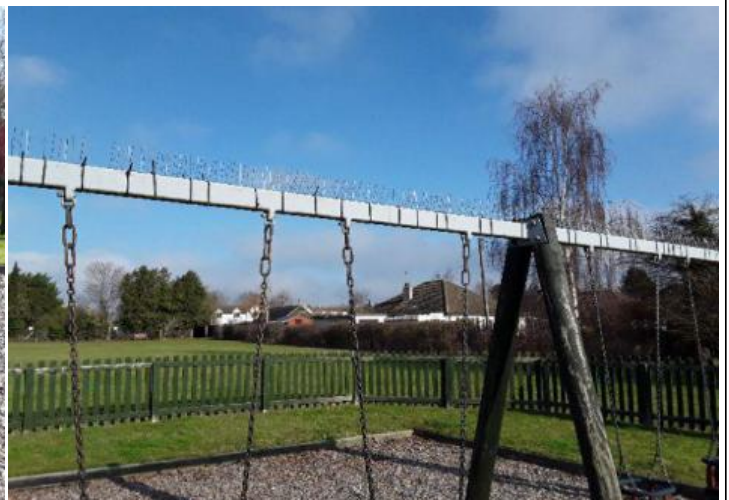
Item: Swings - 2 Bay 2 Flat 2 Cradle
Manufacturer: Unknown

Finding: Steel bird deterrents have been used on the cross beam
Action: Remove and replace with cable ties

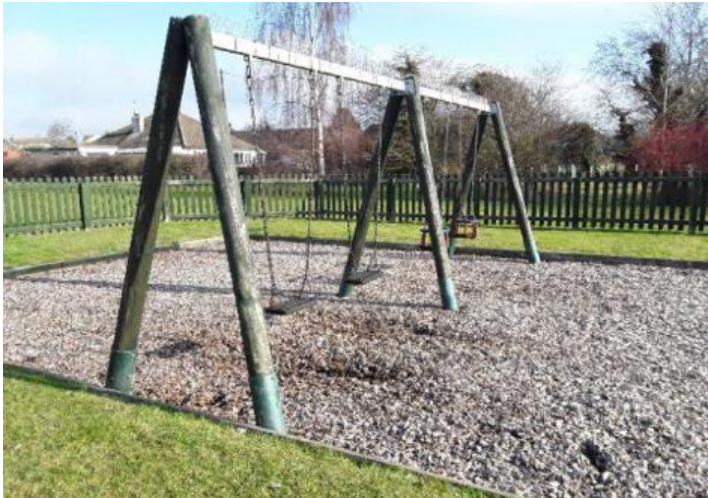
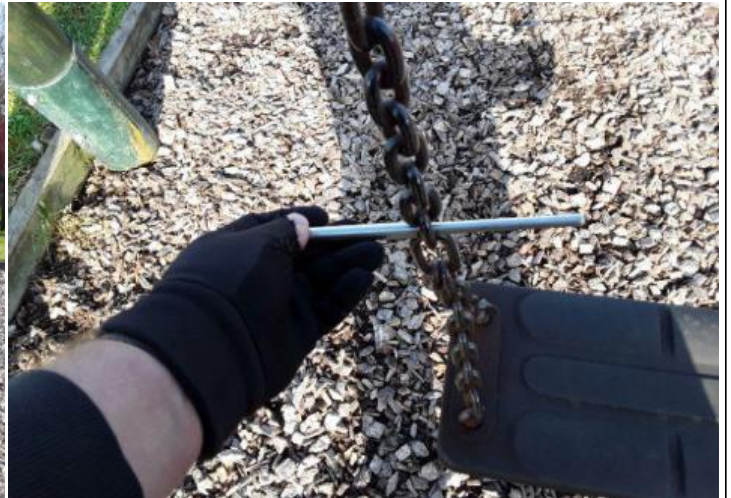
Item: Swings - 2 Bay 2 Flat 2 Cradle
Manufacturer: Unknown

Finding: The connecting links are in excess of 8.6mm and less than 12mm and fail the requirements of BS EN 1176 Part 1; clause 4.2.13, Chains

Action: Monitor - No remedial work recommended

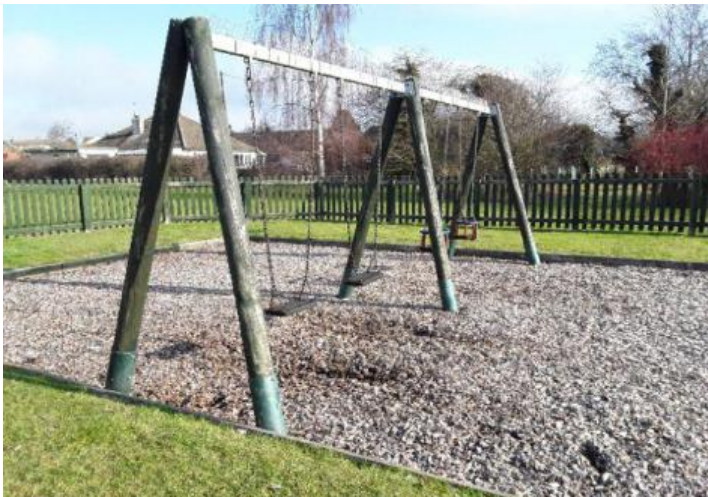
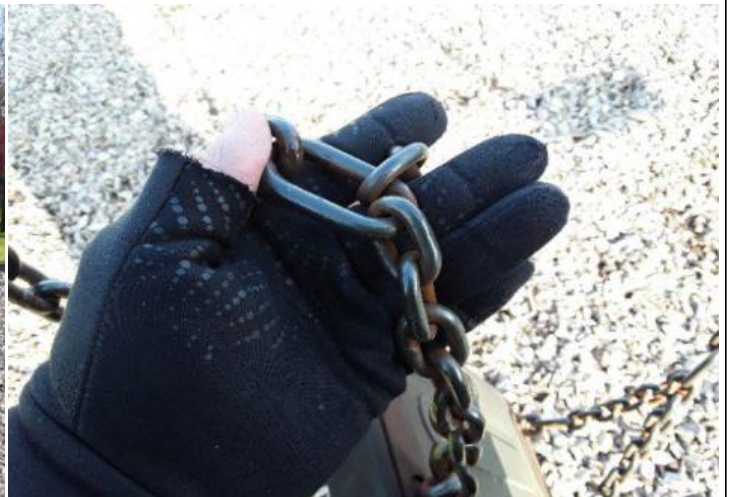
Item: Swings - 2 Bay 2 Flat 2 Cradle
Manufacturer: Unknown

Finding: There is some notable evidence of chain wear

Action: Monitor for any further deterioration and replace when 40% worn

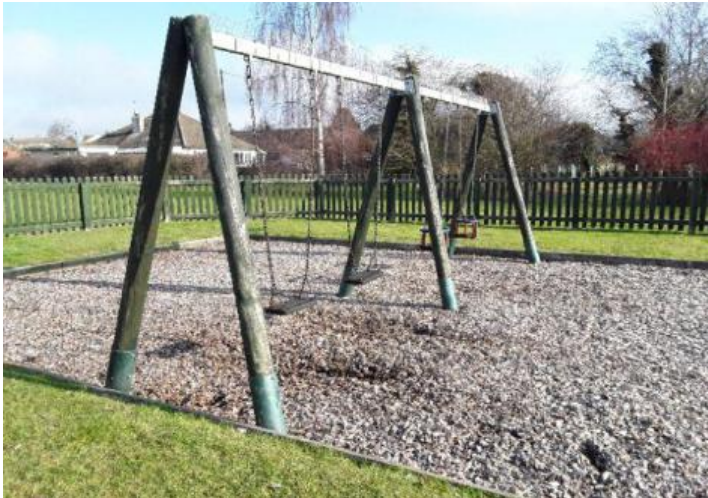
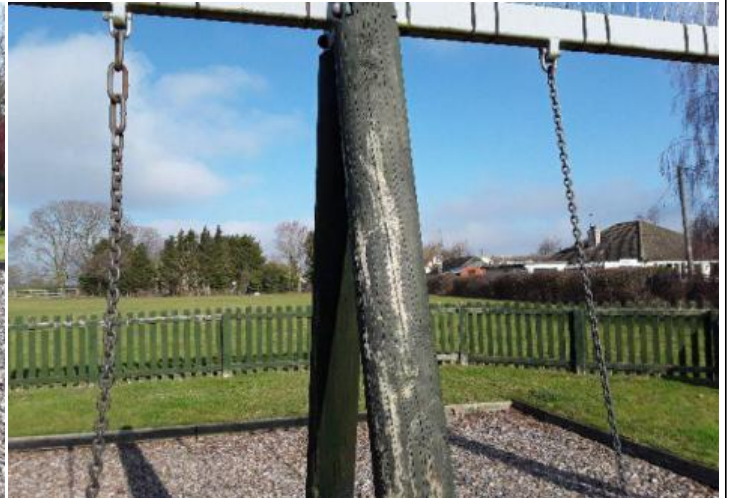
Item: Swings - 2 Bay 2 Flat 2 Cradle
Manufacturer: Unknown

Finding: The timber has a number of splits/shakes or air cracks and this may affect the stability or allow water ingress which will accelerate the rotting process
Action: Monitor to ensure the splits do not cross through fixing points of the structure and/or cause any instability

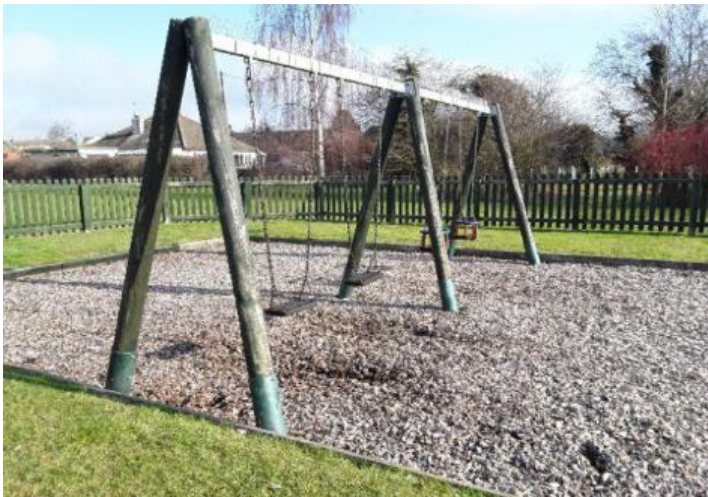
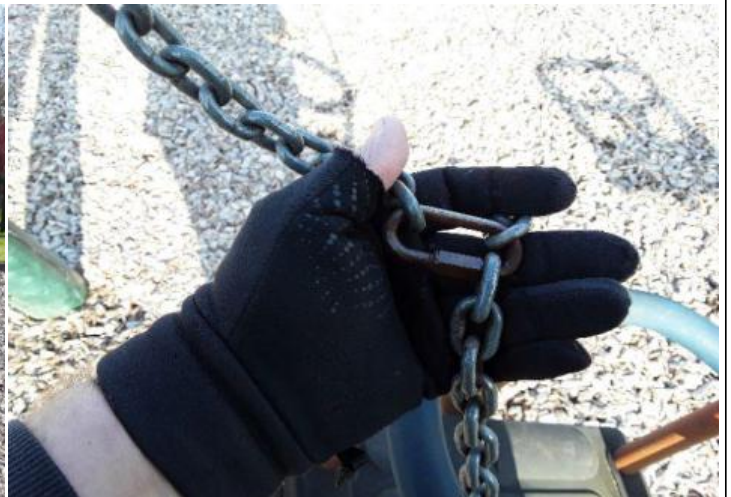
Item: Swings - 2 Bay 2 Flat 2 Cradle
Manufacturer: Unknown

Finding: There is some wear to the shackles.
Action: Monitor for any further deterioration and replace when 40% worn

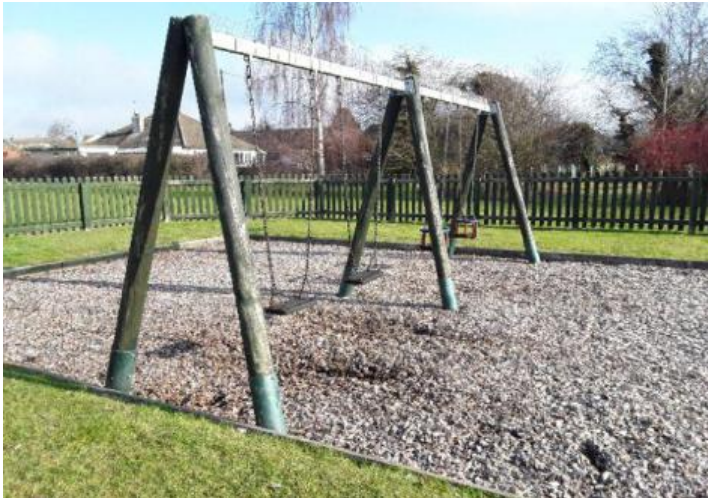
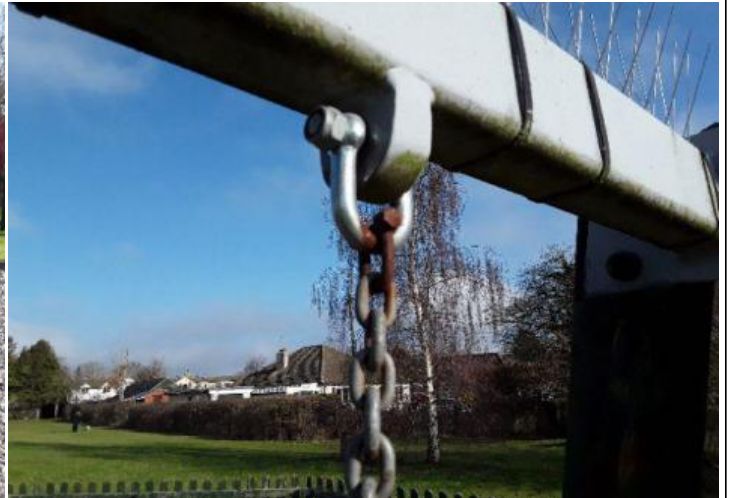
Item: Swings - 2 Bay 2 Flat 2 Cradle
Manufacturer: Unknown

Finding: The shackles are worn in excess of 40% and require renewing

Action: Replace worn shackles

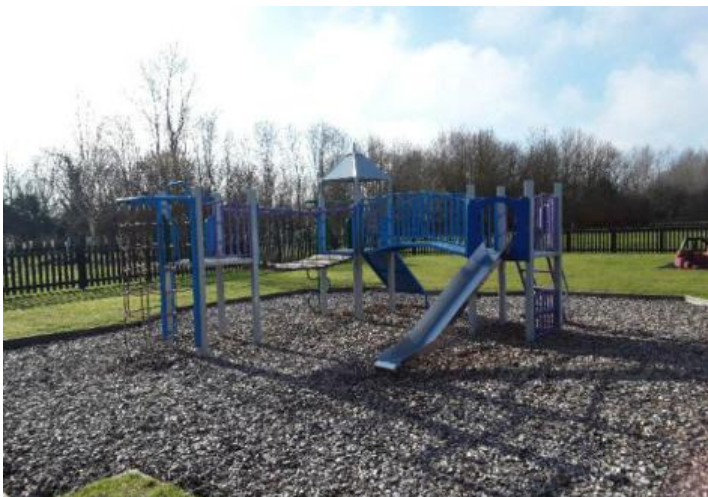
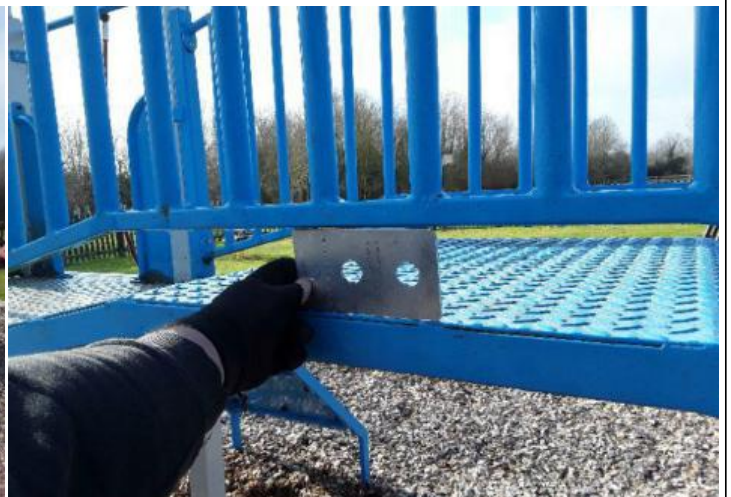
Item: Activity Equipment - Multi Play (Junior)
Manufacturer: Not Identified

Finding: The item fails to meet the requirements of BS EN 1176 Part 1 4.2.7.2 head and neck entrapment in the barriers and/or steps

Action: Monitor - No remedial work recommended

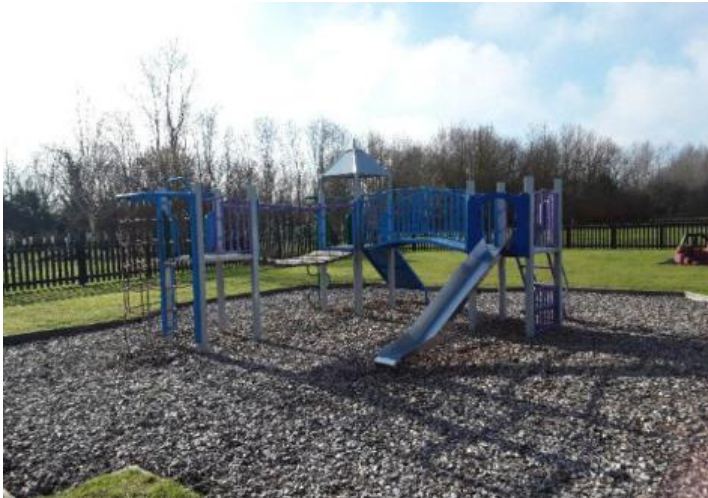
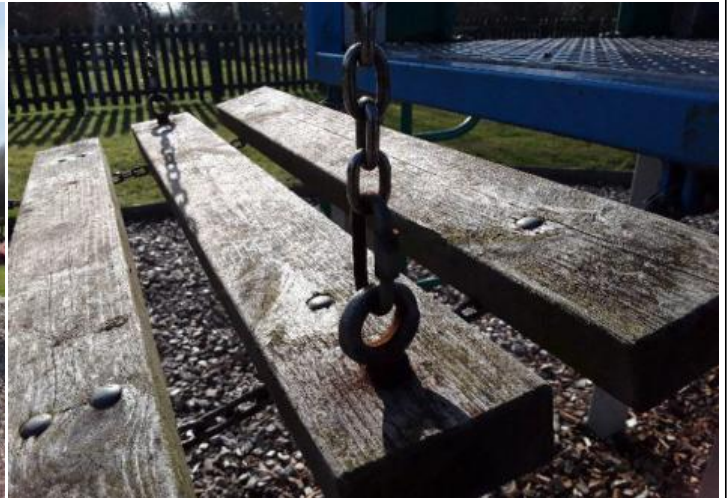
Item: Activity Equipment - Multi Play (Junior)
Manufacturer: Not Identified

Finding: There is some notable evidence of chain and shackle wear

Action: Monitor for any further deterioration and replace when 40% worn

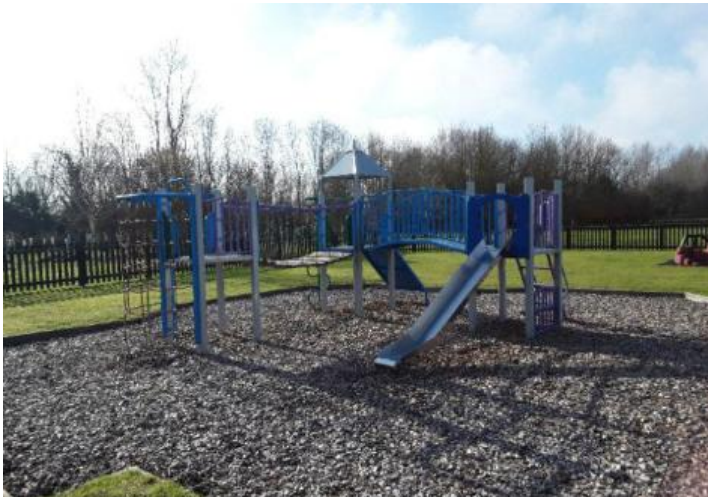
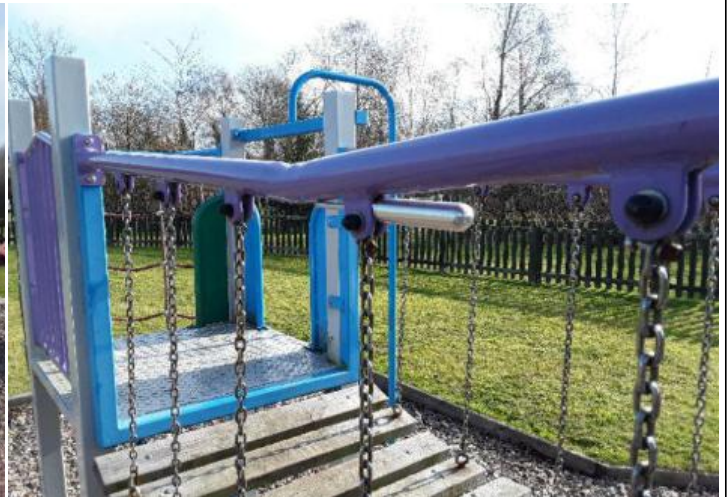
Item: Activity Equipment - Multi Play (Junior)
Manufacturer: Not Identified

Finding: There is/are finger entrapment/s in the frame and the item fails to meet the requirements of BS EN 1176 Part 1 4.2.7.6 Entrapment of fingers

Action: Monitor - No remedial work recommended

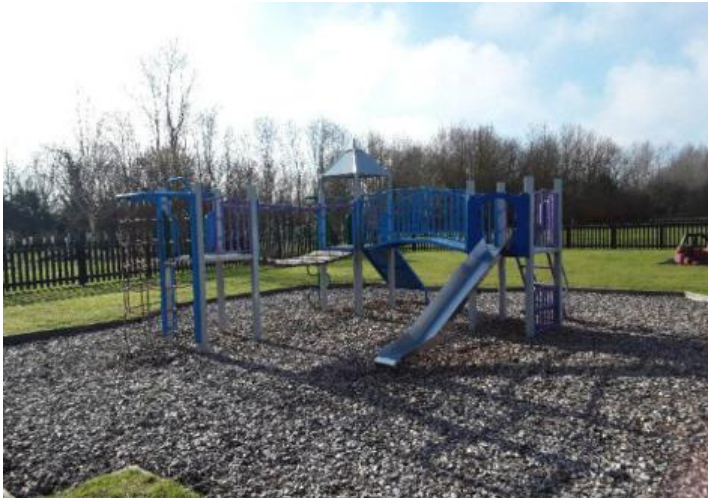
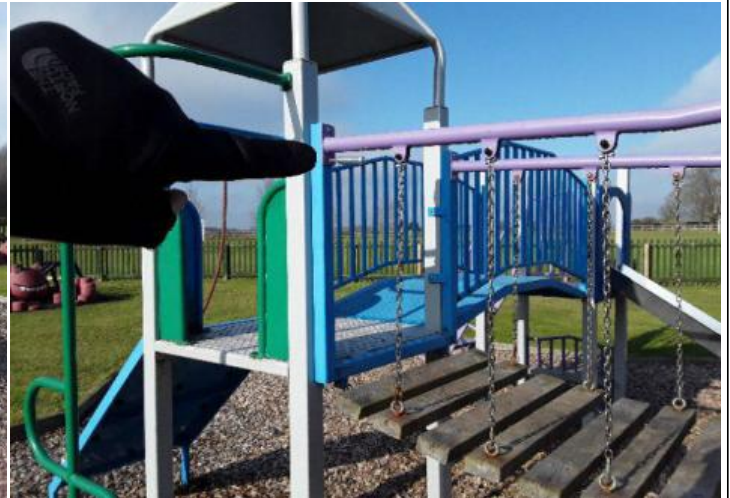
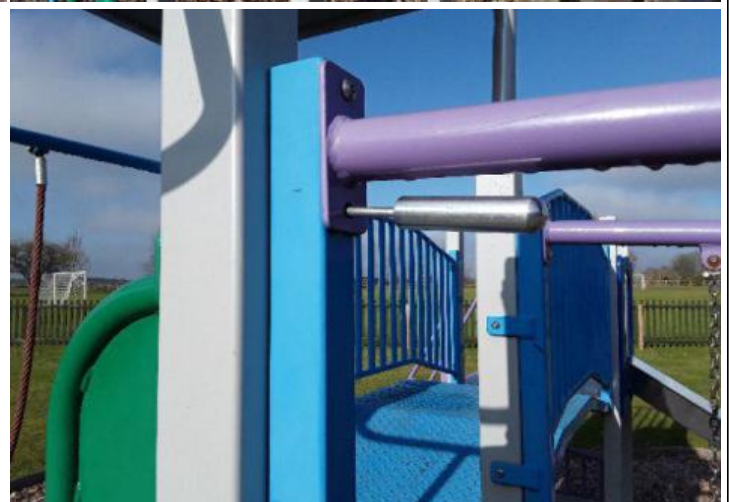
Item: Activity Equipment - Multi Play (Junior)
Manufacturer: Not Identified

Finding: There is/are finger entrapment/s in the frame due to missing fixings and the item fails to meet the requirements of BS EN 1176 Part 1 4.2.7.6 Entrapment of fingers
Action: Replace the missing fixings to remove the entrapment

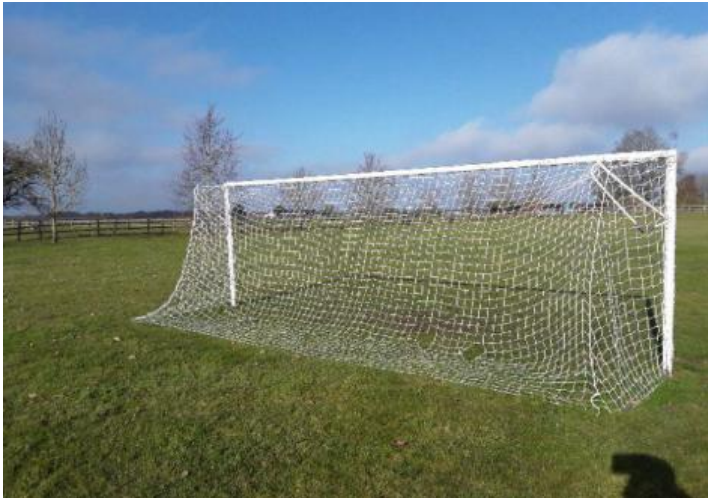
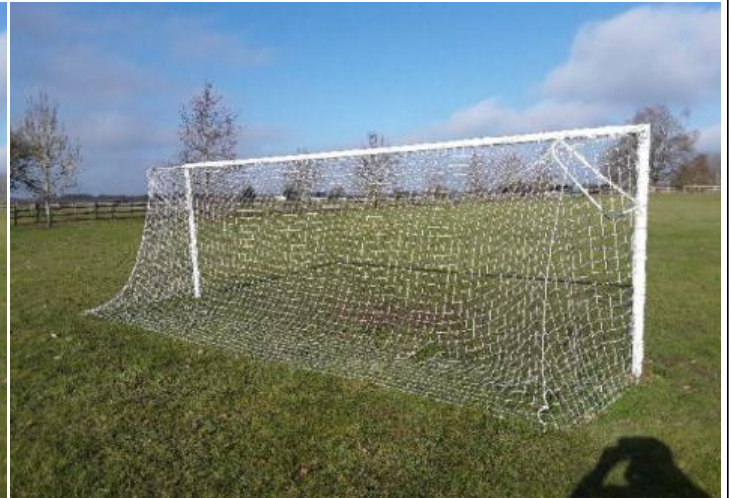
Item: Multi Use Games Area - Goal End
Manufacturer: Unknown

Finding: NB: We have undertaken a maintenance inspection only of the football goal(s); full load testing falls outside the scope of our inspection.

Action: Implement load testing as required

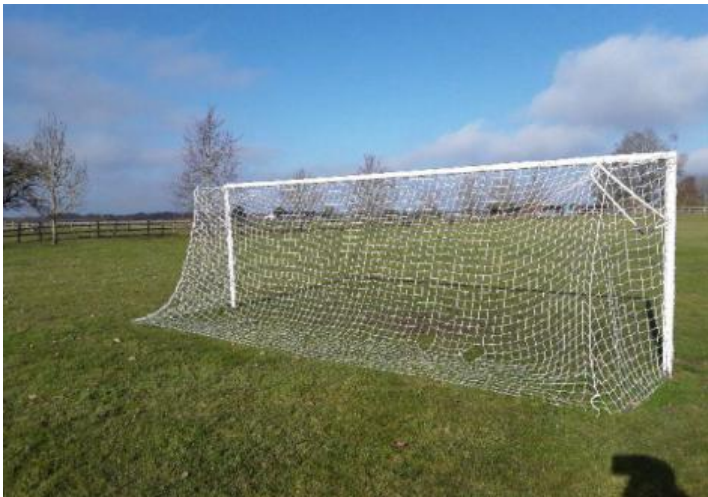
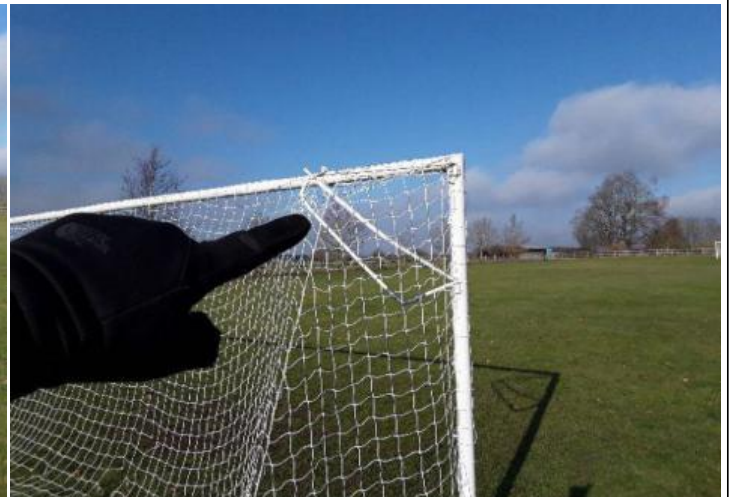
Item: Multi Use Games Area - Goal End
Manufacturer: Unknown

Finding: The framework has been damaged

Action: Repair or replace the item

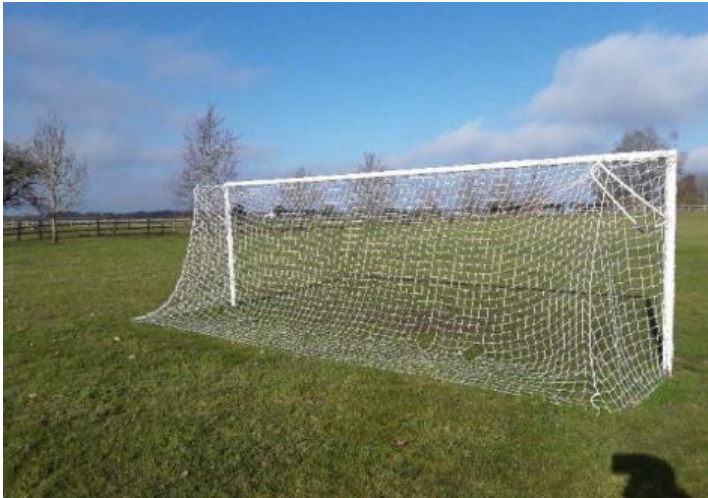
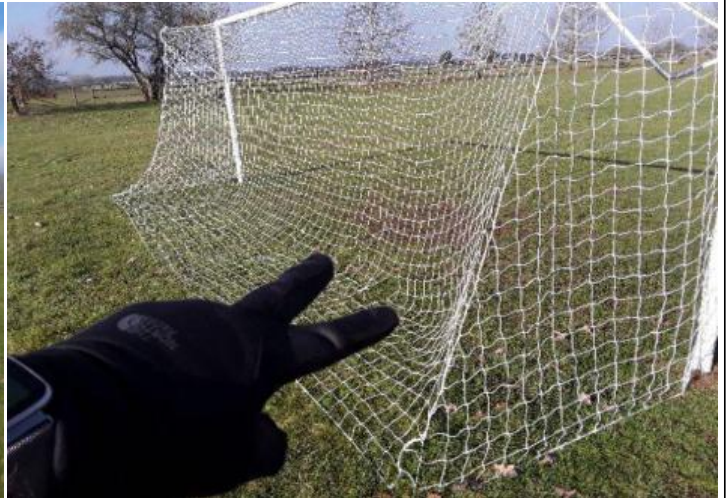
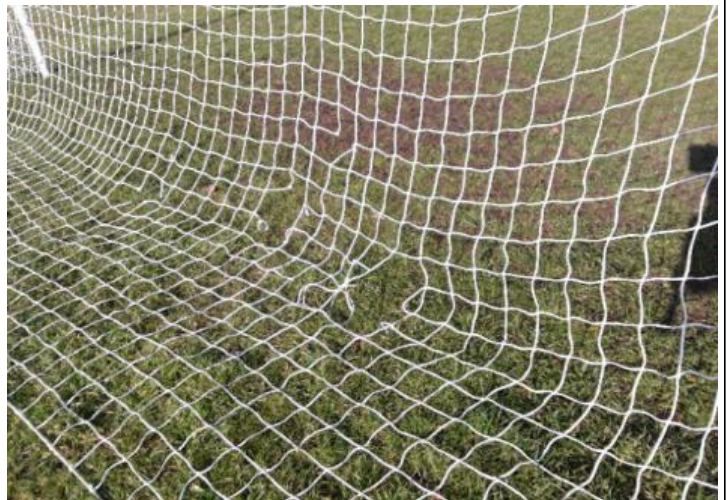
Item: Multi Use Games Area - Goal End
Manufacturer: Unknown

Finding: The goal netting has been damaged

Action: Monitor for any further deterioration and replace as required
