the **play inspection** company

Annual Inspection

Charney Hall and Field Trust

Charney Field

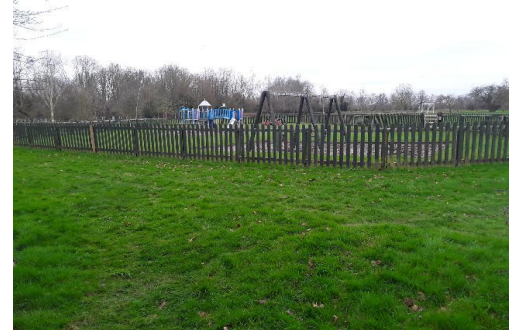
Item: Site General
Manufacturer: Unknown
Surface Type: Grass
Item Quantity: 1
Equipment Compliance: N/A
Surface Area Compliance: N/A

The depth of the loose fill surfacing is lower than the recommended depth specified in BS EN 1176; the free height of fall of the equipment is less than 2.0m and a minimum of 300mm depth should be provided (including an extra 100mm to allow for compaction and displacement as per BS EN 1176 Part 1 - Table 4) - Top up loose fill surfacing to recommended levels

The bark pit timber edgings are loose / displaced - Resecure the timber edgings

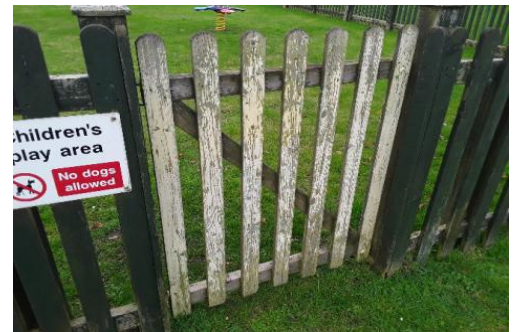
Item: Gate - Self Closing
Manufacturer: Unknown
Surface Type: Grass
Item Quantity: 2
Equipment Compliance: N/A
Surface Area Compliance: N/A

The gate is not operating correctly - Take effective action to ensure the gate closes between 4 and 8 seconds

There is some evidence of rot in the timber - Monitor for any further deterioration and replace as required

There are openings that are less than 12mm that could trap or crush fingers - Provide a 12mm gap throughout full range of motion at both sides of gate

There are projecting bolt thread(s) present - Remove excess thread length and deburr or provide cap

There are sharp protruding staples on the item - Remove staples

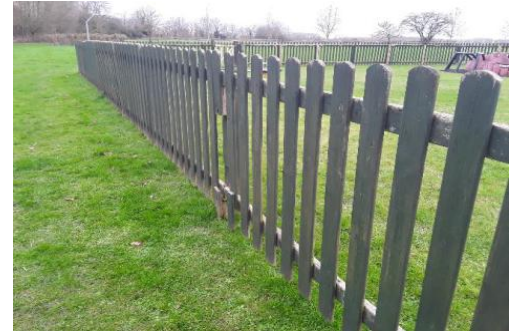
Item: Fencing - Timber
Manufacturer: Unknown
Surface Type: Grass
Item Quantity: 1
Equipment Compliance: N/A
Surface Area Compliance: N/A

The lower rail may encourage climbing creating a potential head and neck entrapment in the framework - Monitor and adjust if required

The fence is damaged in places - Repair or replace all affected sections

There are a number of loose posts around the fence - Reset the posts as required

There are areas or parts of the timber on the structure that have rotted - Replace all affected timbers

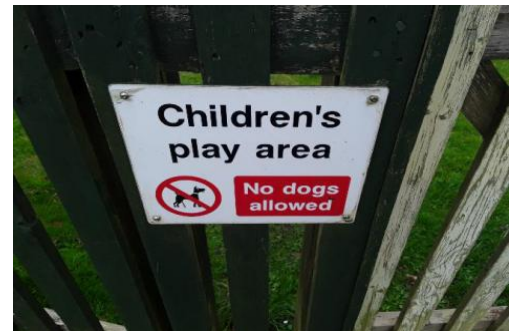
Item: Sign
Manufacturer: Unknown
Surface Type: Grass
Item Quantity: 1
Equipment Compliance: N/A
Surface Area Compliance: N/A

It is recommended that signage, with information including the site address, contact information for maintenance issues and emergency contact details are provided at the entrance to the facility - Provide in accordance with the recommendations

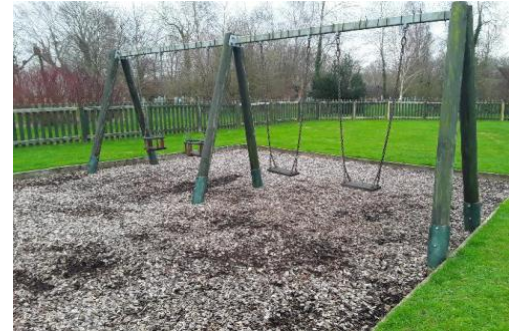
Item: 2 Bay 2 Flat 2 Cradle
Manufacturer: Unknown
Surface Type: Bark Mulch
Item Quantity: 1
Equipment Compliance: No
Surface Area Compliance: Yes

There is wear damage to the quick links - Monitor and replace when 40% worn

There is some notable evidence of chain wear - Monitor for any further deterioration and replace when 40% worn

The timber has a number of splits/shakes or air cracks and this may affect the stability or allow water ingress which will accelerate the rotting process - Monitor to ensure the splits do not cross through fixing points of the structure and/or cause any instability

There is/are bolt cap covers missing or damaged on the item - Replace missing or damaged bolt cap covers

The chain openings are in excess of the 8.6mm as recommended by BS EN 1176 - Monitor - No remedial work recommended

The swing seat connectors are loose - Tighten to secure

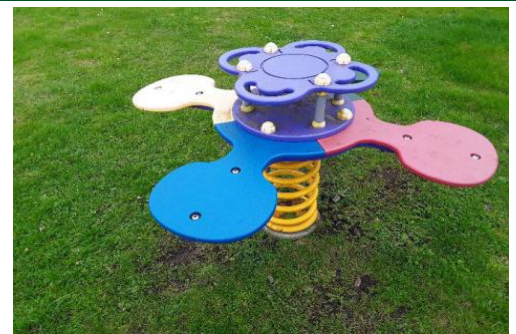
Item: Four Way Springer
Manufacturer: Fahr Industries
Surface Type: Grass Matrix Tiles
Item Quantity: 1
Equipment Compliance: Yes
Surface Area Compliance: Yes

There is minor distortion damage to the seat - Monitor and repair if required

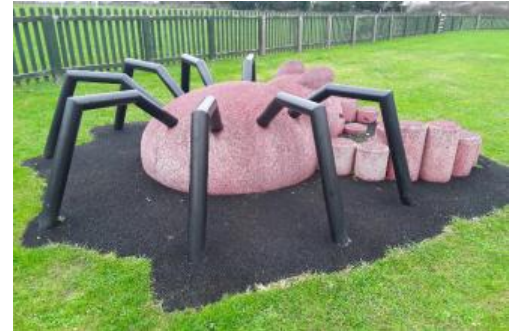
Item: Wetpour Animal
Manufacturer: Not Identified
Surface Type: Wet Pour
Item Quantity: 1
Equipment Compliance: Yes
Surface Area Compliance: Yes

This item is satisfactory - no work required -

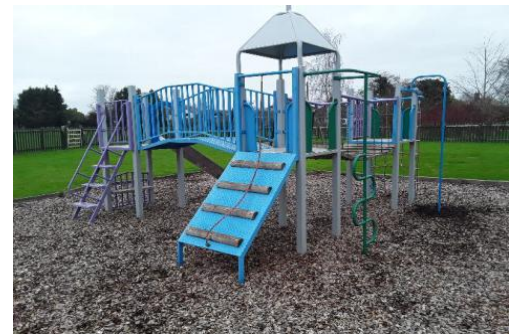
Item: Multi Play (Junior)
Manufacturer: Not Identified
Surface Type: Bark Mulch
Item Quantity: 1
Equipment Compliance: No
Surface Area Compliance: Yes

The fixings have corroded - Replace all corroded fixings

The item fails to meet the requirements of BS EN 1176 Part 1 4.2.7.2 head and neck entrapment in the barriers and/or steps - Monitor - No remedial work recommended

There is some notable evidence of chain and shackle wear - Monitor for any further deterioration and replace when 40% worn

There is/are finger entrapment/s in the frame and the item fails to meet the requirements of BS EN 1176 Part 1 4.2.7.6 Entrapment of fingers - Monitor - No remedial work recommended

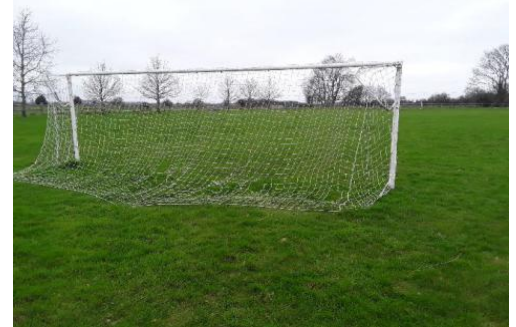
Item: Football Goal
Manufacturer: Unknown
Surface Type: Grass
Item Quantity: 2
Equipment Compliance: N/A
Surface Area Compliance: N/A

NB: We have undertaken a maintenance inspection only of the football goal(s); full load testing falls outside the scope of our inspection. - Implement load testing as required

There is surface corrosion / rust present on the item - Consider treating the item

The net is damaged - Repair or replace the damaged net

The item is slightly loose in its foundations - Monitor for any further deterioration and repair as required

There is damage to the frame (patch repaired using gaffa tape) - Replace the damaged component

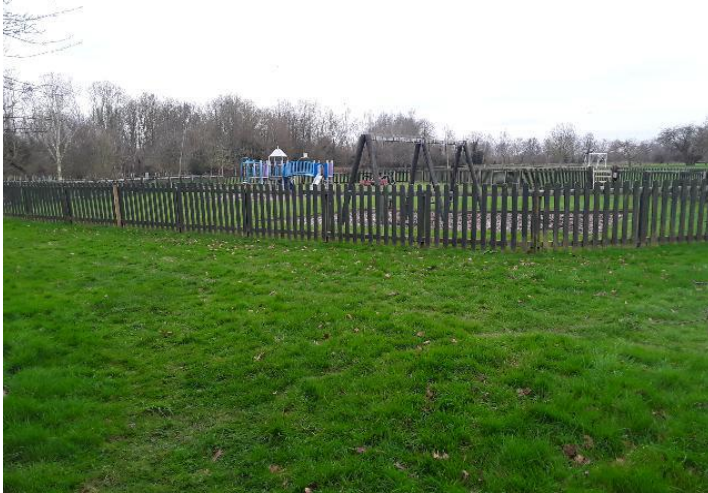
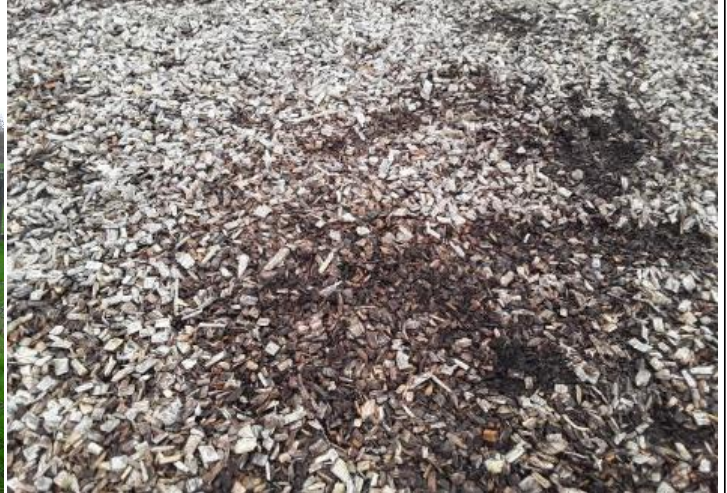
Item: Ancillary Items - Site General
Manufacturer: Unknown

Finding: The depth of the loose fill surfacing is lower than the recommended depth specified in BS EN 1176; the free height of fall of the equipment is less than 2.0m and a minimum of 300mm depth should be provided (including an extra 100mm to allow for compaction and displacement as per BS EN 1176 Part 1 - Table 4)

Action: Top up loose fill surfacing to recommended levels

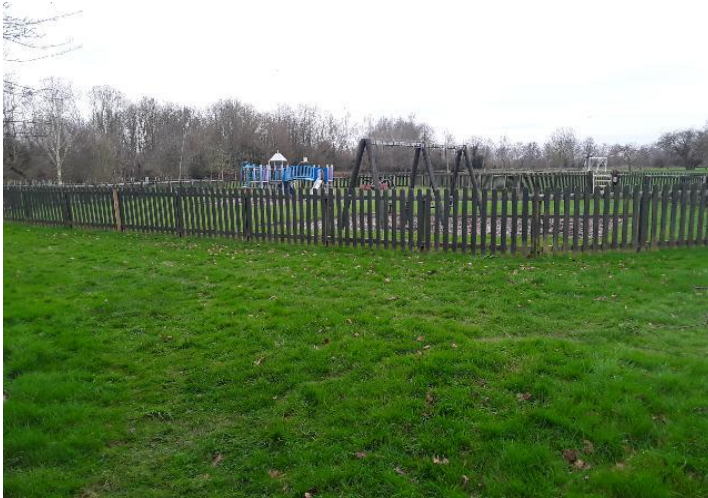
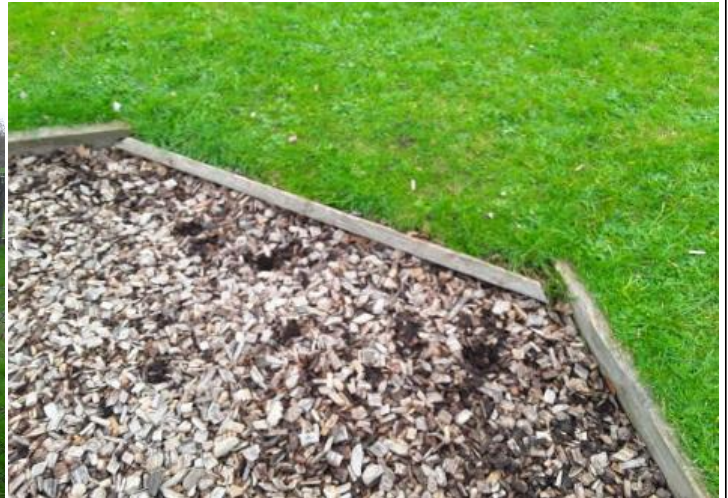
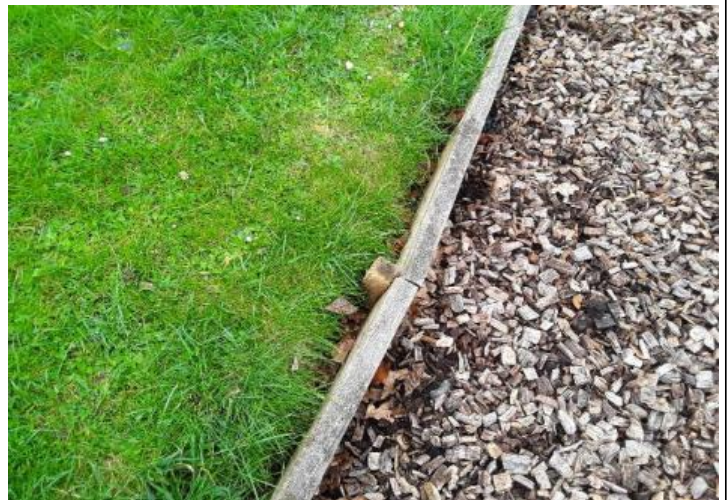
Item: Ancillary Items - Site General
Manufacturer: Unknown

Finding: The bark pit timber edgings are loose / displaced

Action: Resecure the timber edgings

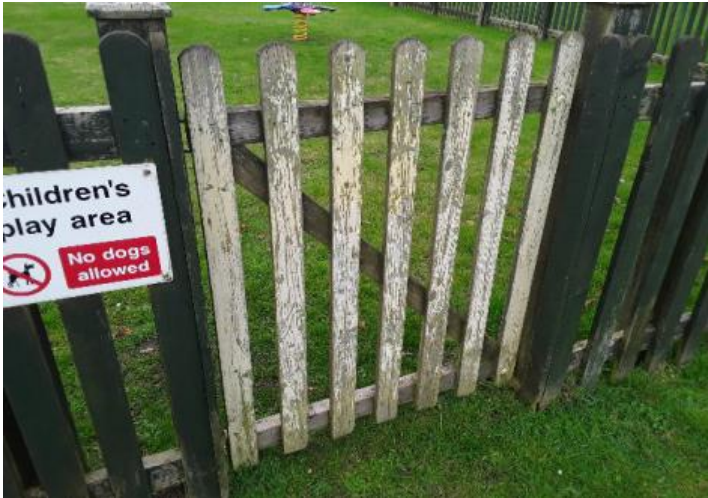
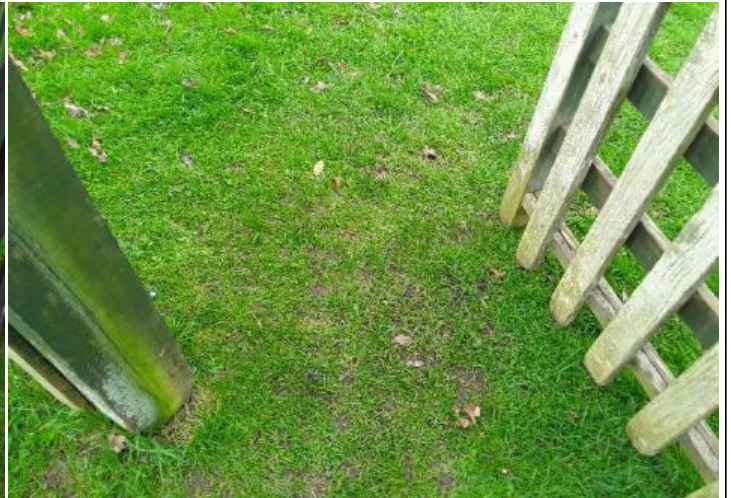
Item: Gates - Gate - Self Closing
Manufacturer: Unknown

Finding: The gate is not operating correctly

Action: Take effective action to ensure the gate closes between 4 and 8 seconds

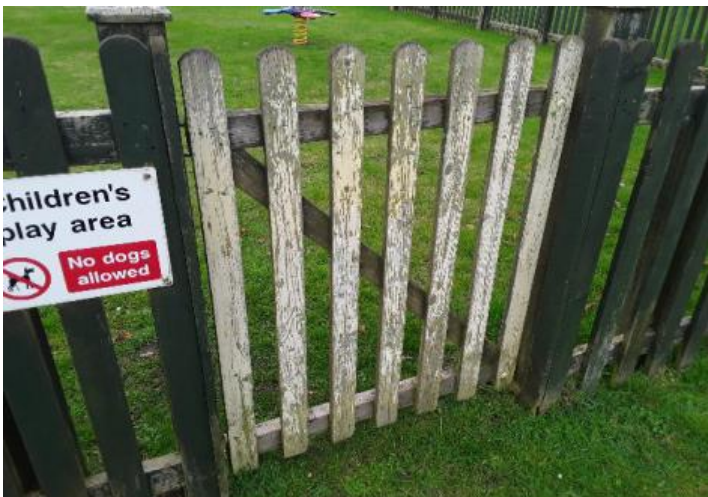
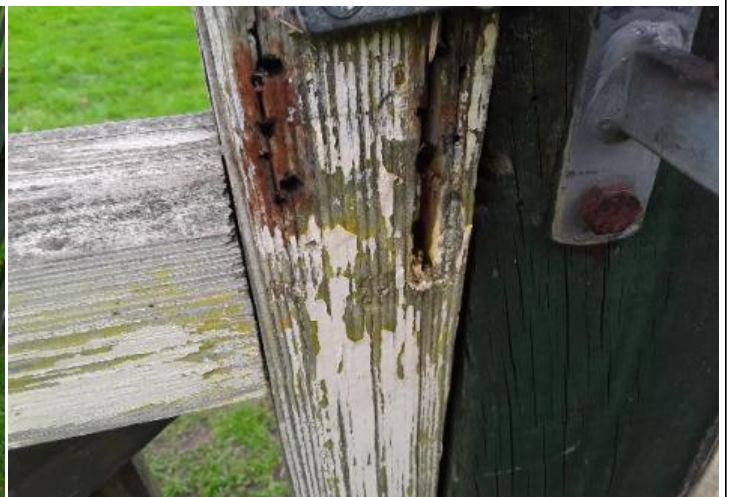
Item: Gates - Gate - Self Closing
Manufacturer: Unknown

Finding: There is some evidence of rot in the timber

Action: Monitor for any further deterioration and replace as required

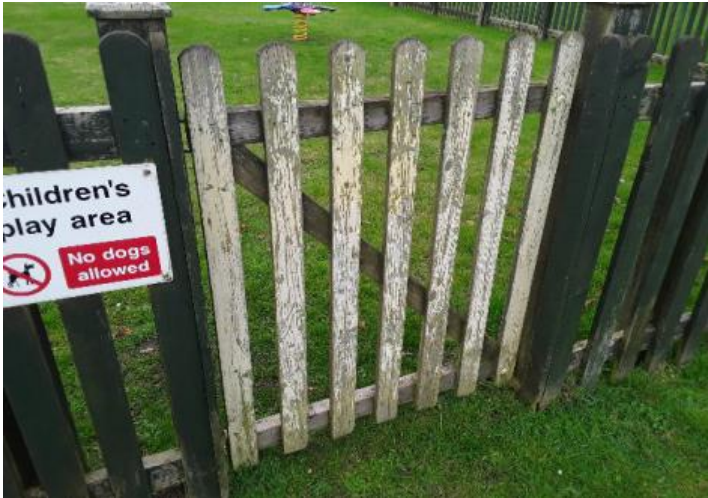
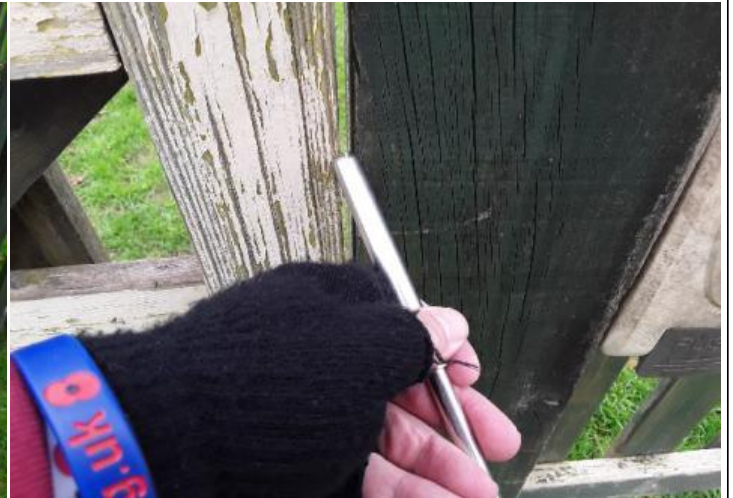
Item: Gates - Gate - Self Closing
Manufacturer: Unknown

Finding: There are openings that are less than 12mm that could trap or crush fingers

Action: Provide a 12mm gap throughout full range of motion at both sides of gate

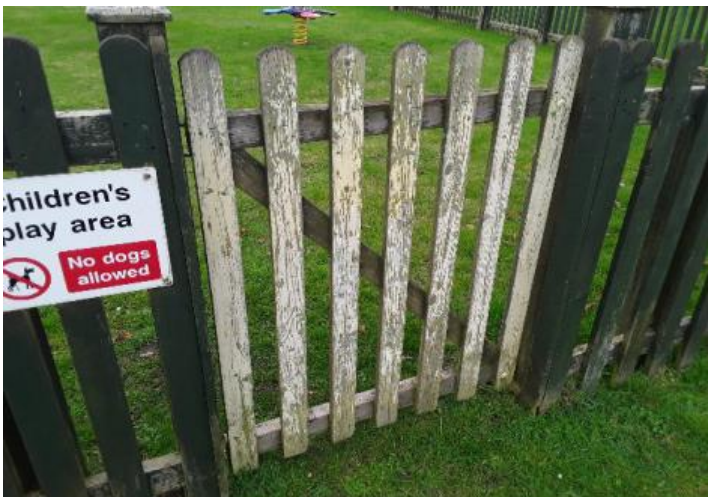
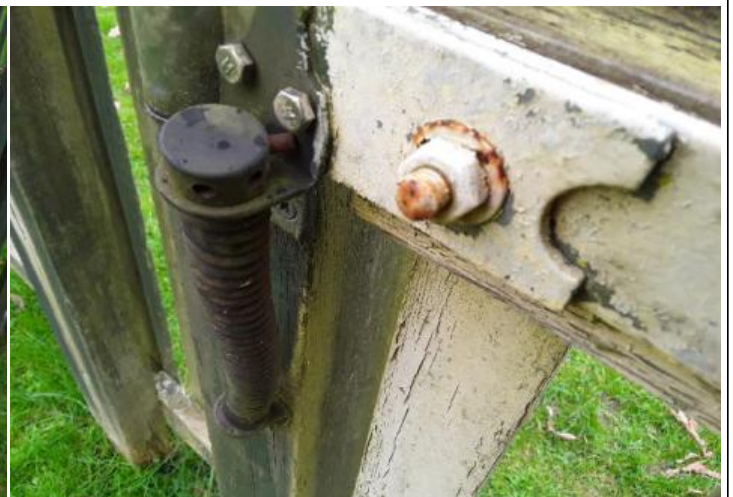
Item: Gates - Gate - Self Closing
Manufacturer: Unknown

Finding: There are projecting bolt thread(s) present

Action: Remove excess thread length and deburr or provide cap

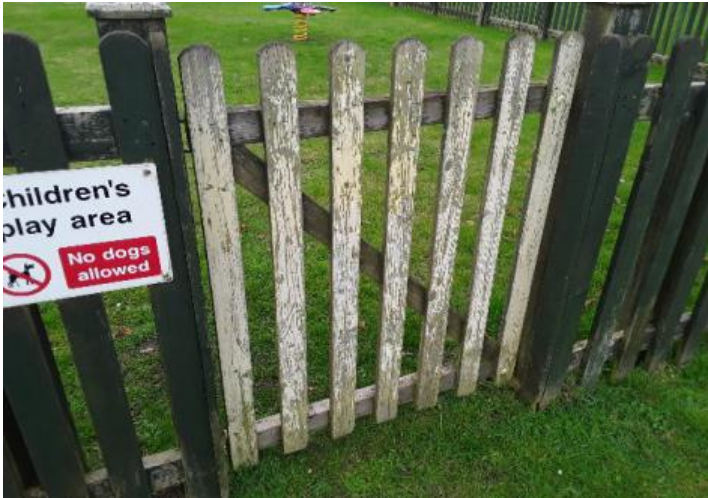
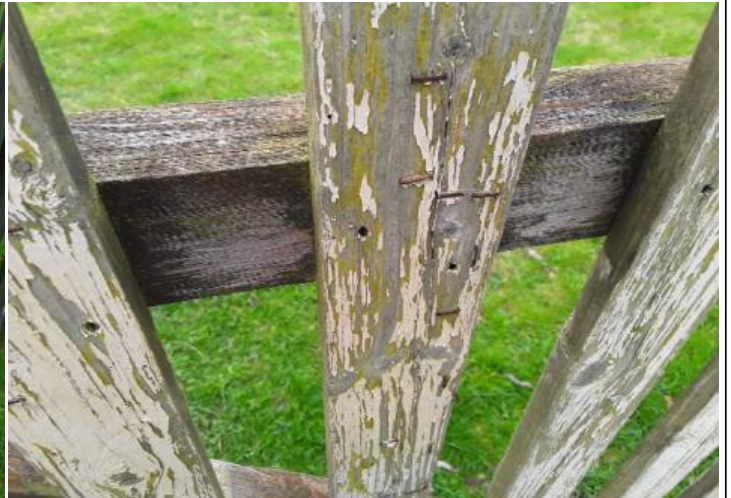
Item: Gates - Gate - Self Closing
Manufacturer: Unknown

Finding: There are sharp protruding staples on the item

Action: Remove staples

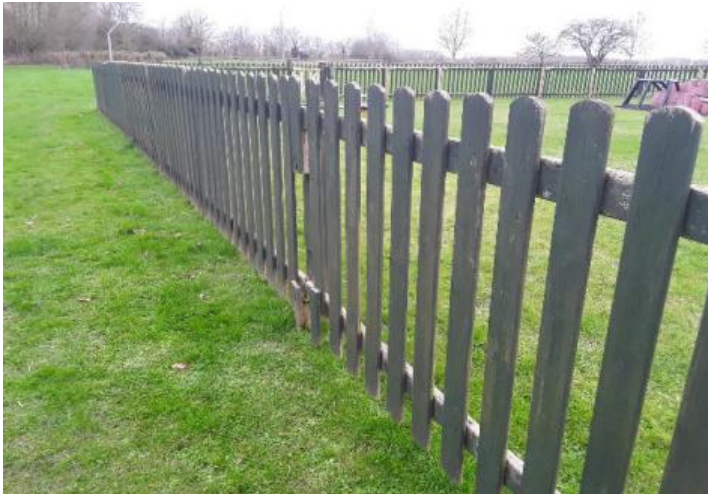
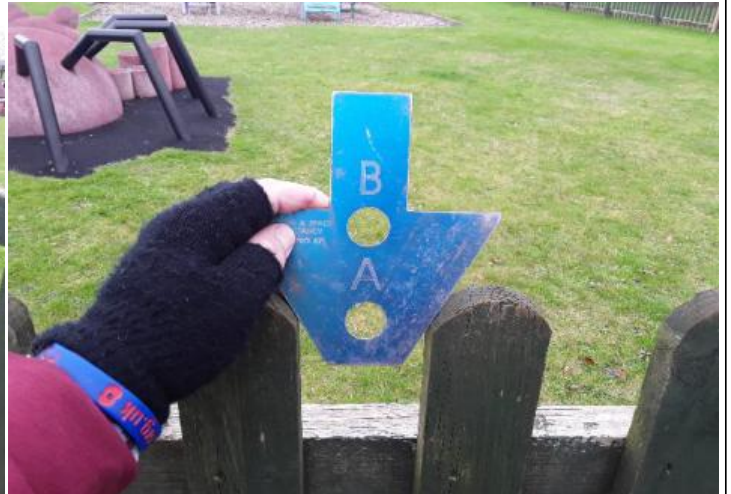
Item: Fences - Fencing - Timber
Manufacturer: Unknown

Finding: The lower rail may encourage climbing creating a potential head and neck entrapment in the framework

Action: Monitor and adjust if required

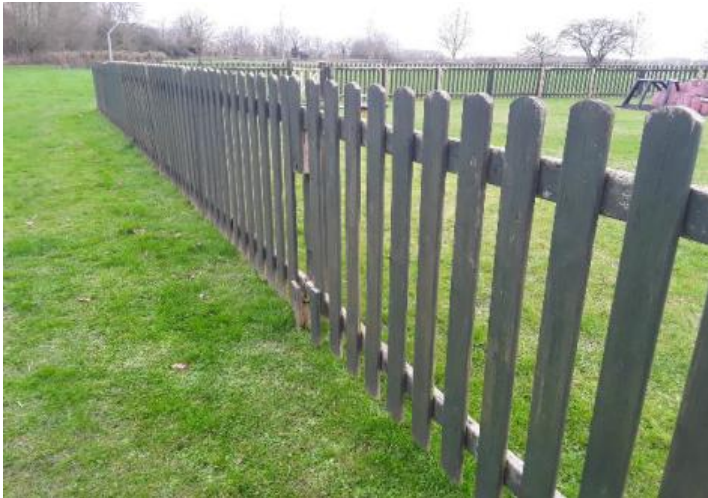
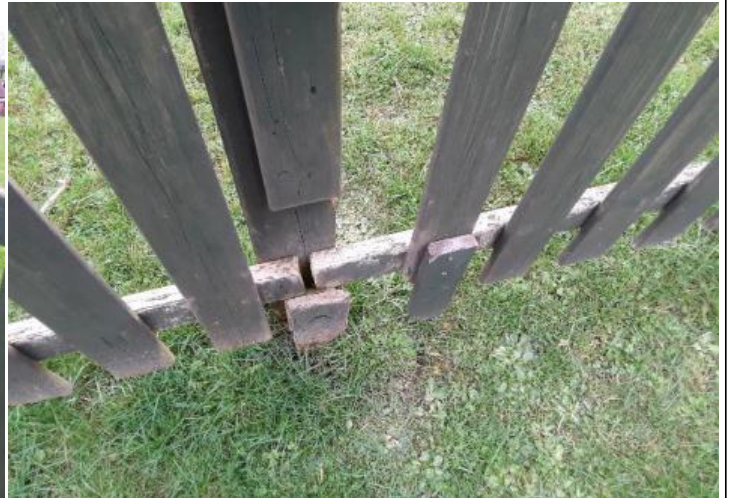
Item: Fences - Fencing - Timber
Manufacturer: Unknown

Finding: The fence is damaged in places

Action: Repair or replace all affected sections

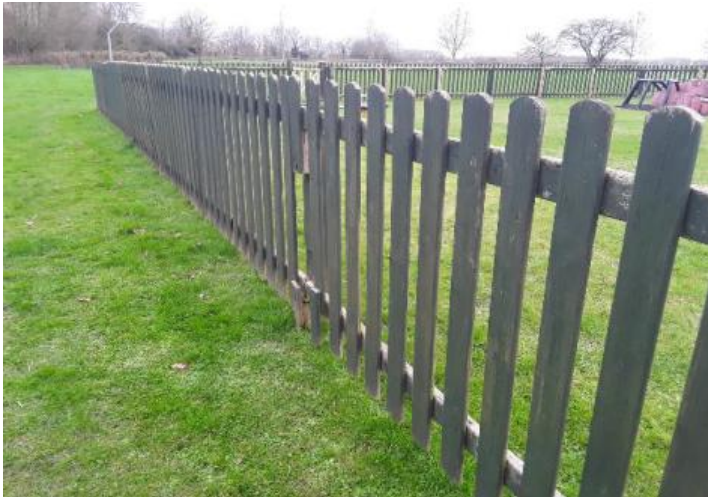
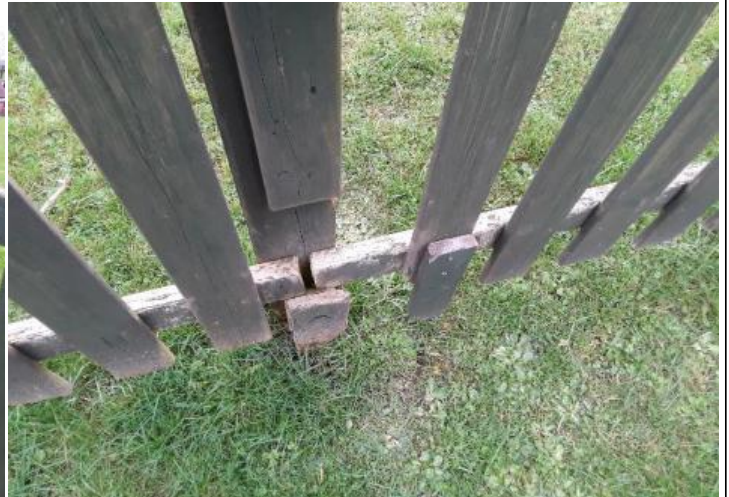
Item: Fences - Fencing - Timber
Manufacturer: Unknown

Finding: There are a number of loose posts around the fence

Action: Reset the posts as required

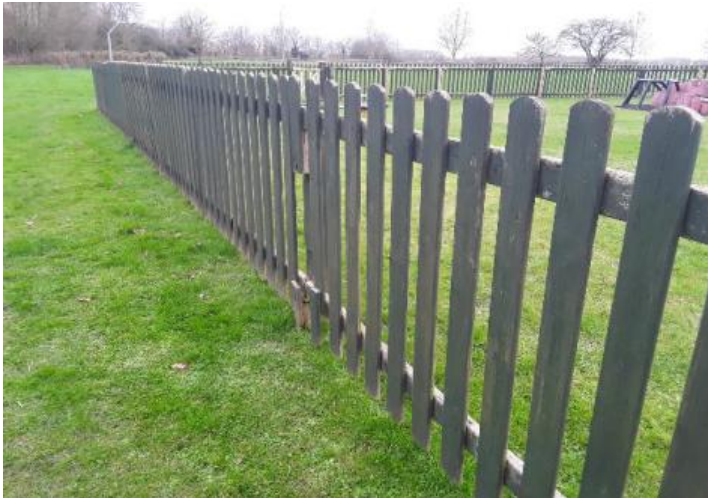
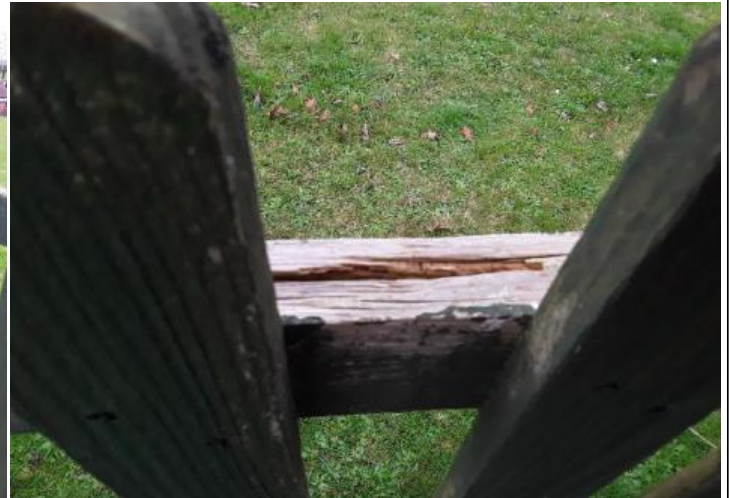
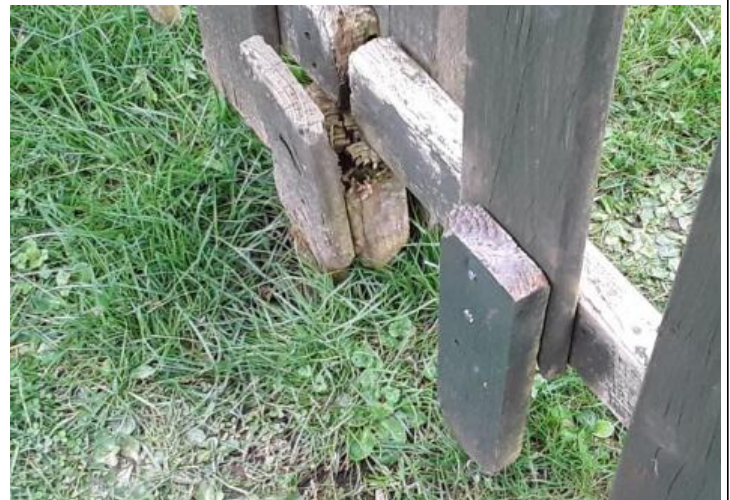
Item: Fences - Fencing - Timber
Manufacturer: Unknown

Finding: There are areas or parts of the timber on the structure that have rotted

Action: Replace all affected timbers

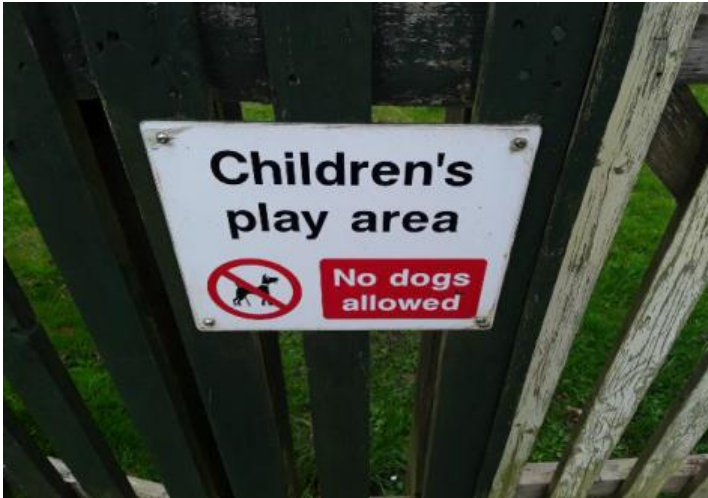
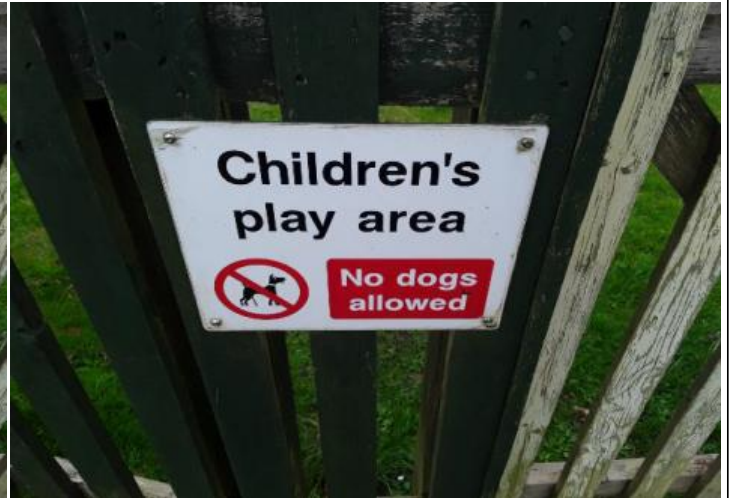
Item: Ancillary Items - Sign
Manufacturer: Unknown

Finding: It is recommended that signage, with information including the site address, contact information for maintenance issues and emergency contact details are provided at the entrance to the facility

Action: Provide in accordance with the recommendations

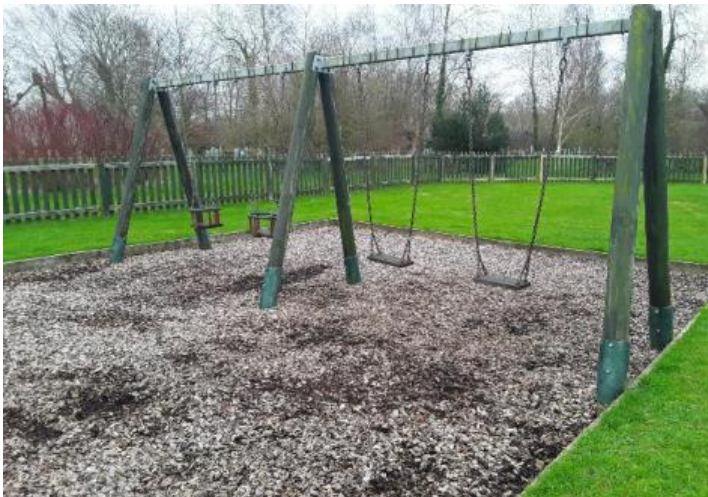
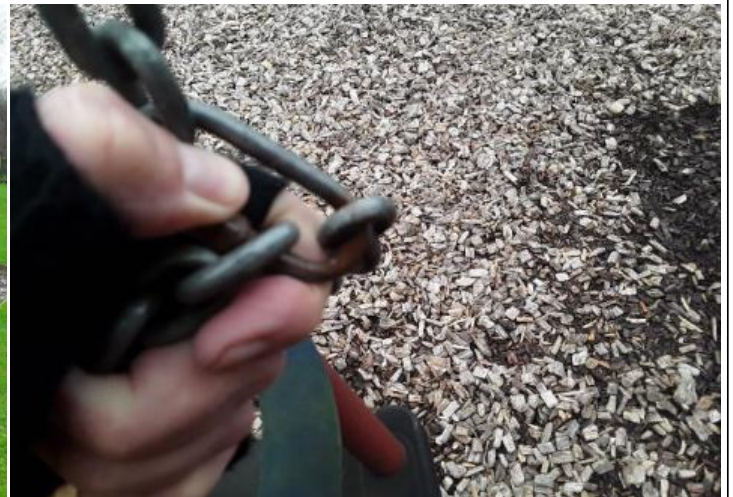
Item: Swings - 2 Bay 2 Flat 2 Cradle
Manufacturer: Unknown

Finding: There is wear damage to the quick links

Action: Monitor and replace when 40% worn

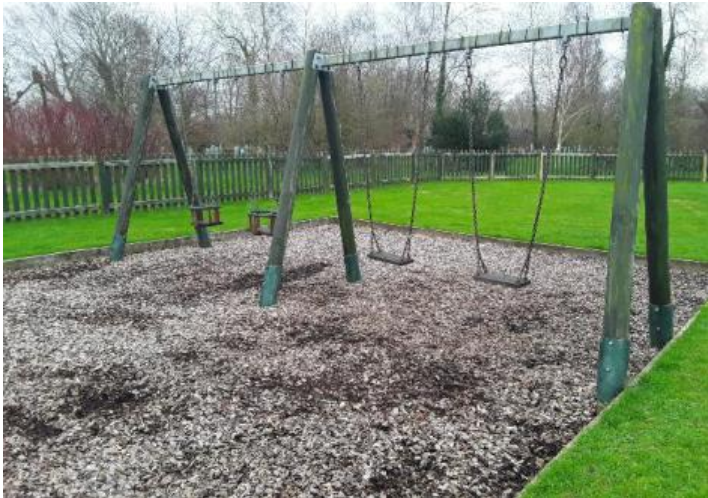
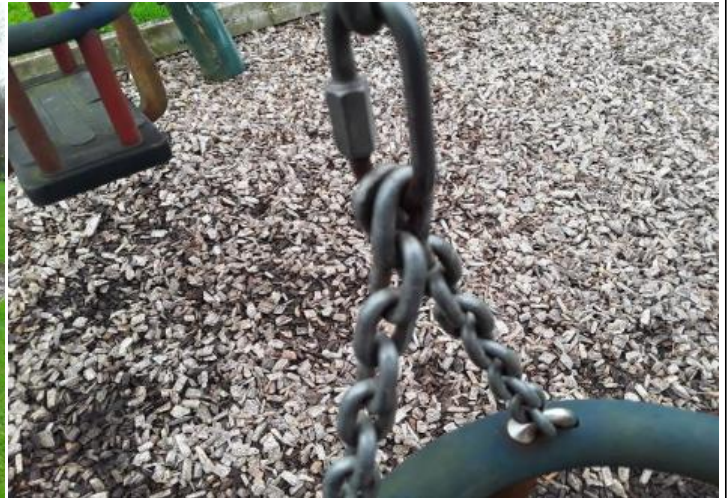
Item: Swings - 2 Bay 2 Flat 2 Cradle
Manufacturer: Unknown

Finding: There is some notable evidence of chain wear

Action: Monitor for any further deterioration and replace when 40% worn

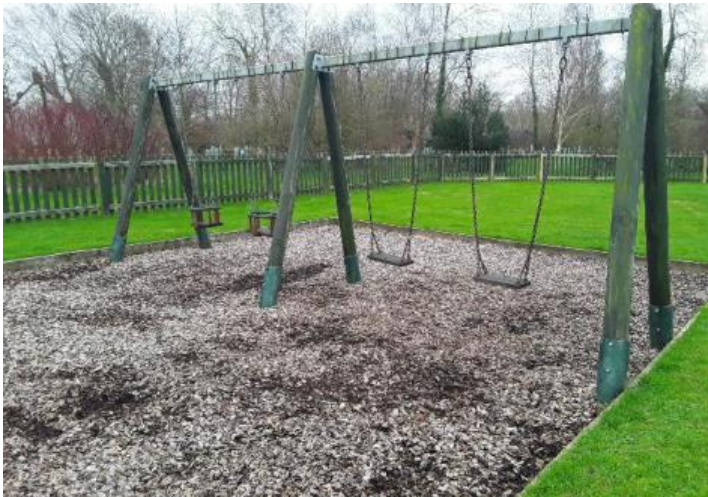
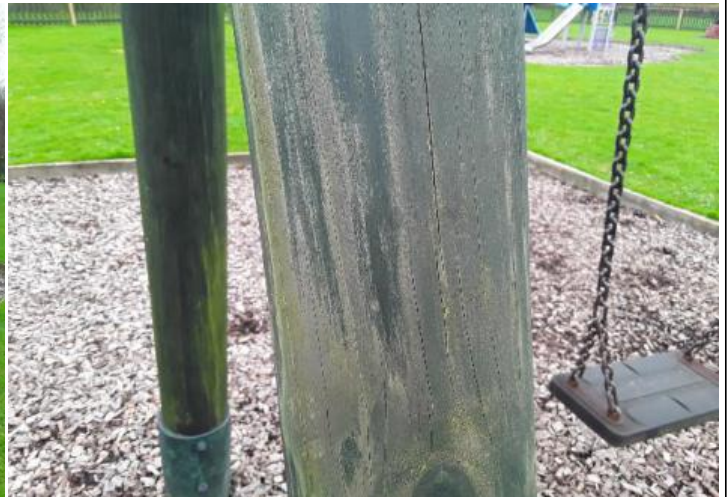
Item: Swings - 2 Bay 2 Flat 2 Cradle
Manufacturer: Unknown

Finding: The timber has a number of splits/shakes or air cracks and this may affect the stability or allow water ingress which will accelerate the rotting process

Action: Monitor to ensure the splits do not cross through fixing points of the structure and/or cause any instability

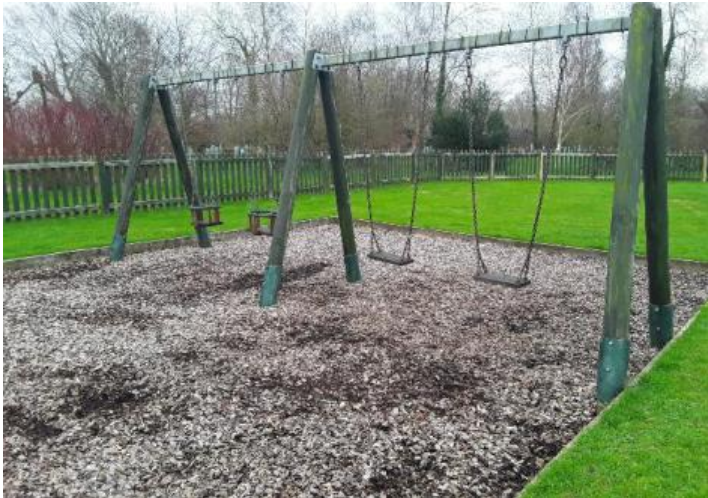
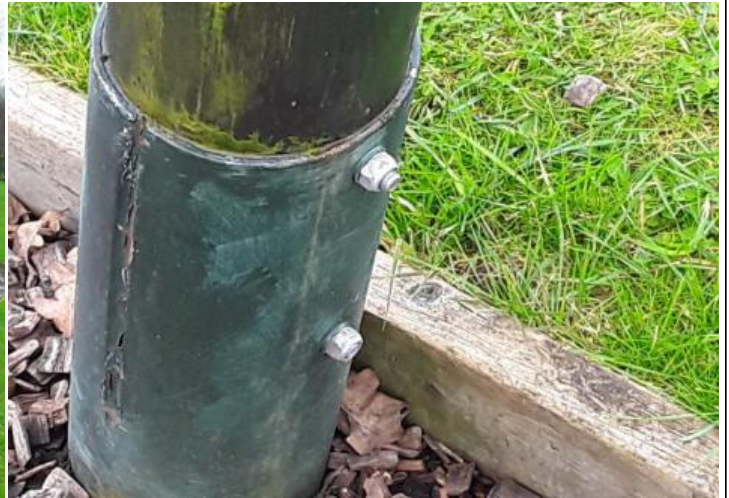
Item: Swings - 2 Bay 2 Flat 2 Cradle
Manufacturer: Unknown

Finding: There is/are bolt cap covers missing or damaged on the item

Action: Replace missing or damaged bolt cap covers

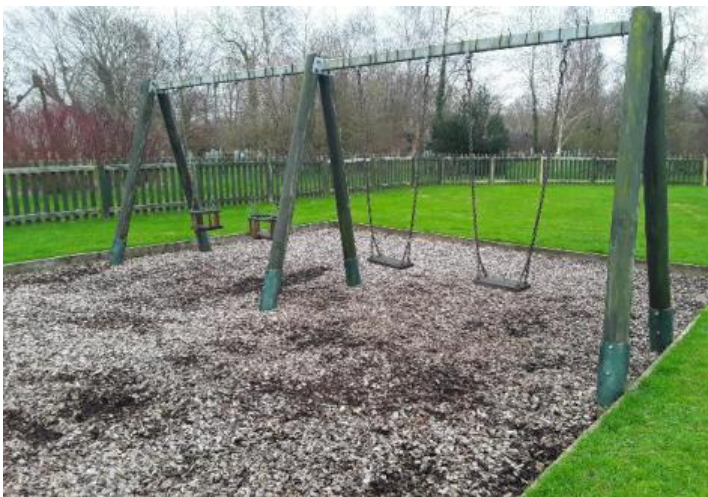
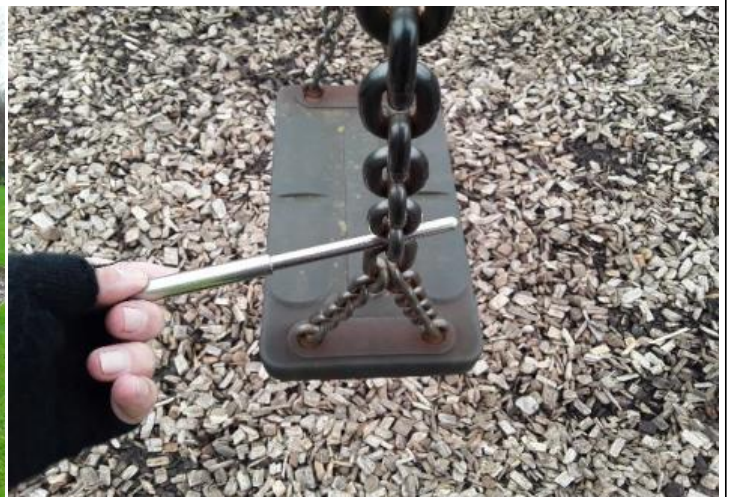
Item: Swings - 2 Bay 2 Flat 2 Cradle
Manufacturer: Unknown

Finding: The chain openings are in excess of the 8.6mm as recommended by BS EN 1176

Action: Monitor - No remedial work recommended

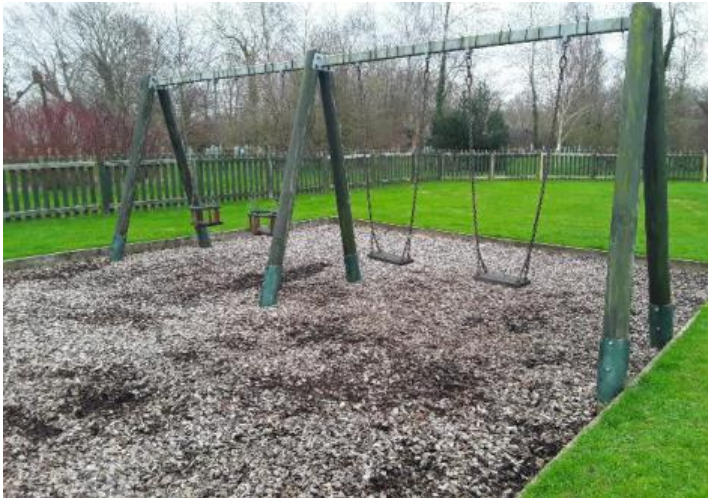
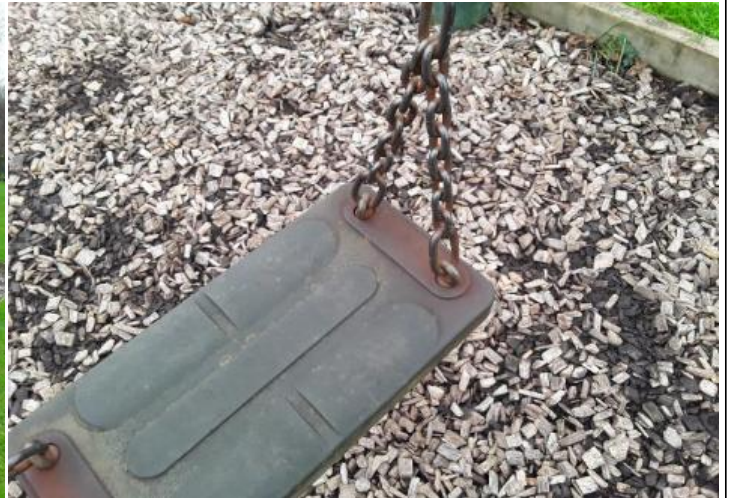
Item: Swings - 2 Bay 2 Flat 2 Cradle
Manufacturer: Unknown

Finding: The swing seat connectors are loose

Action: Tighten to secure

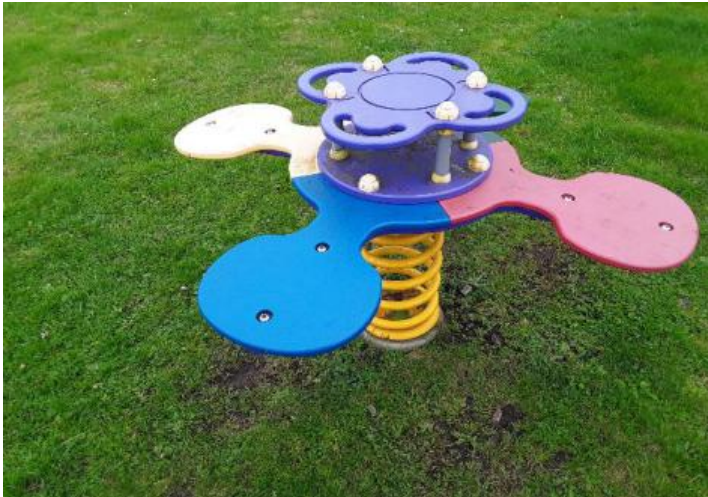
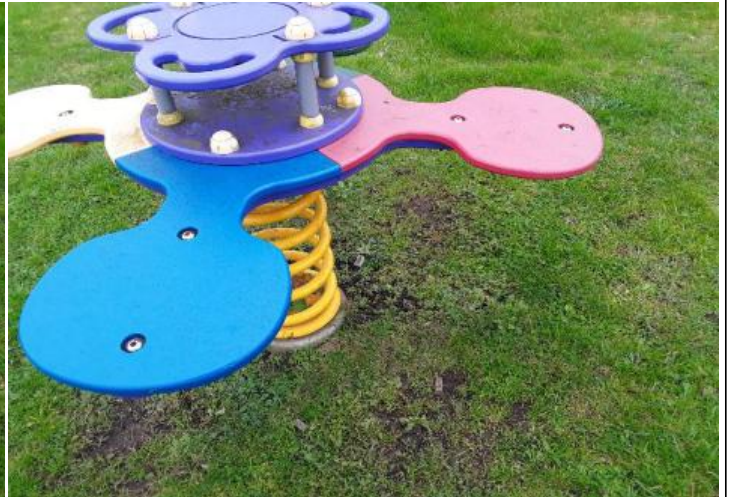
Item: Rocking Equipment - Four Way Springer
Manufacturer: Fahr Industries

Finding: There is minor distortion damage to the seat

Action: Monitor and repair if required

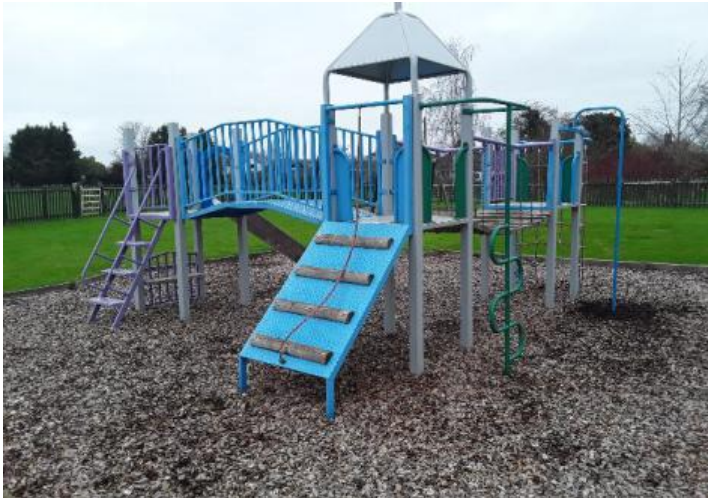
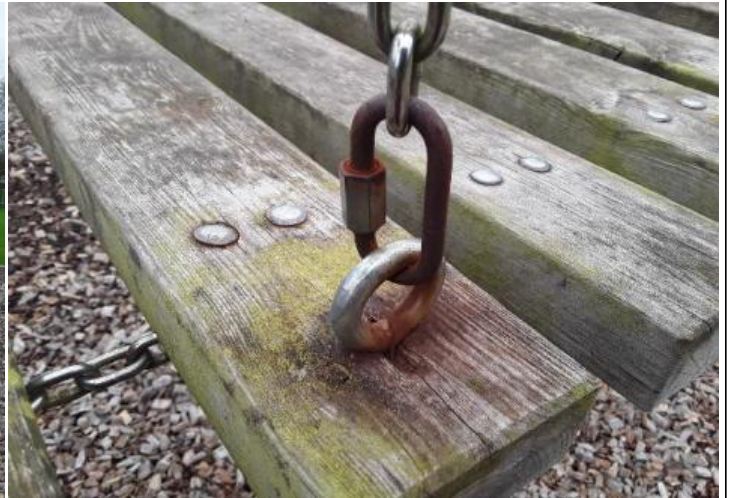
Item: Activity Equipment - Multi Play (Junior)
Manufacturer: Not Identified

Finding: The fixings have corroded

Action: Replace all corroded fixings

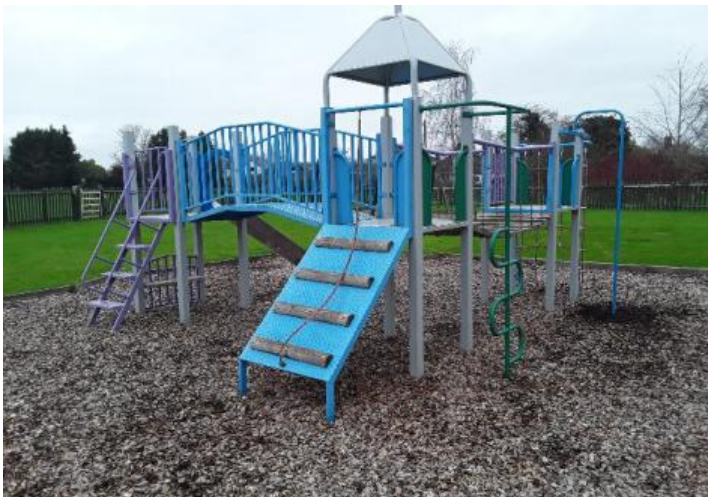
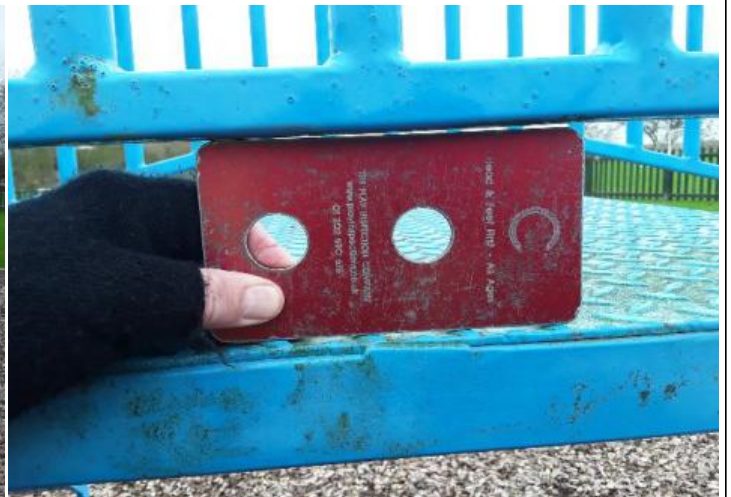
Item: Activity Equipment - Multi Play (Junior)
Manufacturer: Not Identified

Finding: The item fails to meet the requirements of BS EN 1176 Part 1 4.2.7.2 head and neck entrapment in the barriers and/or steps

Action: Monitor - No remedial work recommended

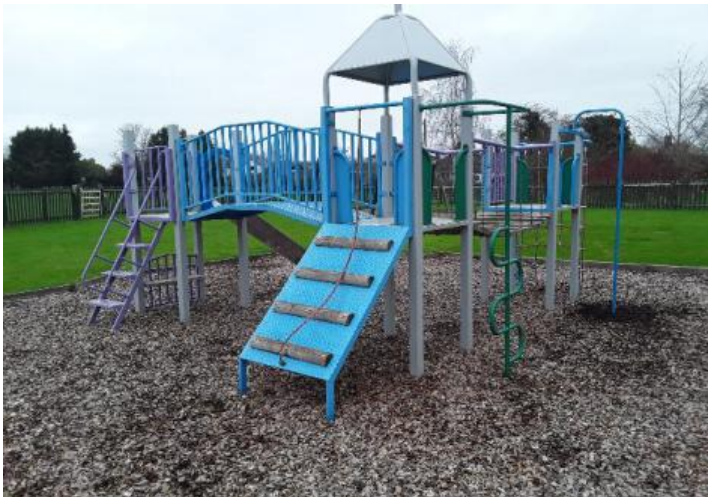
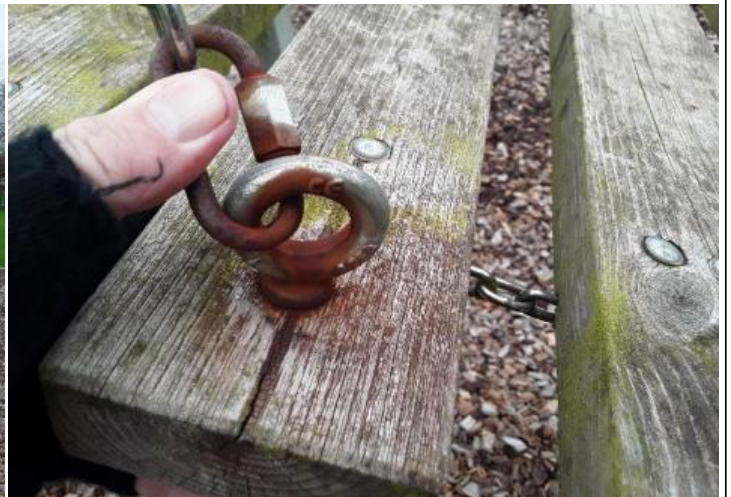
Item: Activity Equipment - Multi Play (Junior)
Manufacturer: Not Identified

Finding: There is some notable evidence of chain and shackle wear

Action: Monitor for any further deterioration and replace when 40% worn

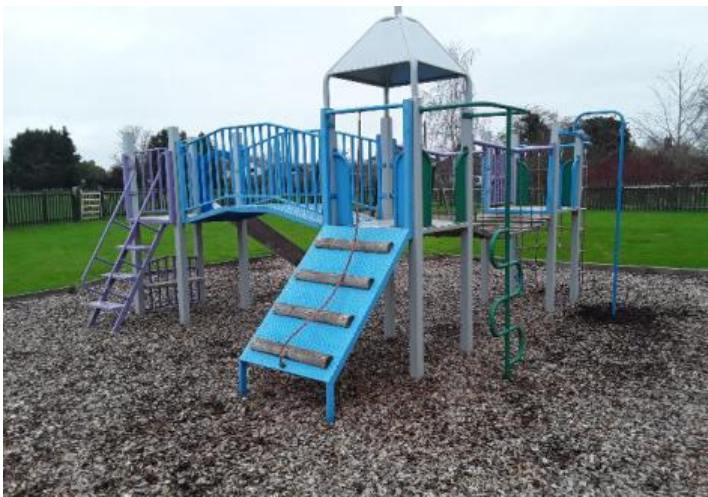
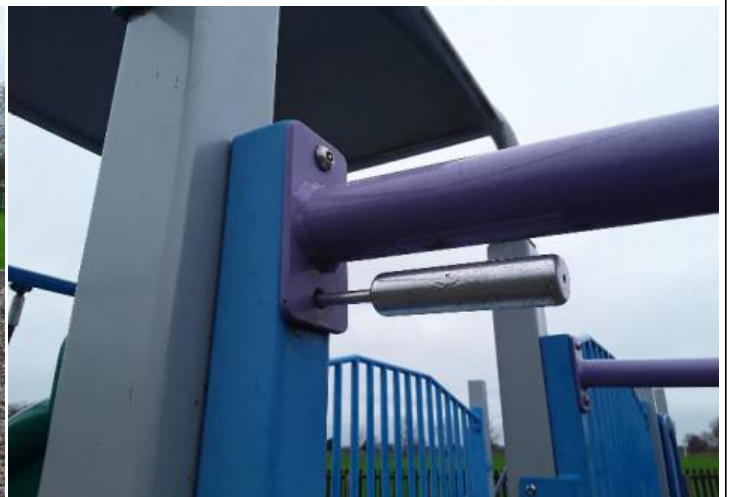
Item: Activity Equipment - Multi Play (Junior)
Manufacturer: Not Identified

Finding: There is/are finger entrapment/s in the frame and the item fails to meet the requirements of BS EN 1176 Part 1 4.2.7.6 Entrapment of fingers

Action: Monitor - No remedial work recommended

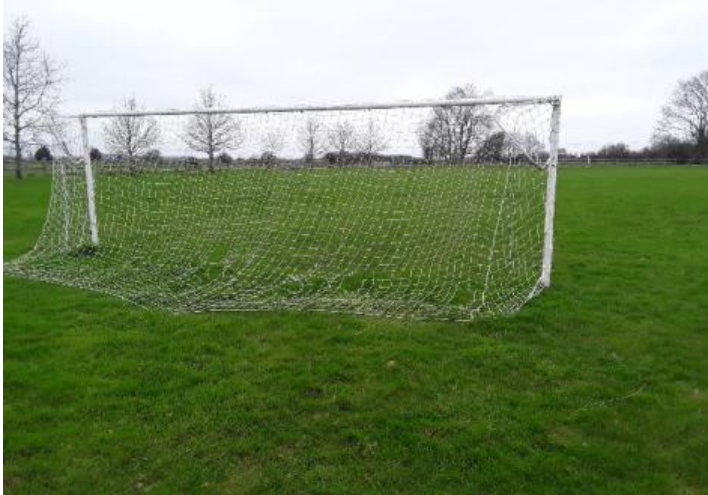
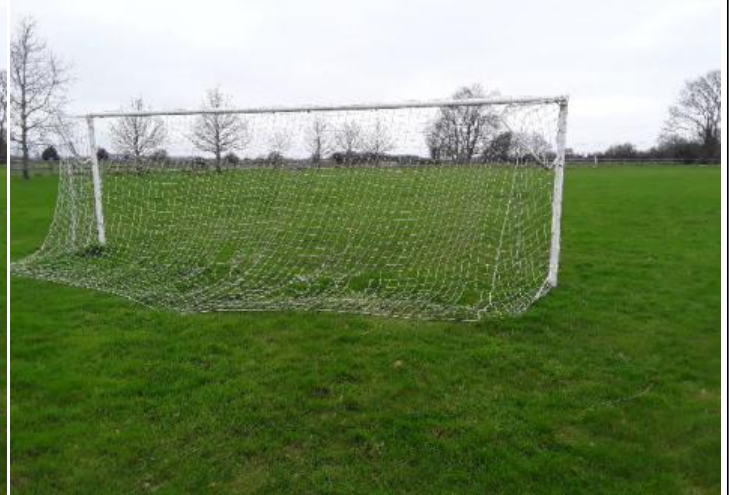
Item: Multi Use Games Area - Football Goal
Manufacturer: Unknown

Finding: NB: We have undertaken a maintenance inspection only of the football goal(s); full load testing falls outside the scope of our inspection.

Action: Implement load testing as required

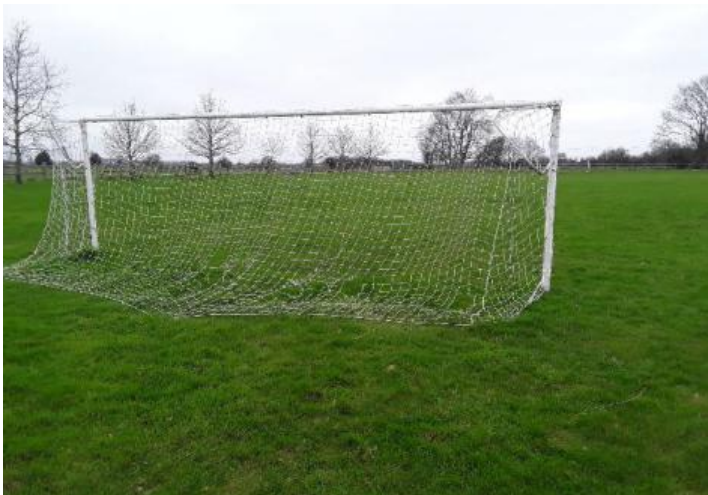
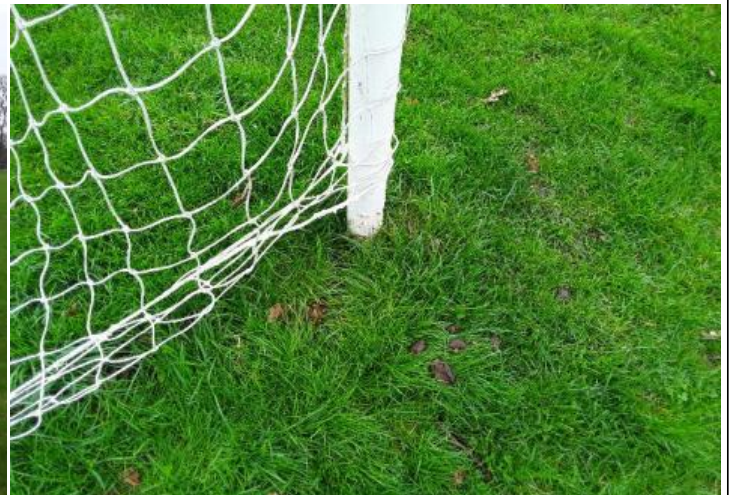
Item: Multi Use Games Area - Football Goal
Manufacturer: Unknown

Finding: The item is slightly loose in its foundations

Action: Monitor for any further deterioration and repair as required
