the **play inspection** company

Annual Inspection

Charney Hall and Field Trust

Charney Field

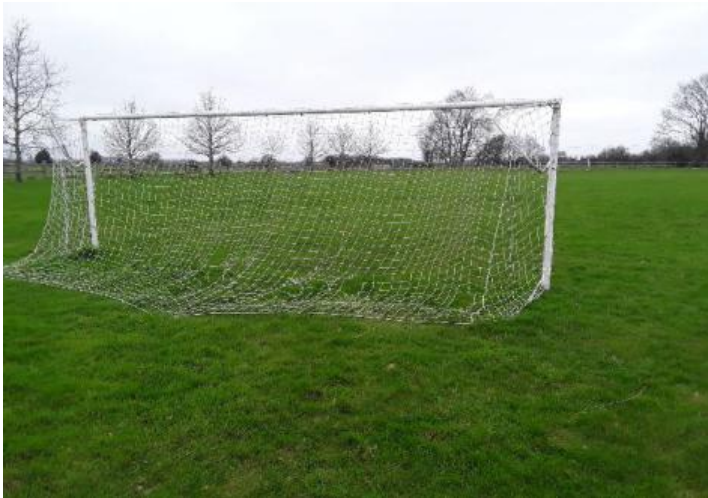
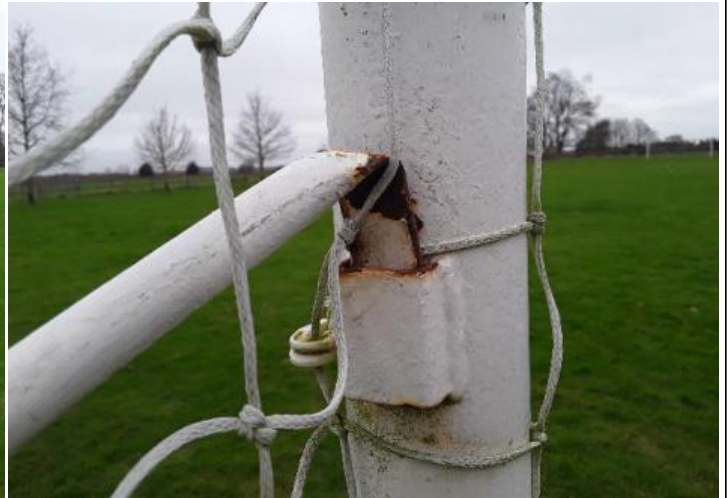
Item: Multi Use Games Area - Football Goal
Manufacturer: Unknown

Finding: There is surface corrosion / rust present on the item

Action: Consider treating the item

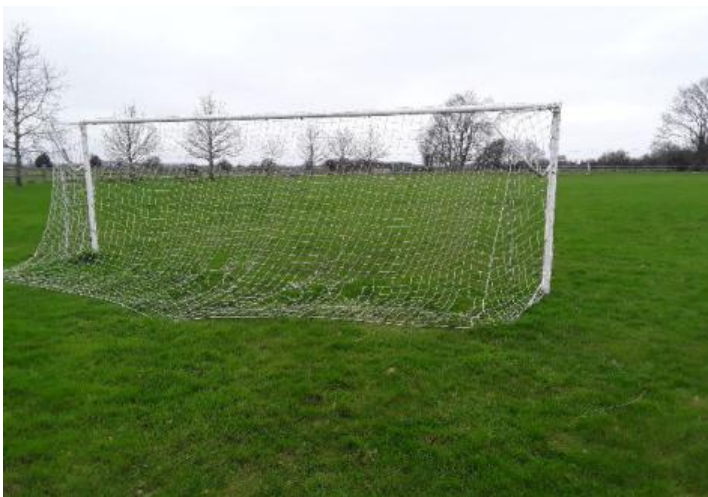
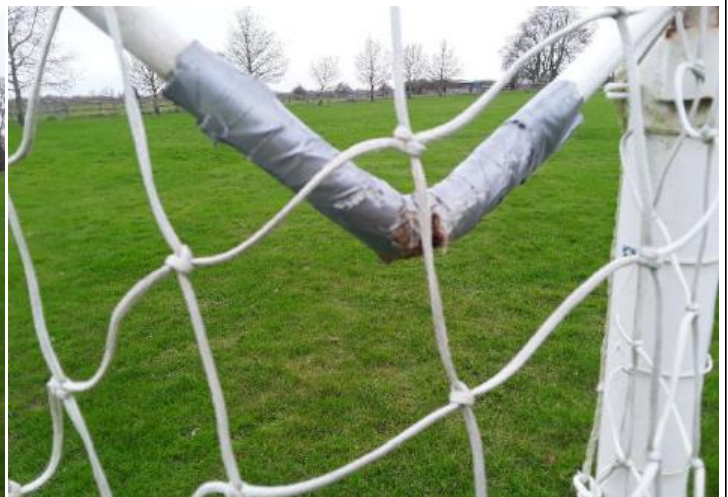
Item: Multi Use Games Area - Football Goal
Manufacturer: Unknown

Finding: There is damage to the frame (patch repaired using gaffa tape)

Action: Replace the damaged component

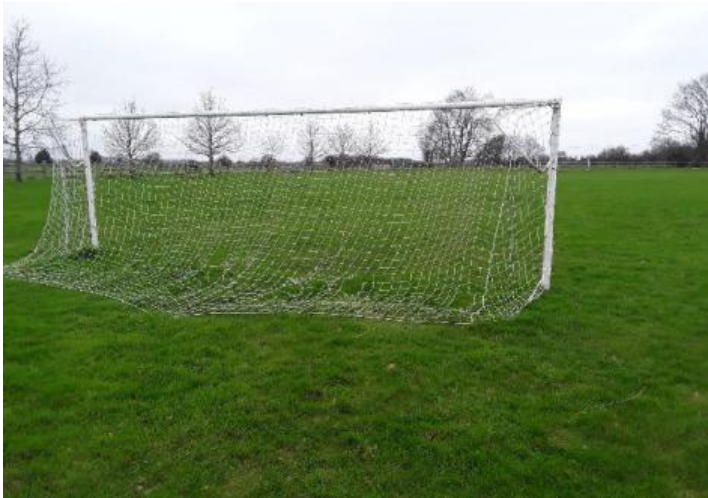
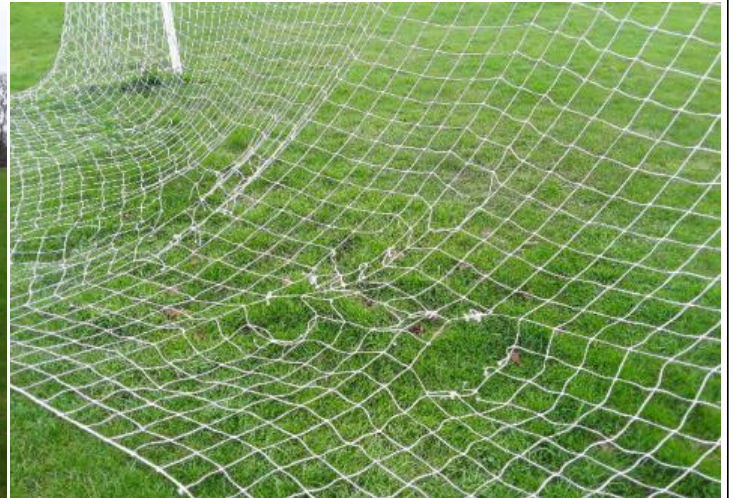
Item: Multi Use Games Area - Football Goal
Manufacturer: Unknown

Finding: The net is damaged

Action: Repair or replace the damaged net
