## Annual Inspection

Charney Hall and Field Trust

Charney Field

Inspection Ref: 2613246

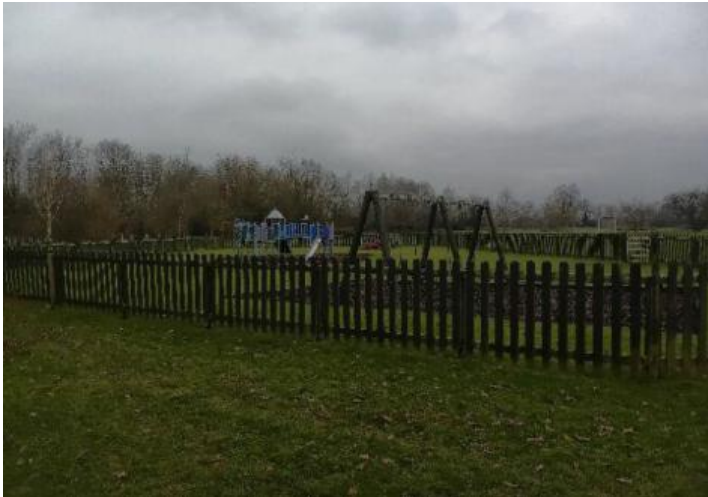
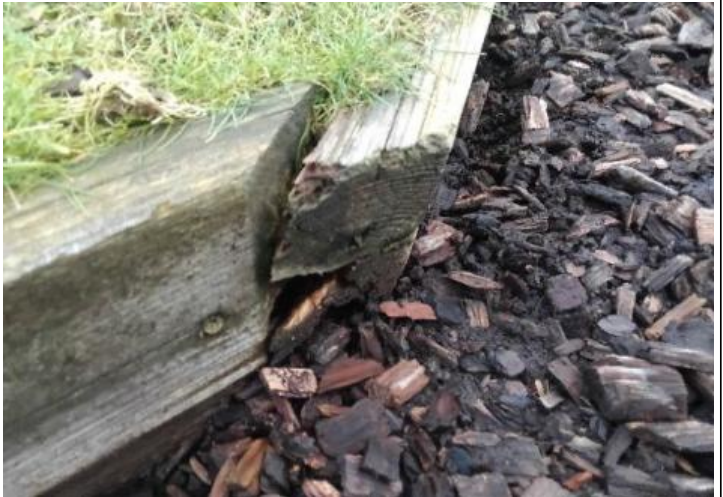
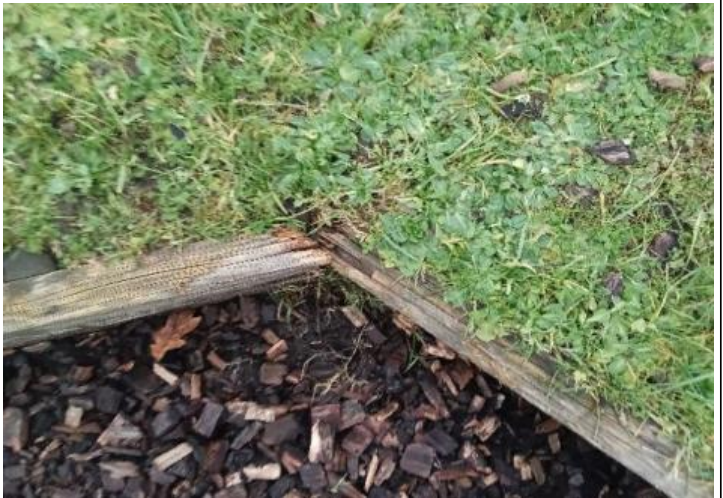
**Item:** Ancillary Items - Site General  
**Manufacturer:** Owner/Operator

**Finding:** There is some evidence of rot in the timber edging **Action:** Monitor for any further deterioration and replace as required

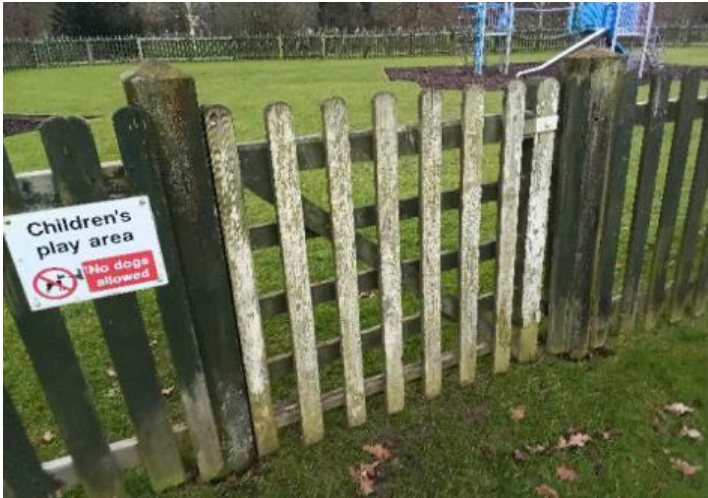
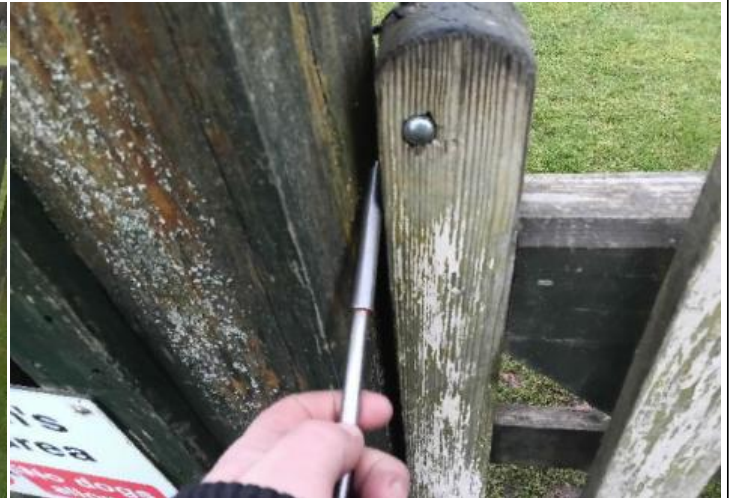
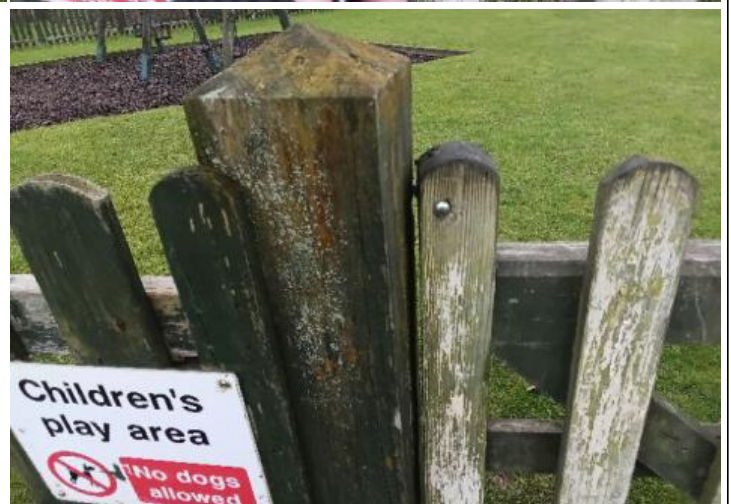
**Item:** Gates - Gate - Self Closing  
**Manufacturer:** Not Identified

**Finding:** There are openings that are less than 12mm that could trap or crush fingers

**Action:** Provide a 12mm gap throughout full range of motion at both sides of gate

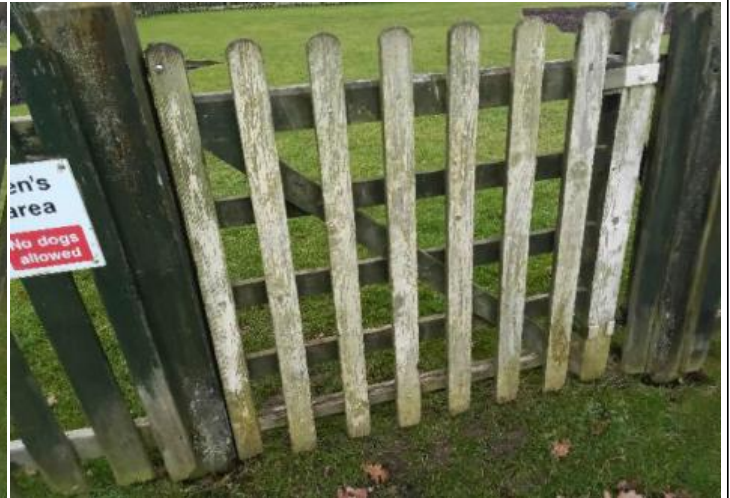
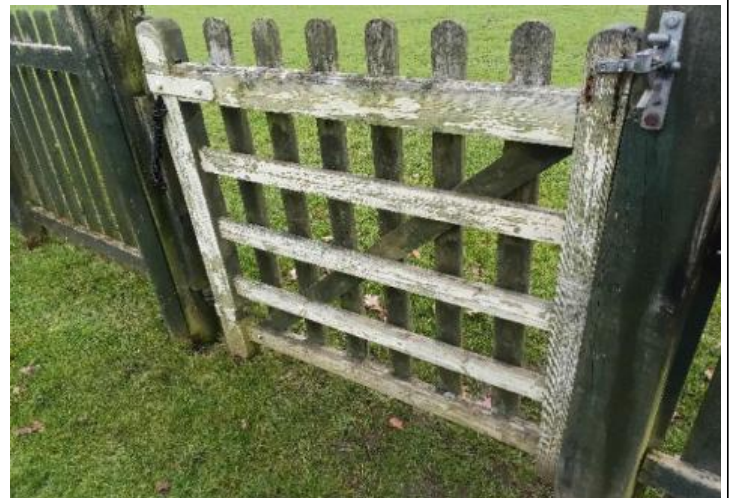
**Item:** Gates - Gate - Self Closing  
**Manufacturer:** Not Identified

**Finding:** The gate is closing too quickly (less than 4 seconds)

**Action:** Take corrective action to ensure that the gate closes in 4-8 seconds from 90 degrees

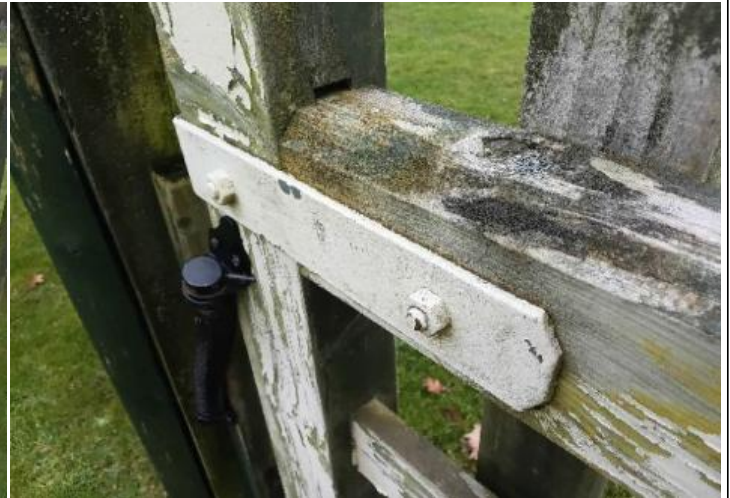
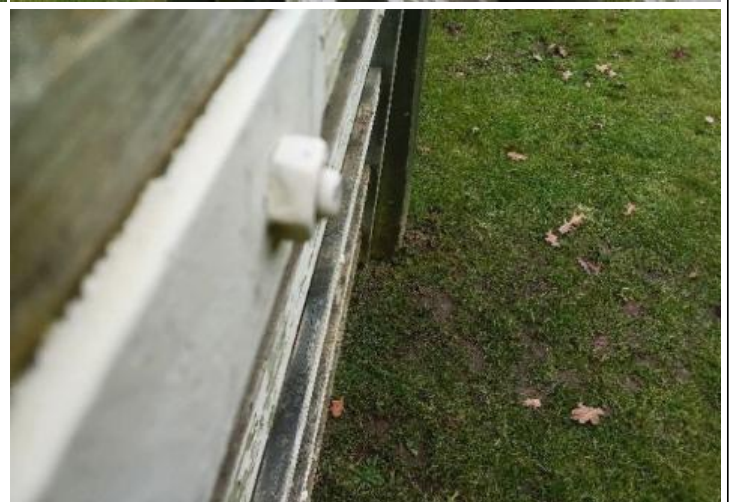
**Item:** Gates - Gate - Self Closing  
**Manufacturer:** Not Identified

**Finding:** There are projecting bolt thread(s) present

**Action:** Remove excess thread length and deburr or provide cap

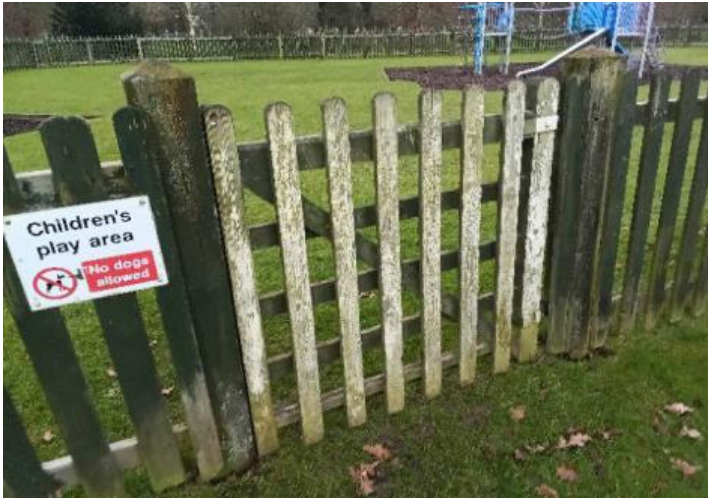
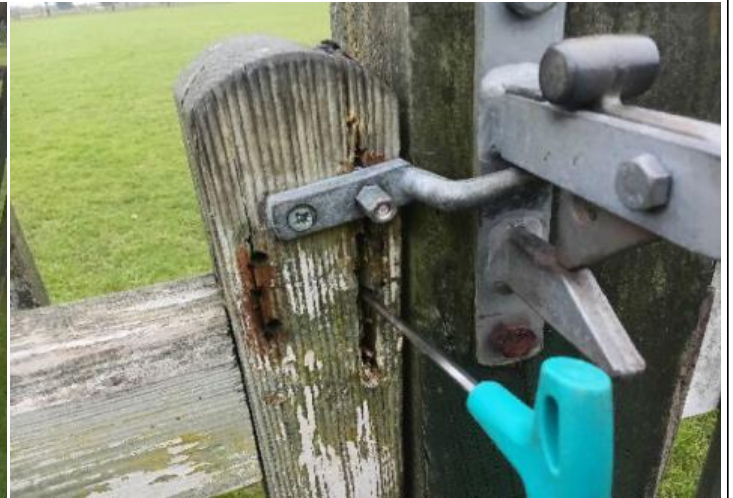
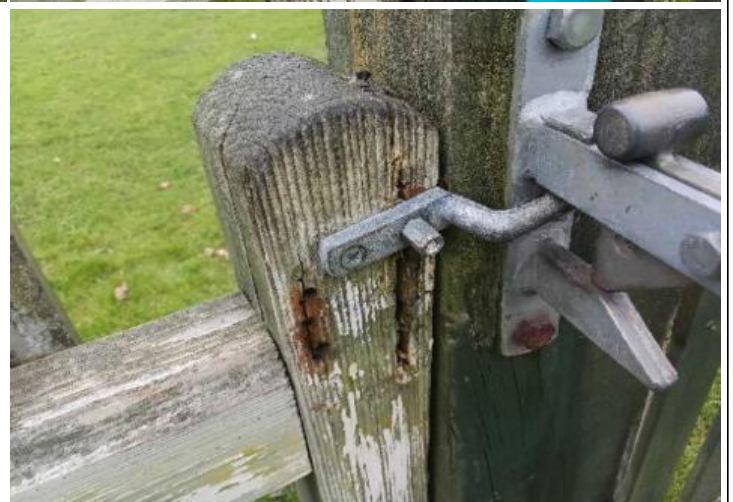
**Item:** Gates - Gate - Self Closing  
**Manufacturer:** Not Identified

**Finding:** There is some evidence of rot in the timber

**Action:** Monitor for any further deterioration and replace as required

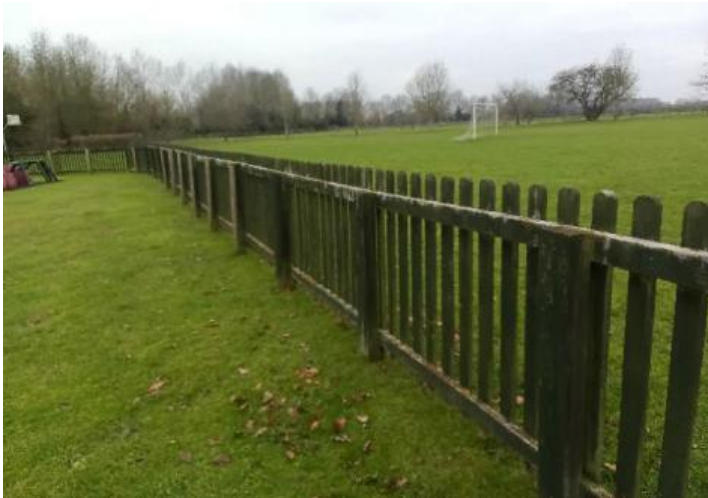
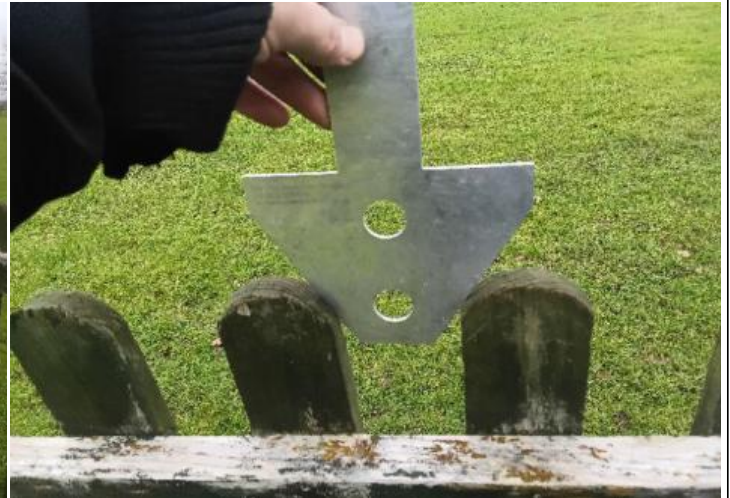
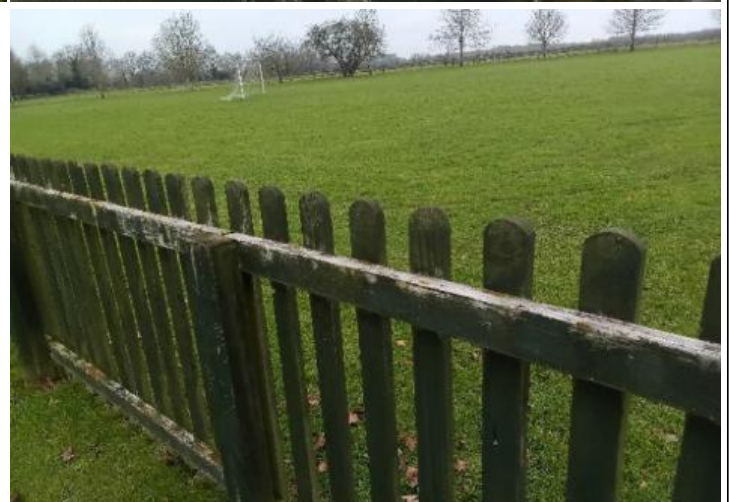
**Item:** Fences - Fencing - Timber  
**Manufacturer:** Not Identified

**Finding:** The configuration of the fence timbers poses a risk of head and neck entrapment in the fence tops **Action:** Monitor - No remedial work recommended

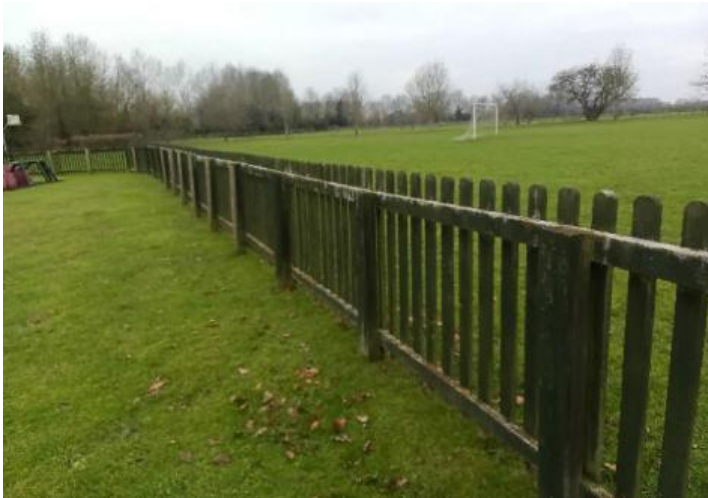
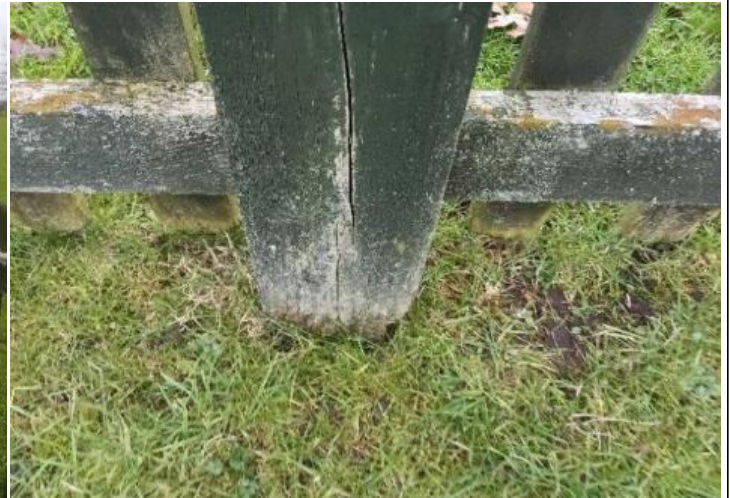
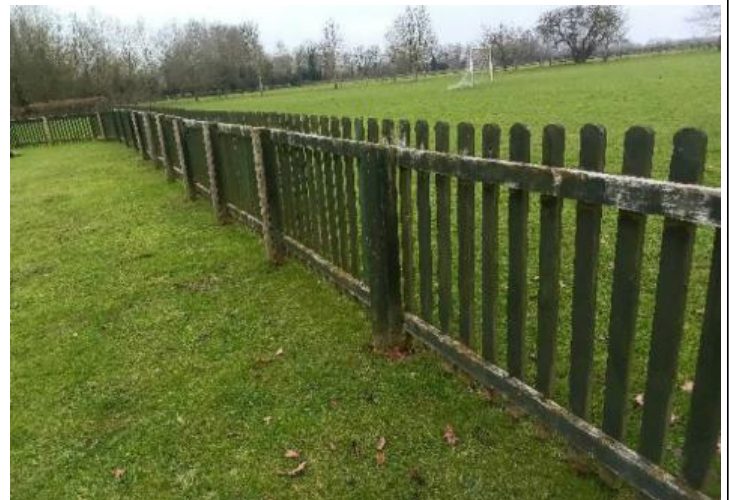
**Item:** Fences - Fencing - Timber  
**Manufacturer:** Not Identified

**Finding:** There are areas or parts of the timber on the structure that have rotted and sheared at base level

**Action:** Replace all affected timbers

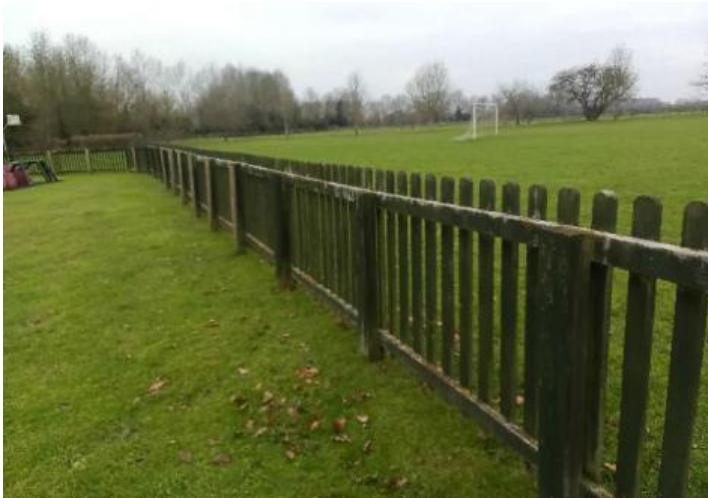
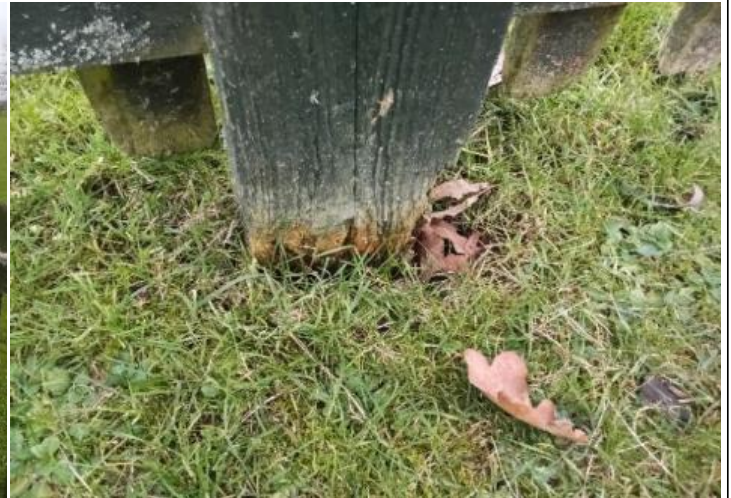
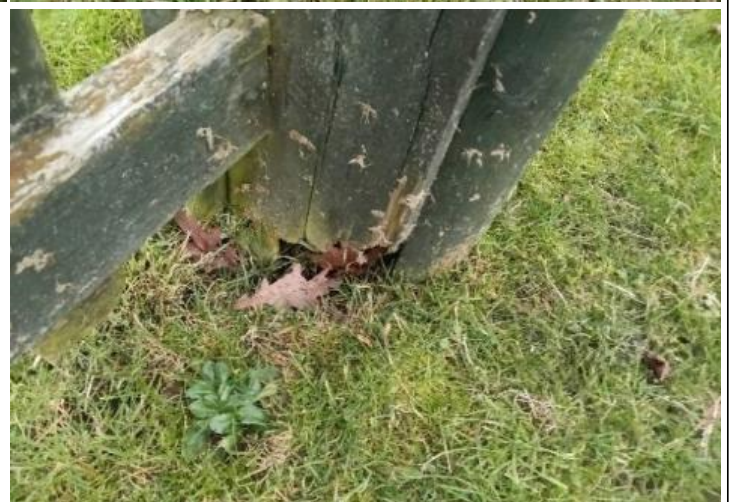
**Item:** Fences - Fencing - Timber  
**Manufacturer:** Not Identified

**Finding:** There is some strimmer / machinery damage apparent on the posts, this can penetrate the preservative applied to the timber and accelerate the rotting process

**Action:** Monitor for any deterioration (rot) and replace as required

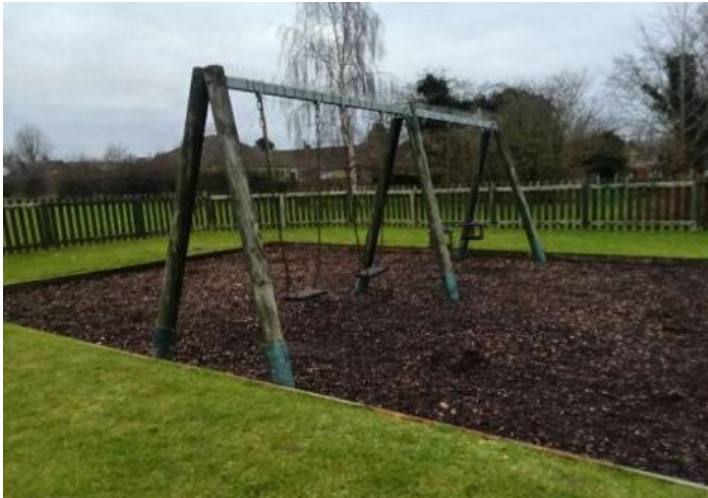
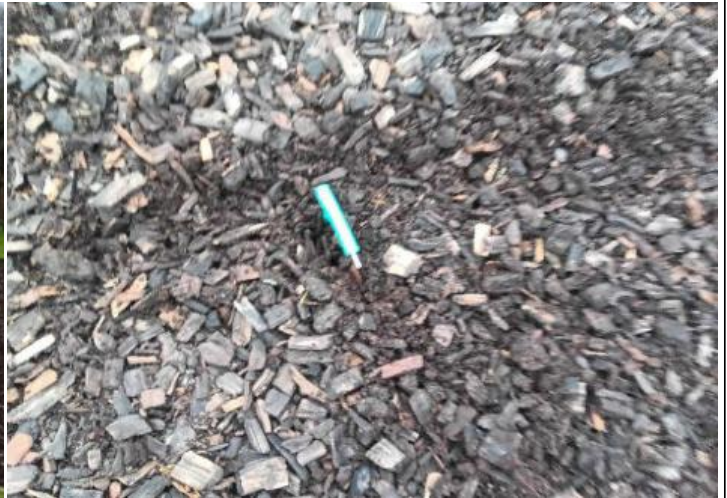
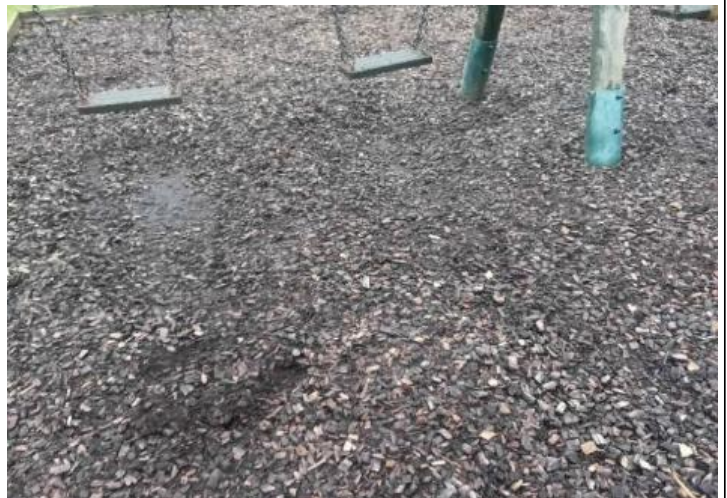
**Item:** Swings - 2 Bay 2 Flat 2 Cradle  
**Manufacturer:** Not Identified

**Finding:** The depth of the loose fill surfacing is lower than the recommended depth specified in BS EN 1176; the free height of fall of the equipment is less than 2.0m and a minimum of 300mm depth should be provided (including an extra 100mm to allow for compaction and displacement as per BS EN 1176 Part 1 - Table 4)

**Action:** Top up loose fill surfacing to recommended levels

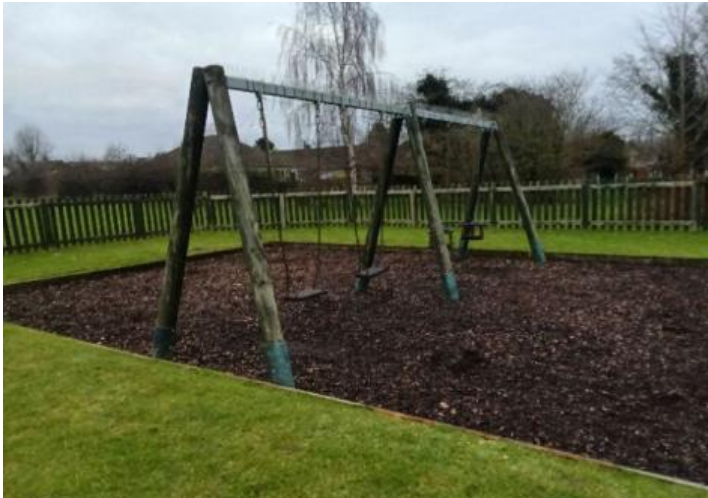
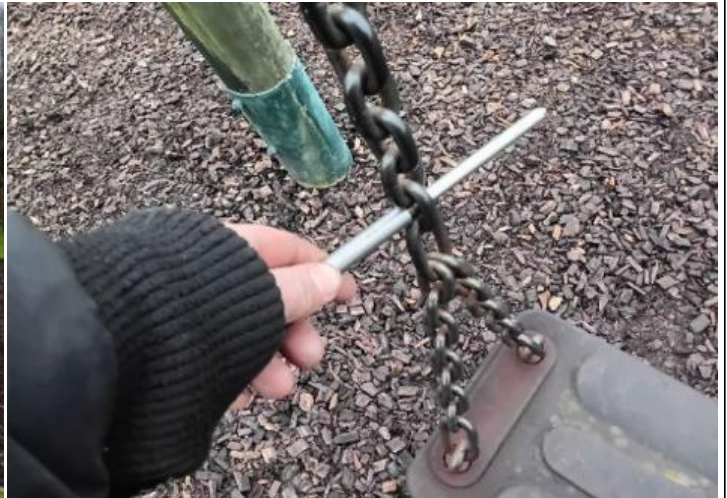
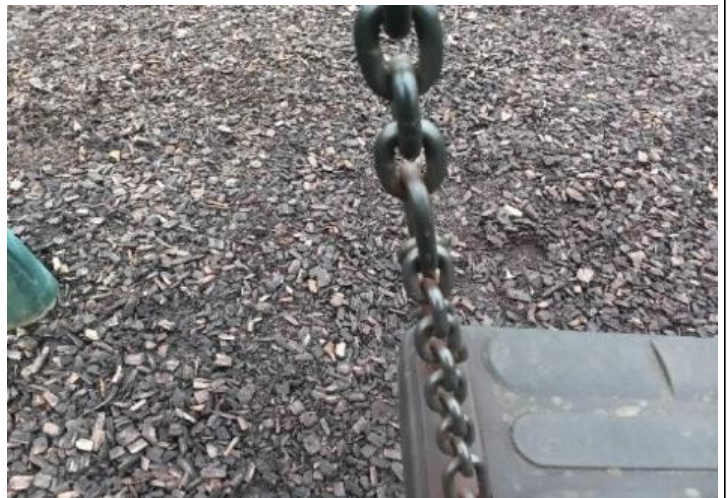
**Item:** Swings - 2 Bay 2 Flat 2 Cradle  
**Manufacturer:** Not Identified

**Finding:** The chain openings are in excess of the 8.6mm as recommended by BS EN 1176 **Action:** Monitor - No action given the risk assessment

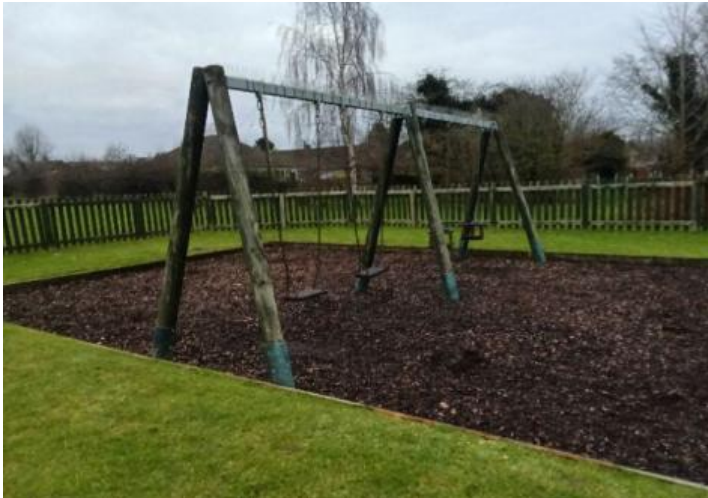
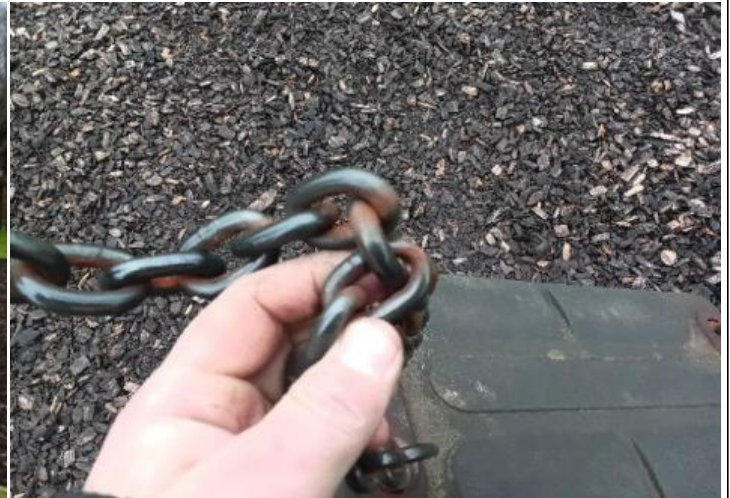
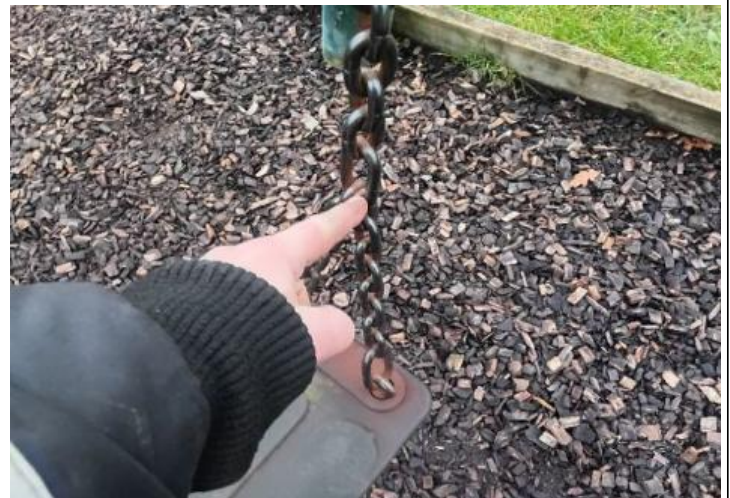
**Item:** Swings - 2 Bay 2 Flat 2 Cradle  
**Manufacturer:** Not Identified

**Finding:** There is some notable evidence of chain wear

**Action:** Monitor for any further deterioration and replace when 40% worn

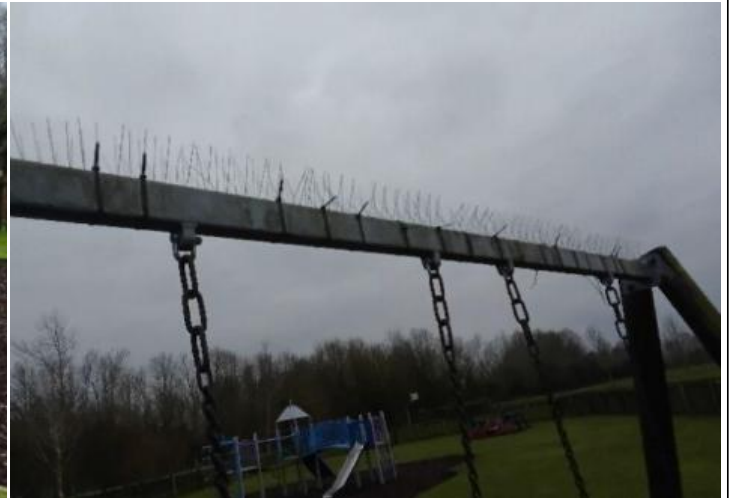
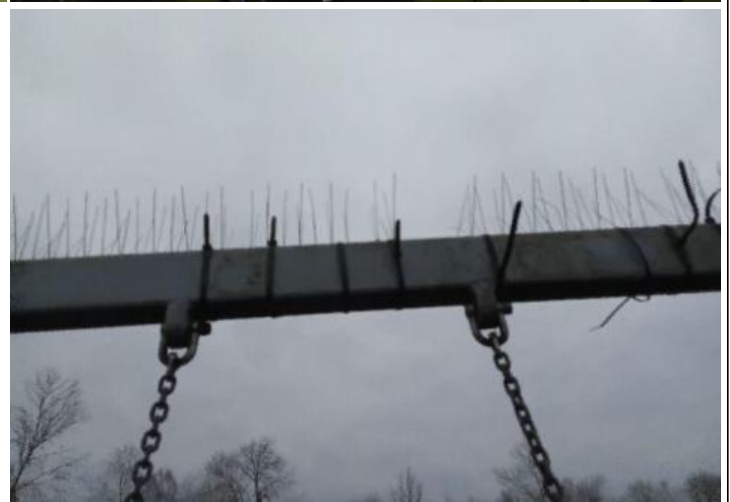
**Item:** Swings - 2 Bay 2 Flat 2 Cradle  
**Manufacturer:** Not Identified

**Finding:** Rigid bird deterrents have been used on the swing cross beam

**Action:** Consider replacing with soft touch deterrents such as cable ties

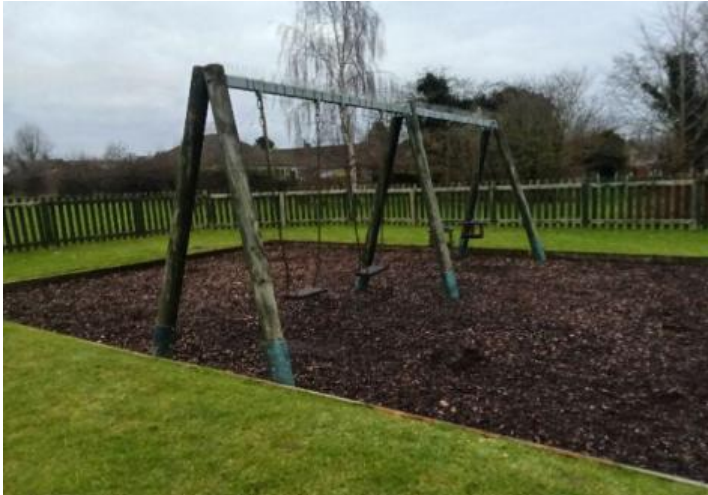
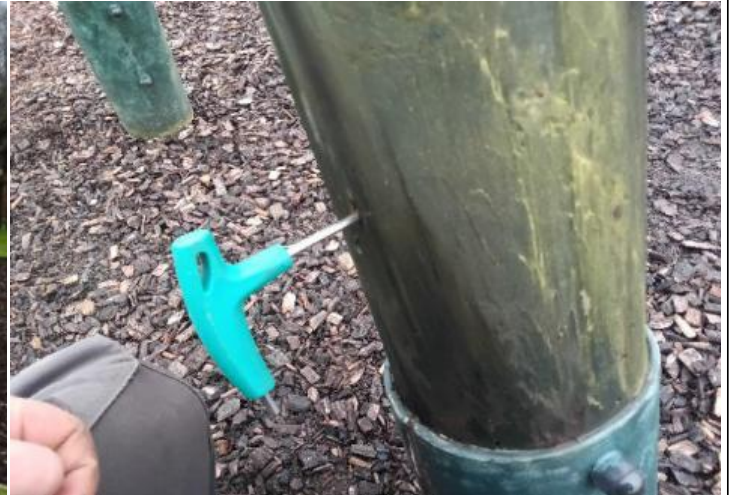
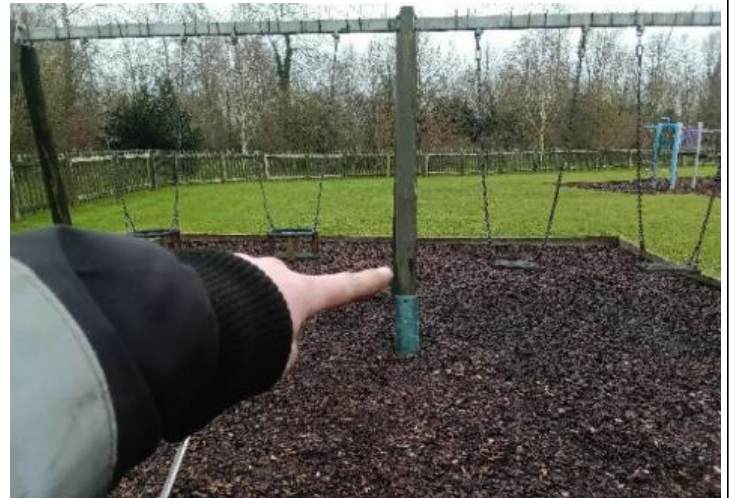
**Item:** Swings - 2 Bay 2 Flat 2 Cradle  
**Manufacturer:** Not Identified

**Finding:** There are areas or parts of the timber posts that have rotted

**Action:** Replace all affected timbers

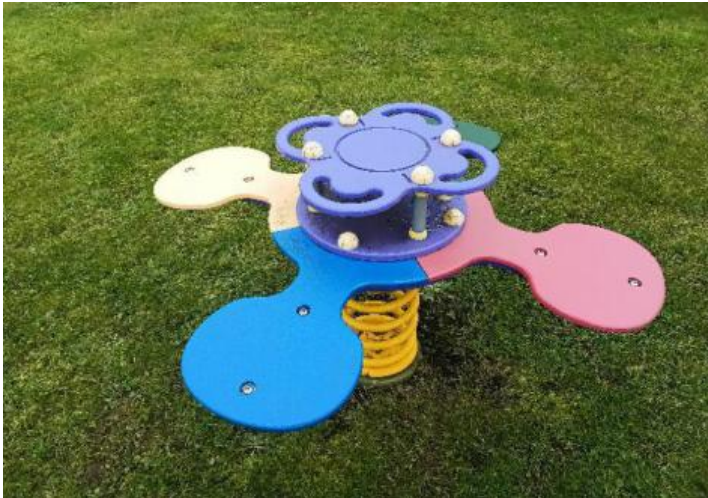
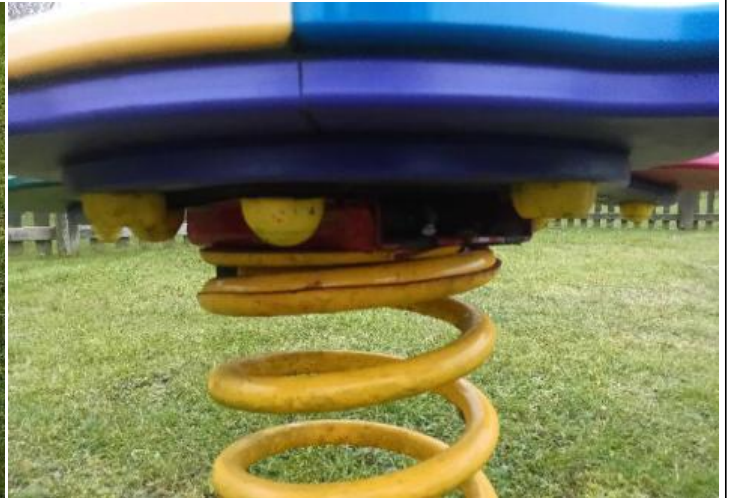
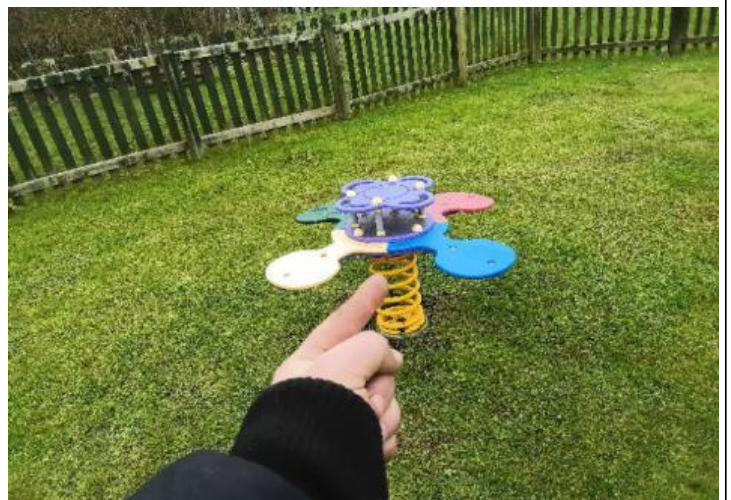
**Item:** Rocking Equipment - Four Way Springer  
**Manufacturer:** Fahr Industries

**Finding:** The paintwork on this item has been damaged or worn exposing the metal underneath which is rusting / corroding

**Action:** Treat affected areas and repaint

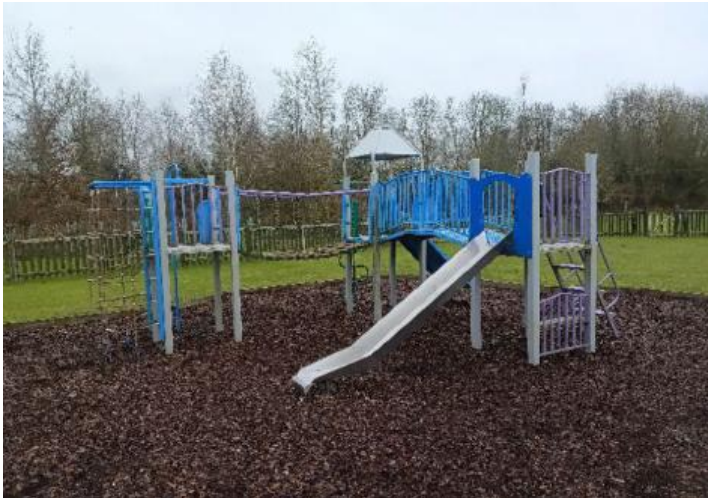
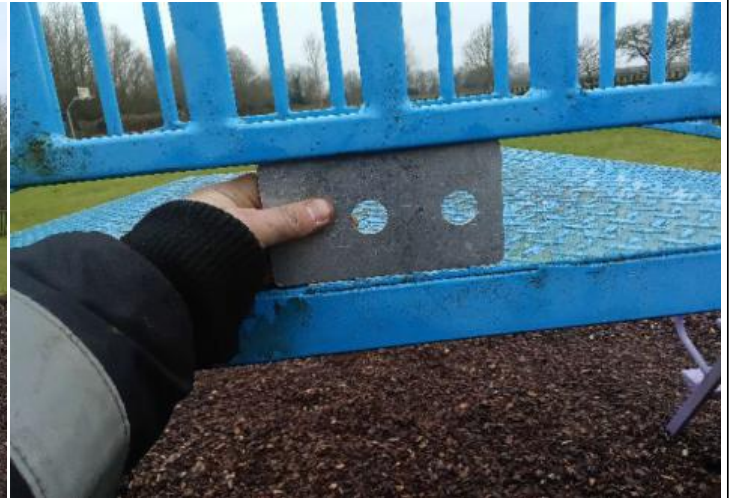
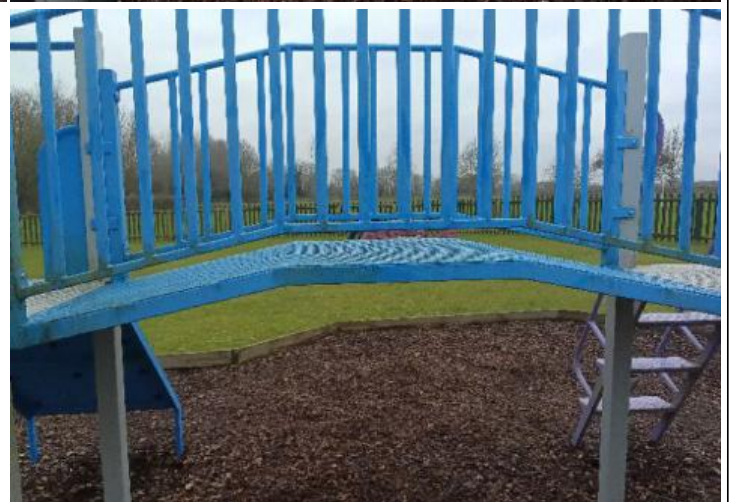
**Item:** Activity Equipment - Multi Play (Junior)  
**Manufacturer:** Not Identified

**Finding:** The item fails to meet the requirements of BS EN 1176 Part 1 4.2.7.2 head and neck entrapment in the barriers and/or steps

**Action:** Monitor - No action given the risk assessment

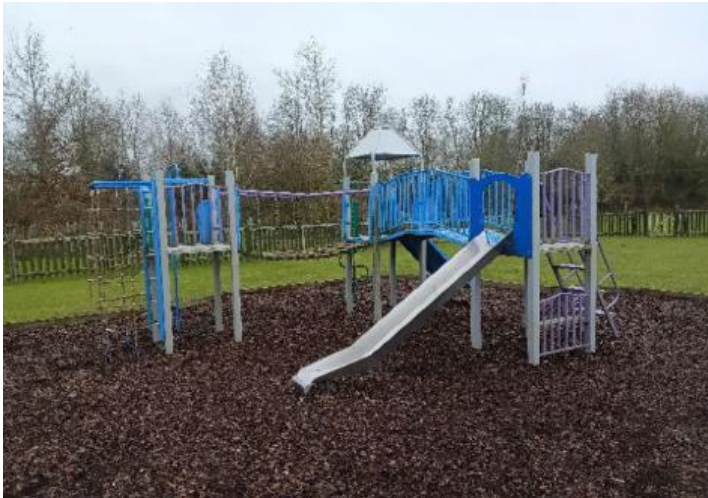
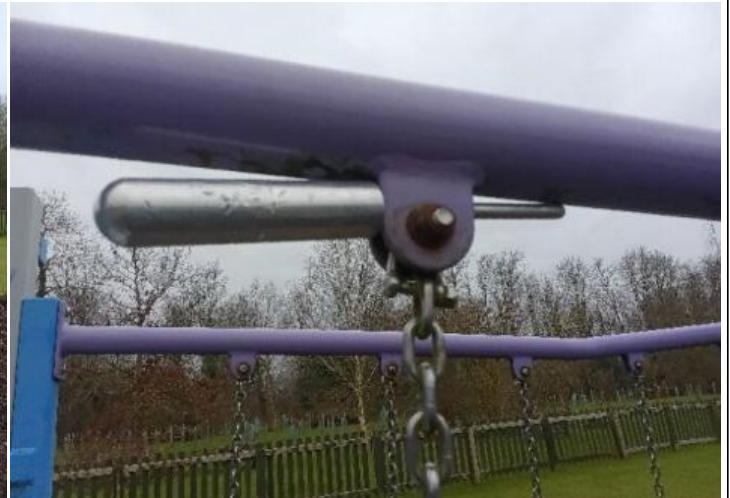
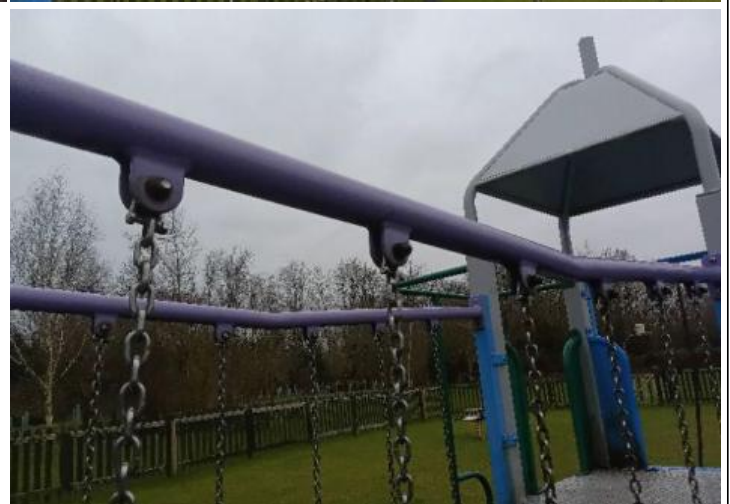
**Item:** Activity Equipment - Multi Play (Junior)  
**Manufacturer:** Not Identified

**Finding:** There is/are finger entrapment/s in the bridge connections and the item fails to meet the requirements of BS EN 1176 Part 1 4.2.7.6 Entrapment of fingers

**Action:** Monitor - No action given the risk assessment

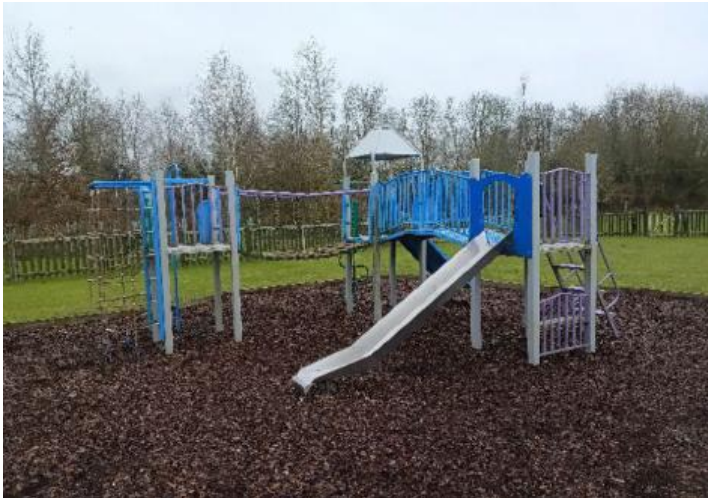
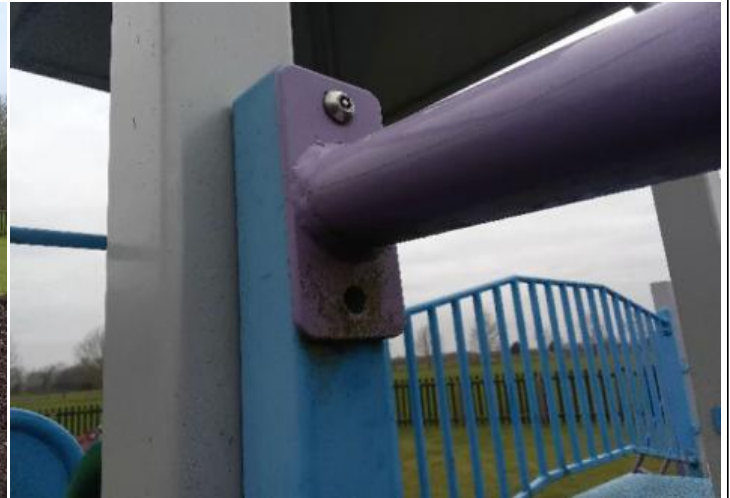
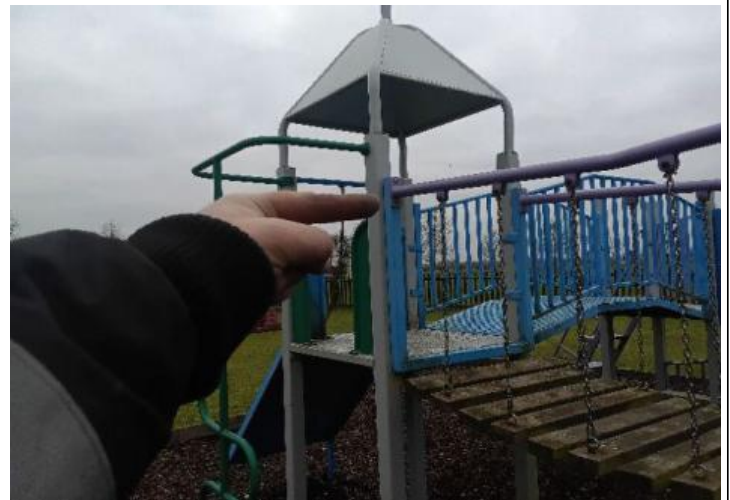
**Item:** Activity Equipment - Multi Play (Junior)  
**Manufacturer:** Not Identified

**Finding:** There is or are fixings missing on the item

**Action:** Replace all missing fixings

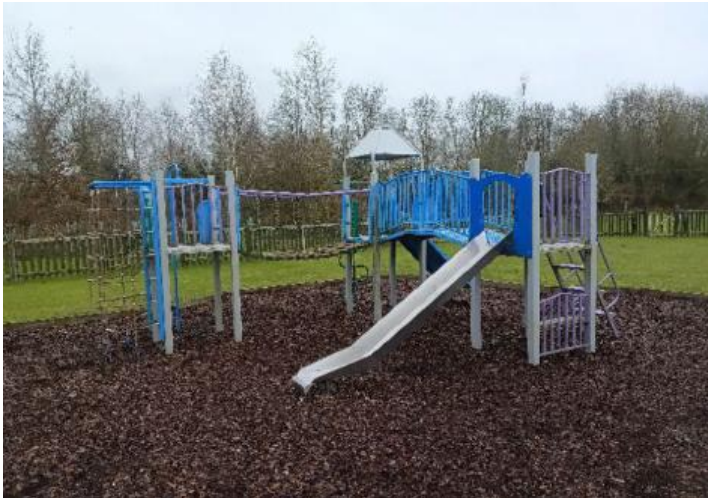
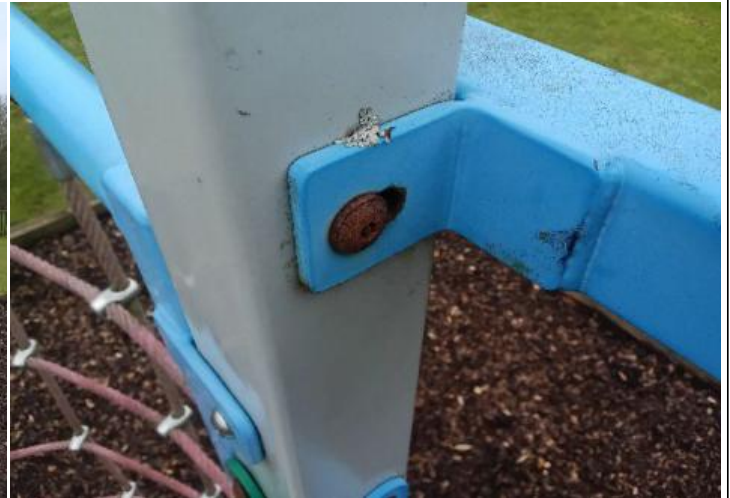
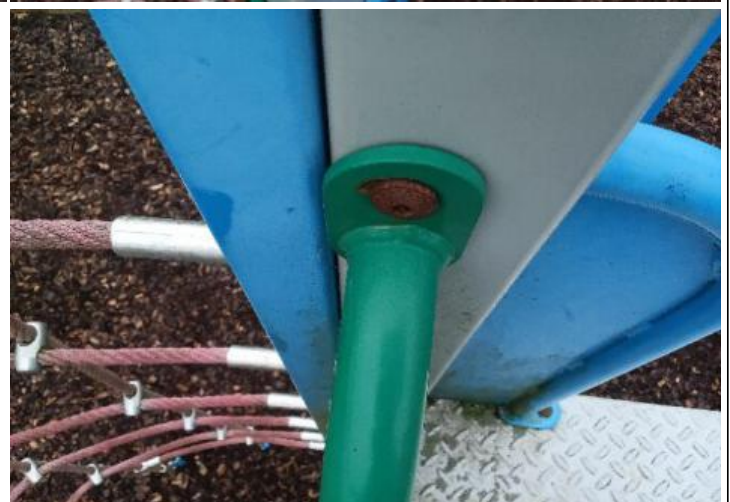
**Item:** Activity Equipment - Multi Play (Junior)  
**Manufacturer:** Not Identified

**Finding:** The fixings have corroded excessively

**Action:** Replace all corroded fixings

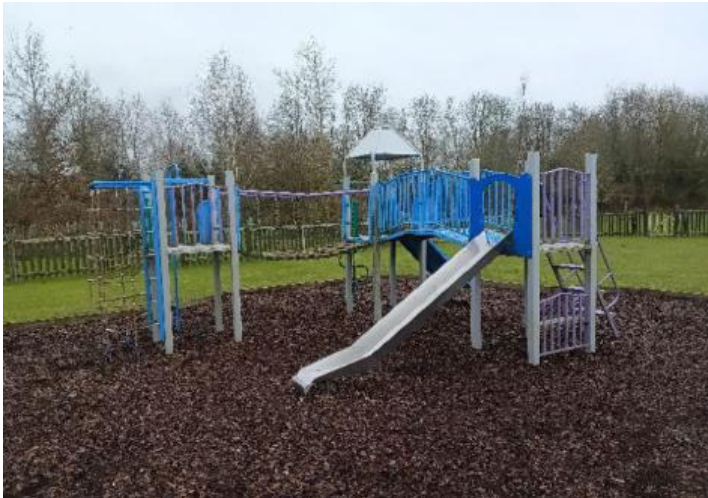
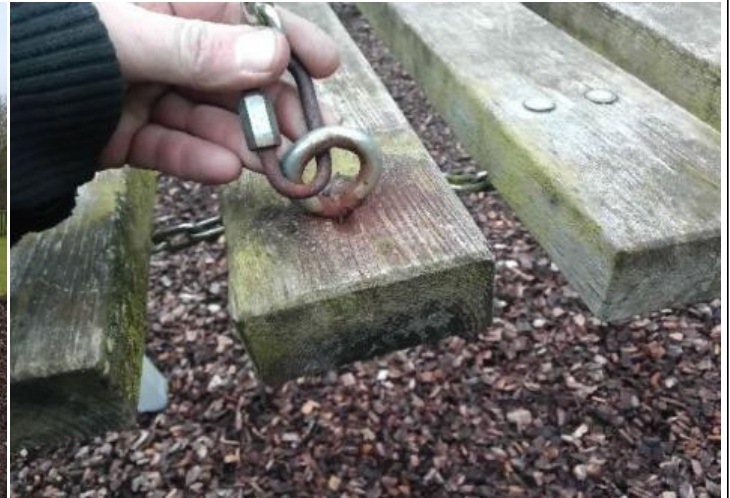
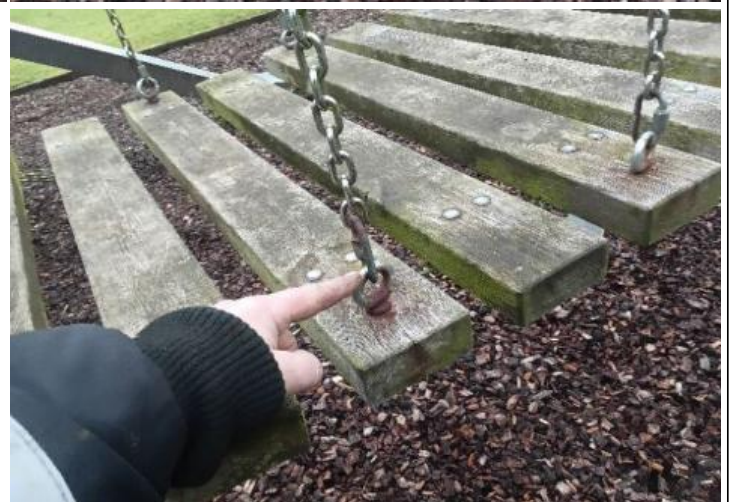
**Item:** Activity Equipment - Multi Play (Junior)  
**Manufacturer:** Not Identified

**Finding:** There is some wear to the shackles.

**Action:** Monitor for any further deterioration and replace when 40% worn

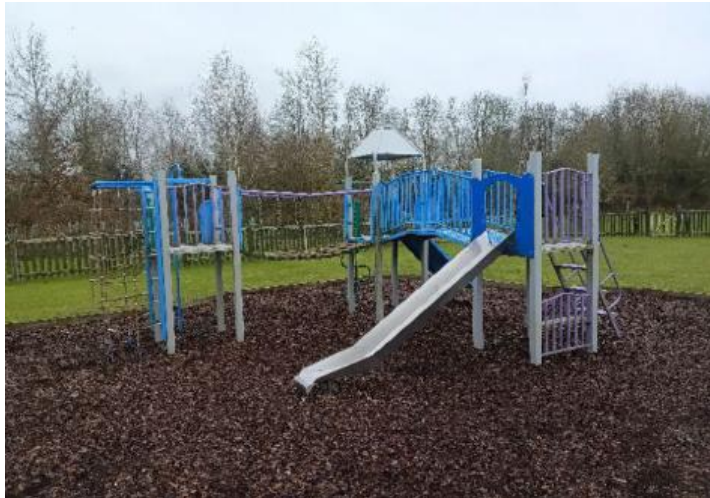
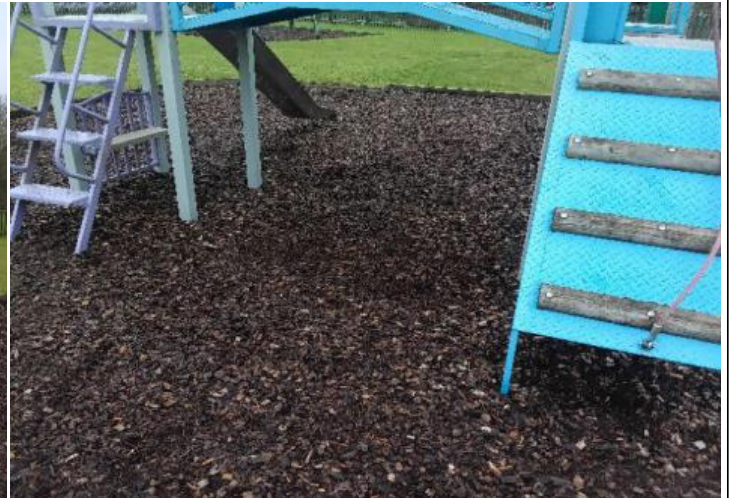
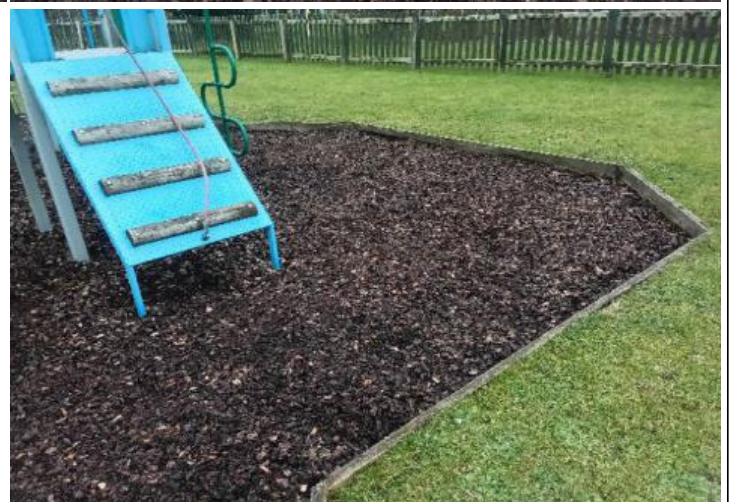
**Item:** Activity Equipment - Multi Play (Junior)  
**Manufacturer:** Not Identified

**Finding:** The depth of the loose fill surfacing is lower than the recommended depth specified in BS EN 1176; the free height of fall of the equipment is less than 2.0m and a minimum of 300mm depth should be provided (including an extra 100mm to allow for compaction and displacement as per BS EN 1176 Part 1 - Table 4)

**Action:** Top up loose fill surfacing to recommended levels

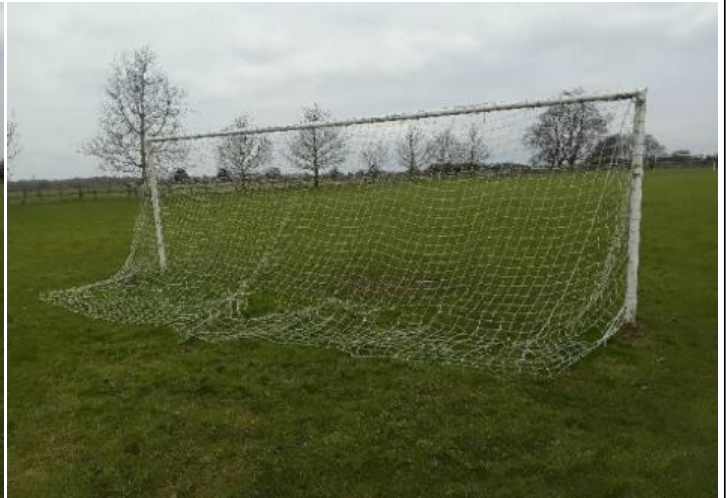
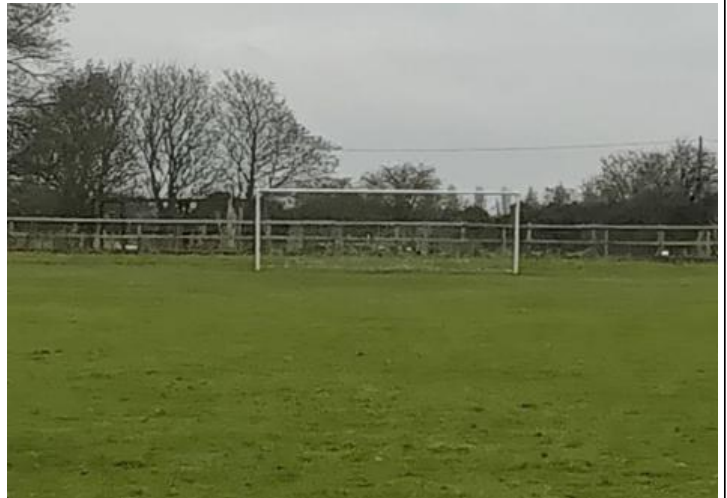
**Item:** Multi Use Games Area - Football Goal  
**Manufacturer:** Not Identified

**Finding:** NB: We have undertaken a maintenance inspection only of the football goal(s); full load testing falls outside the scope of our inspection.

**Action:** Implement load testing as required
