## Annual Inspection

Charney Hall and Field Trust

Charney Field

Inspection Ref: 2613246

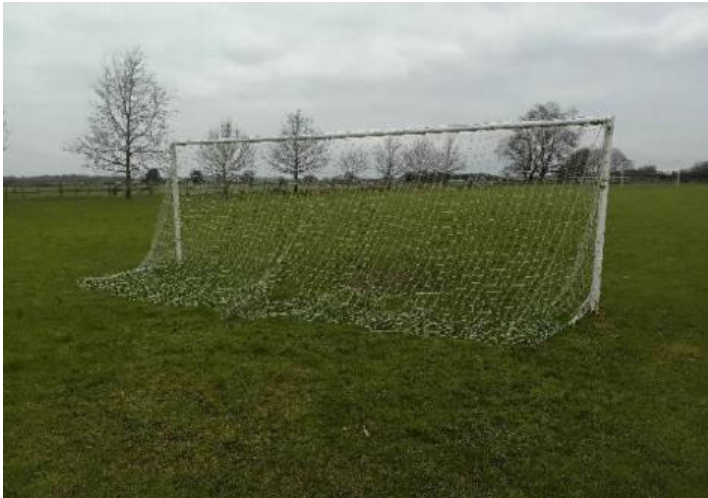
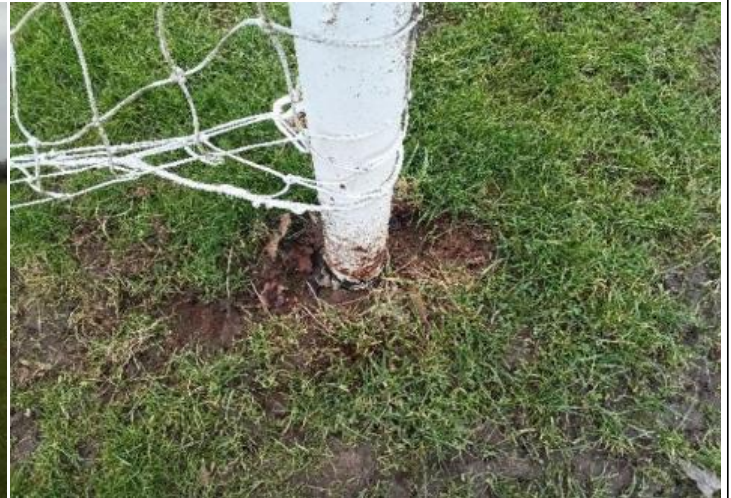
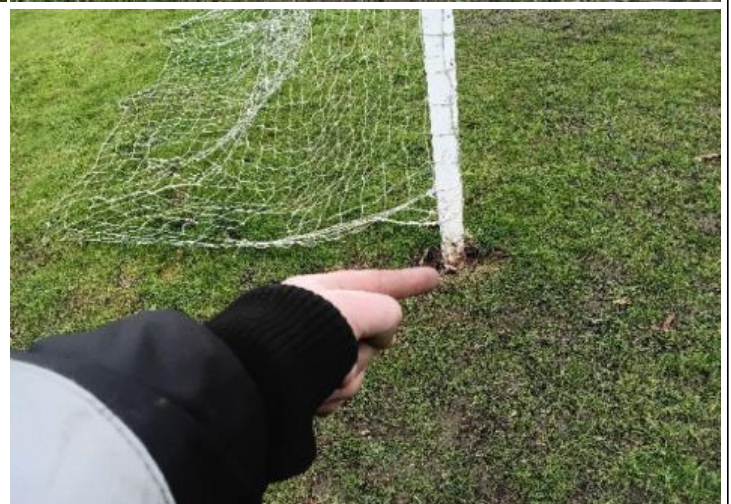
**Item:** Multi Use Games Area - Football Goal  
**Manufacturer:** Not Identified

**Finding:** The item is slightly loose in its foundations

**Action:** Monitor for any further deterioration and repair as required

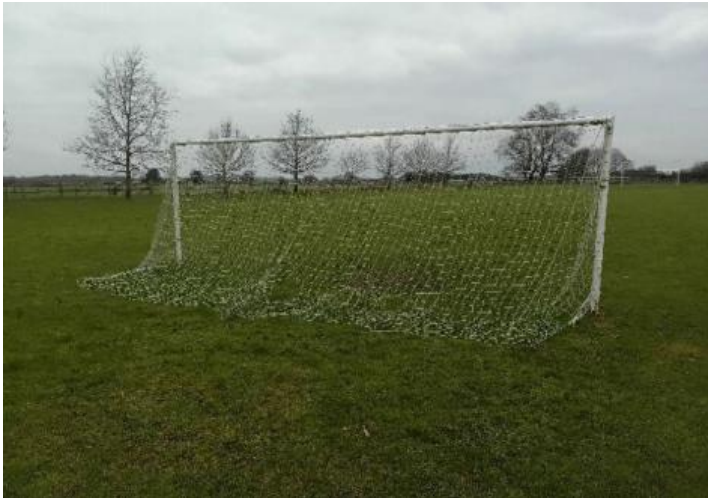
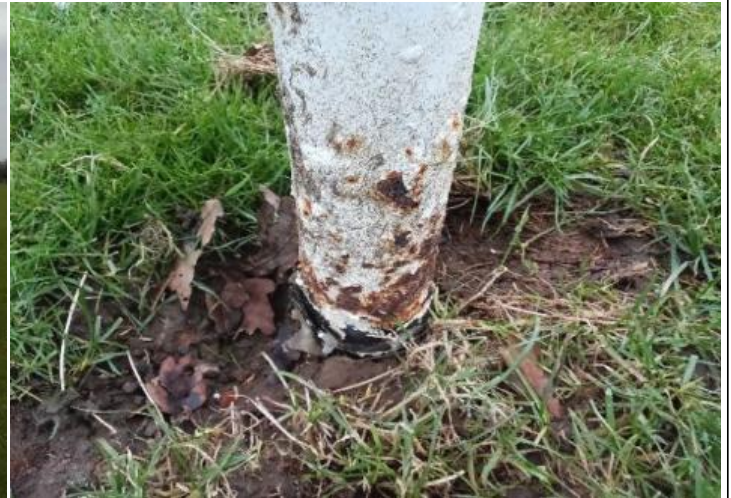
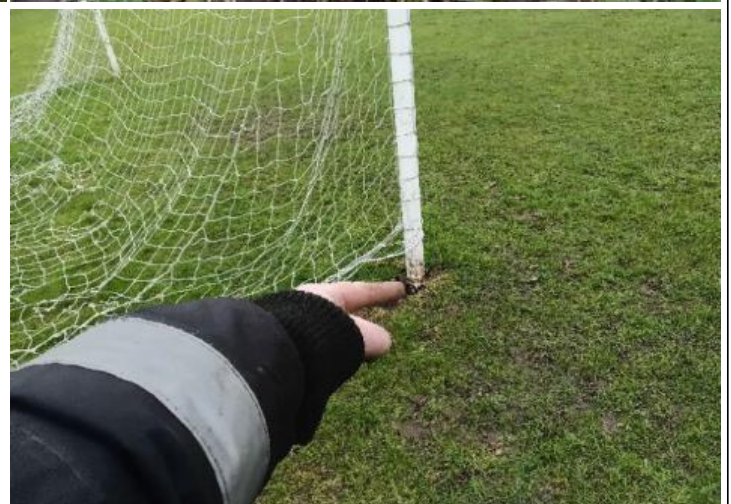
**Item:** Multi Use Games Area - Football Goal  
**Manufacturer:** Not Identified

**Finding:** The paintwork on this item has been damaged or worn exposing the metal underneath which is rusting / corroding

**Action:** Treat affected areas and repaint

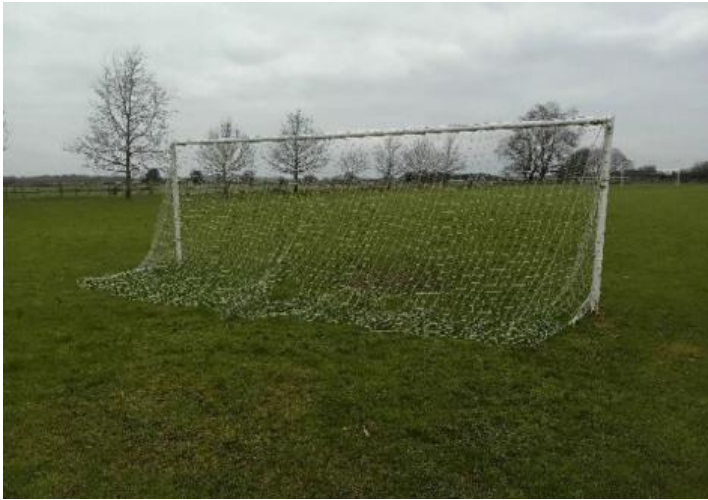
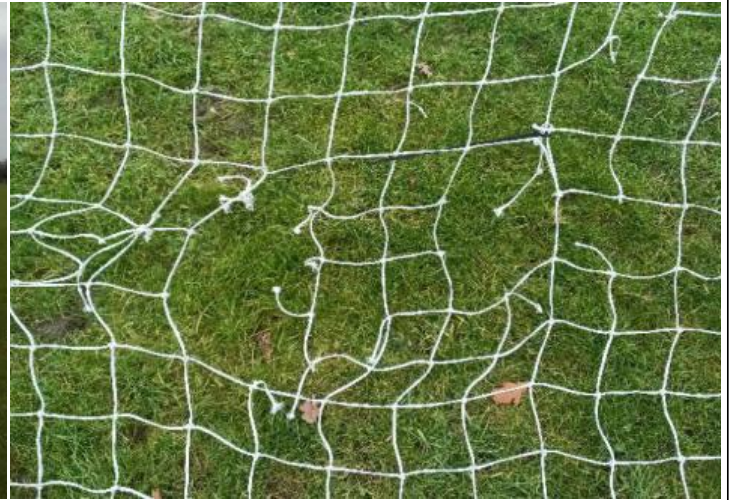
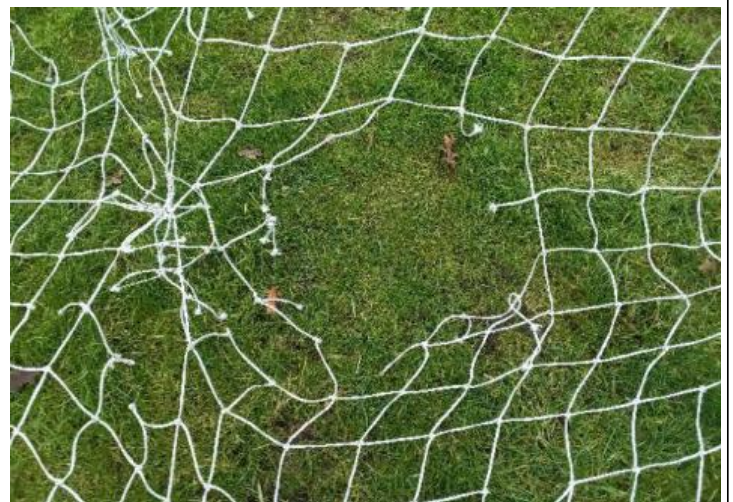
**Item:** Multi Use Games Area - Football Goal  
**Manufacturer:** Not Identified

**Finding:** The net is damaged and requires removal / replacement

**Action:** Replace
