the **play inspection** company

Annual Inspection

Charney Hall and Field Trust

Charney Field

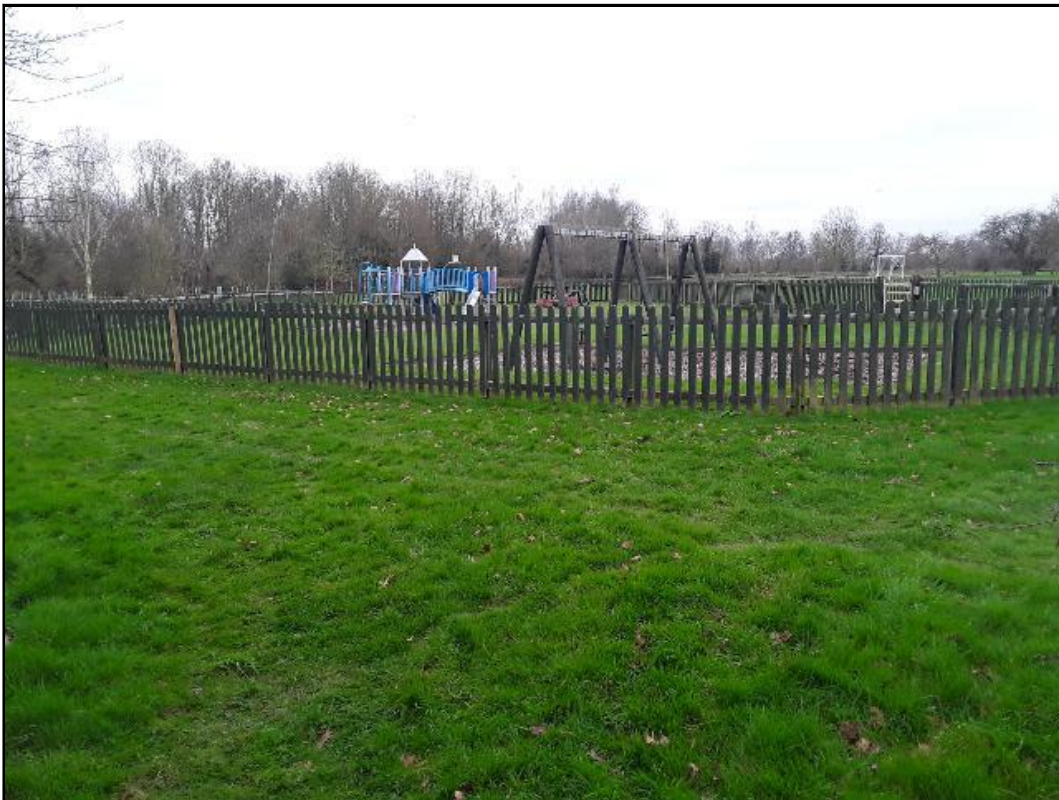
Risk Assessment: 8 Low Risk

The site is located in an area of public open space and is not directly overlooked by any properties in the local community.

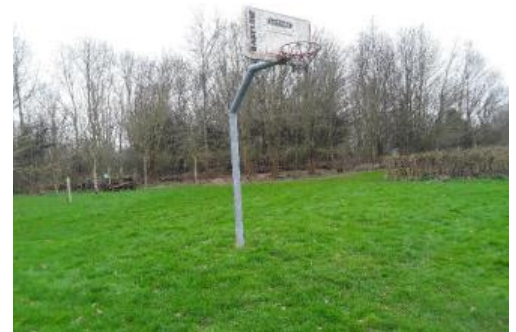
i 4 - Very Low Risk

Item: Basketball Post
Manufacturer: Baseline
Surface Type: Grass
Item Quantity: 1
Equipment Compliance: Yes
Surface Area Compliance: N/A

Total Findings: 1
