## Annual Inspection

Charney Hall and Field Trust

Charney Field

Inspection Ref: 2613246

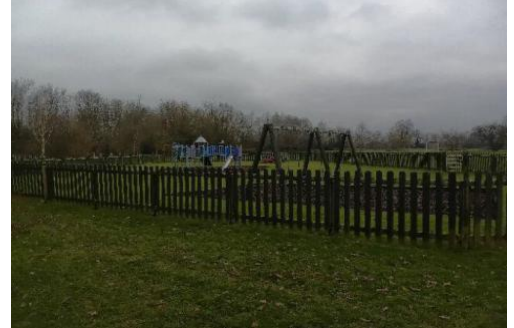
**Item:** Site General  
**Manufacturer:** Owner/Operator  
**Surface Type:** N/A  
**Item Quantity:** 1  
**Equipment Compliance:** N/A  
**Surface Area Compliance:** N/A

There is some evidence of rot in the timber edging - Monitor for any further deterioration and replace as required

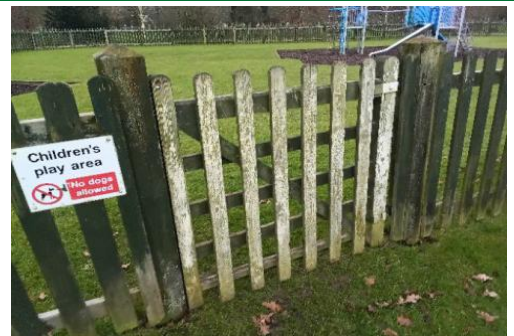
**Item:** Gate - Self Closing  
**Manufacturer:** Not Identified  
**Surface Type:** Grass  
**Item Quantity:** 2  
**Equipment Compliance:** N/A  
**Surface Area Compliance:** N/A

There are openings that are less than 12mm that could trap or crush fingers - Provide a 12mm gap throughout full range of motion at both sides of gate

There is some evidence of rot in the timber - Monitor for any further deterioration and replace as required

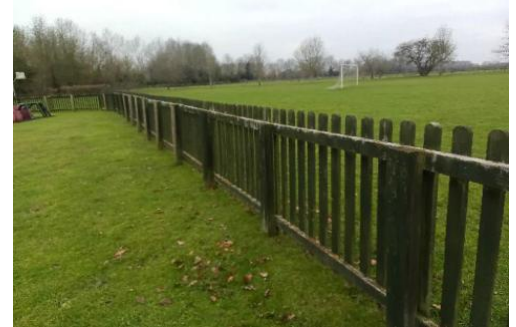
**Item:** Fencing - Timber  
**Manufacturer:** Not Identified  
**Surface Type:** Grass  
**Item Quantity:** 1  
**Equipment Compliance:** N/A  
**Surface Area Compliance:** N/A

The configuration of the fence timbers poses a risk of head and neck entrapment in the fence tops - Monitor - No remedial work recommended

There are areas or parts of the timber on the structure that have rotted and sheared at base level - Replace all affected timbers

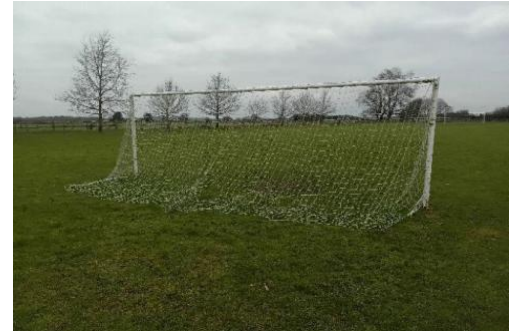
**Item:** Football Goal  
**Manufacturer:** Not Identified  
**Surface Type:** Grass  
**Item Quantity:** 2  
**Equipment Compliance:** N/A  
**Surface Area Compliance:** N/A

NB: We have undertaken a maintenance inspection only of the football goal(s); full load testing falls outside the scope of our inspection. - Implement load testing as required

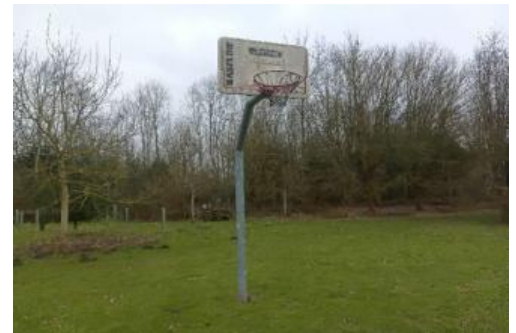
**Item:** Basketball Post  
**Manufacturer:** Baseline  
**Surface Type:** Grass  
**Item Quantity:** 1  
**Equipment Compliance:** Yes  
**Surface Area Compliance:** N/A

This item is satisfactory - no work required -
